**Environmental Review for Activity/Project that is Categorically
Excluded Subject to Section 58.5
Pursuant to 24 CFR 58.35(a)**

Project Name: Davis Ventures Community Center

Project Location: 33478 U.S. Highway 264, Engelhard, Hyde County, NC 27824

ROOF & BUILDING REPAIRS

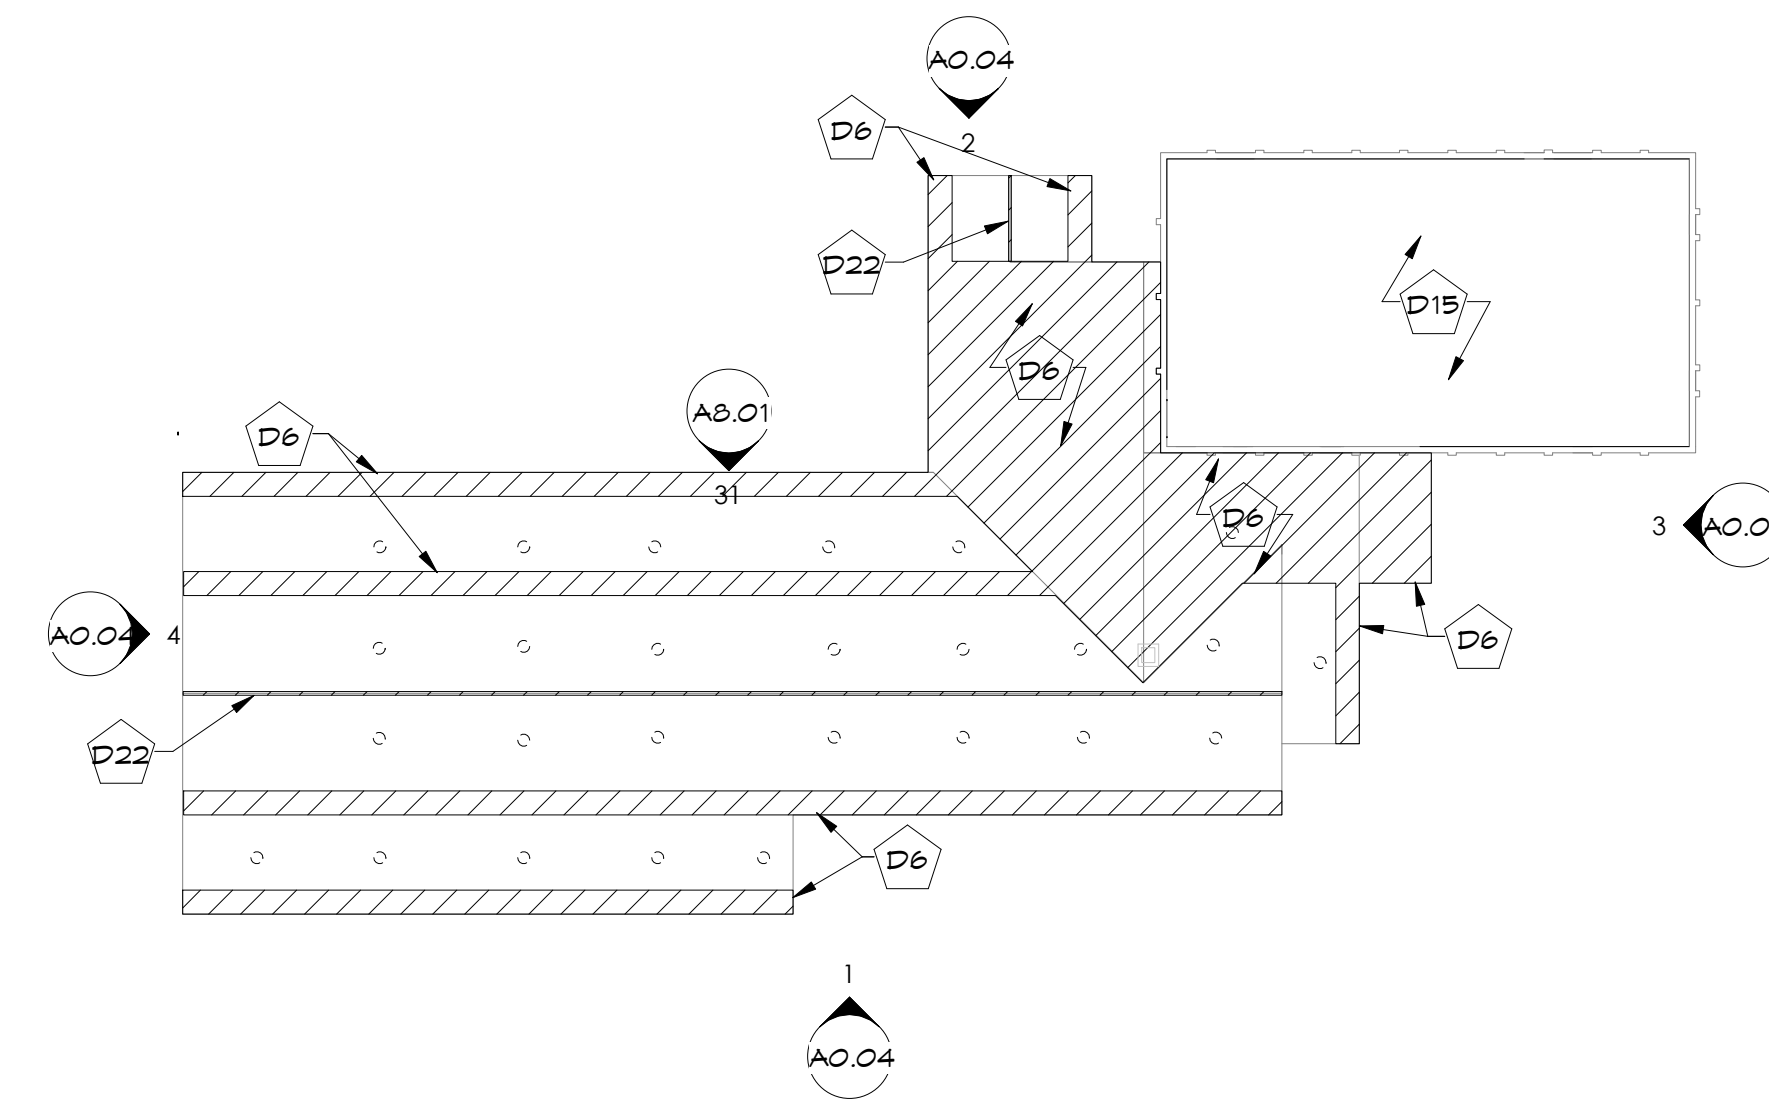
DEMO ROOF PLAN - ROOF SHEATHING
1/32" = 1'-0" **1**

- D21** – EXIST CHIMNEY TO REMAIN, NO WORK.
 - D22** – REMOVE PORTION OF EXISTING ROOF SEATHING FOR VENTED RIDGE PER MANUF. REQUIREMENTS FOR FREE AREA.

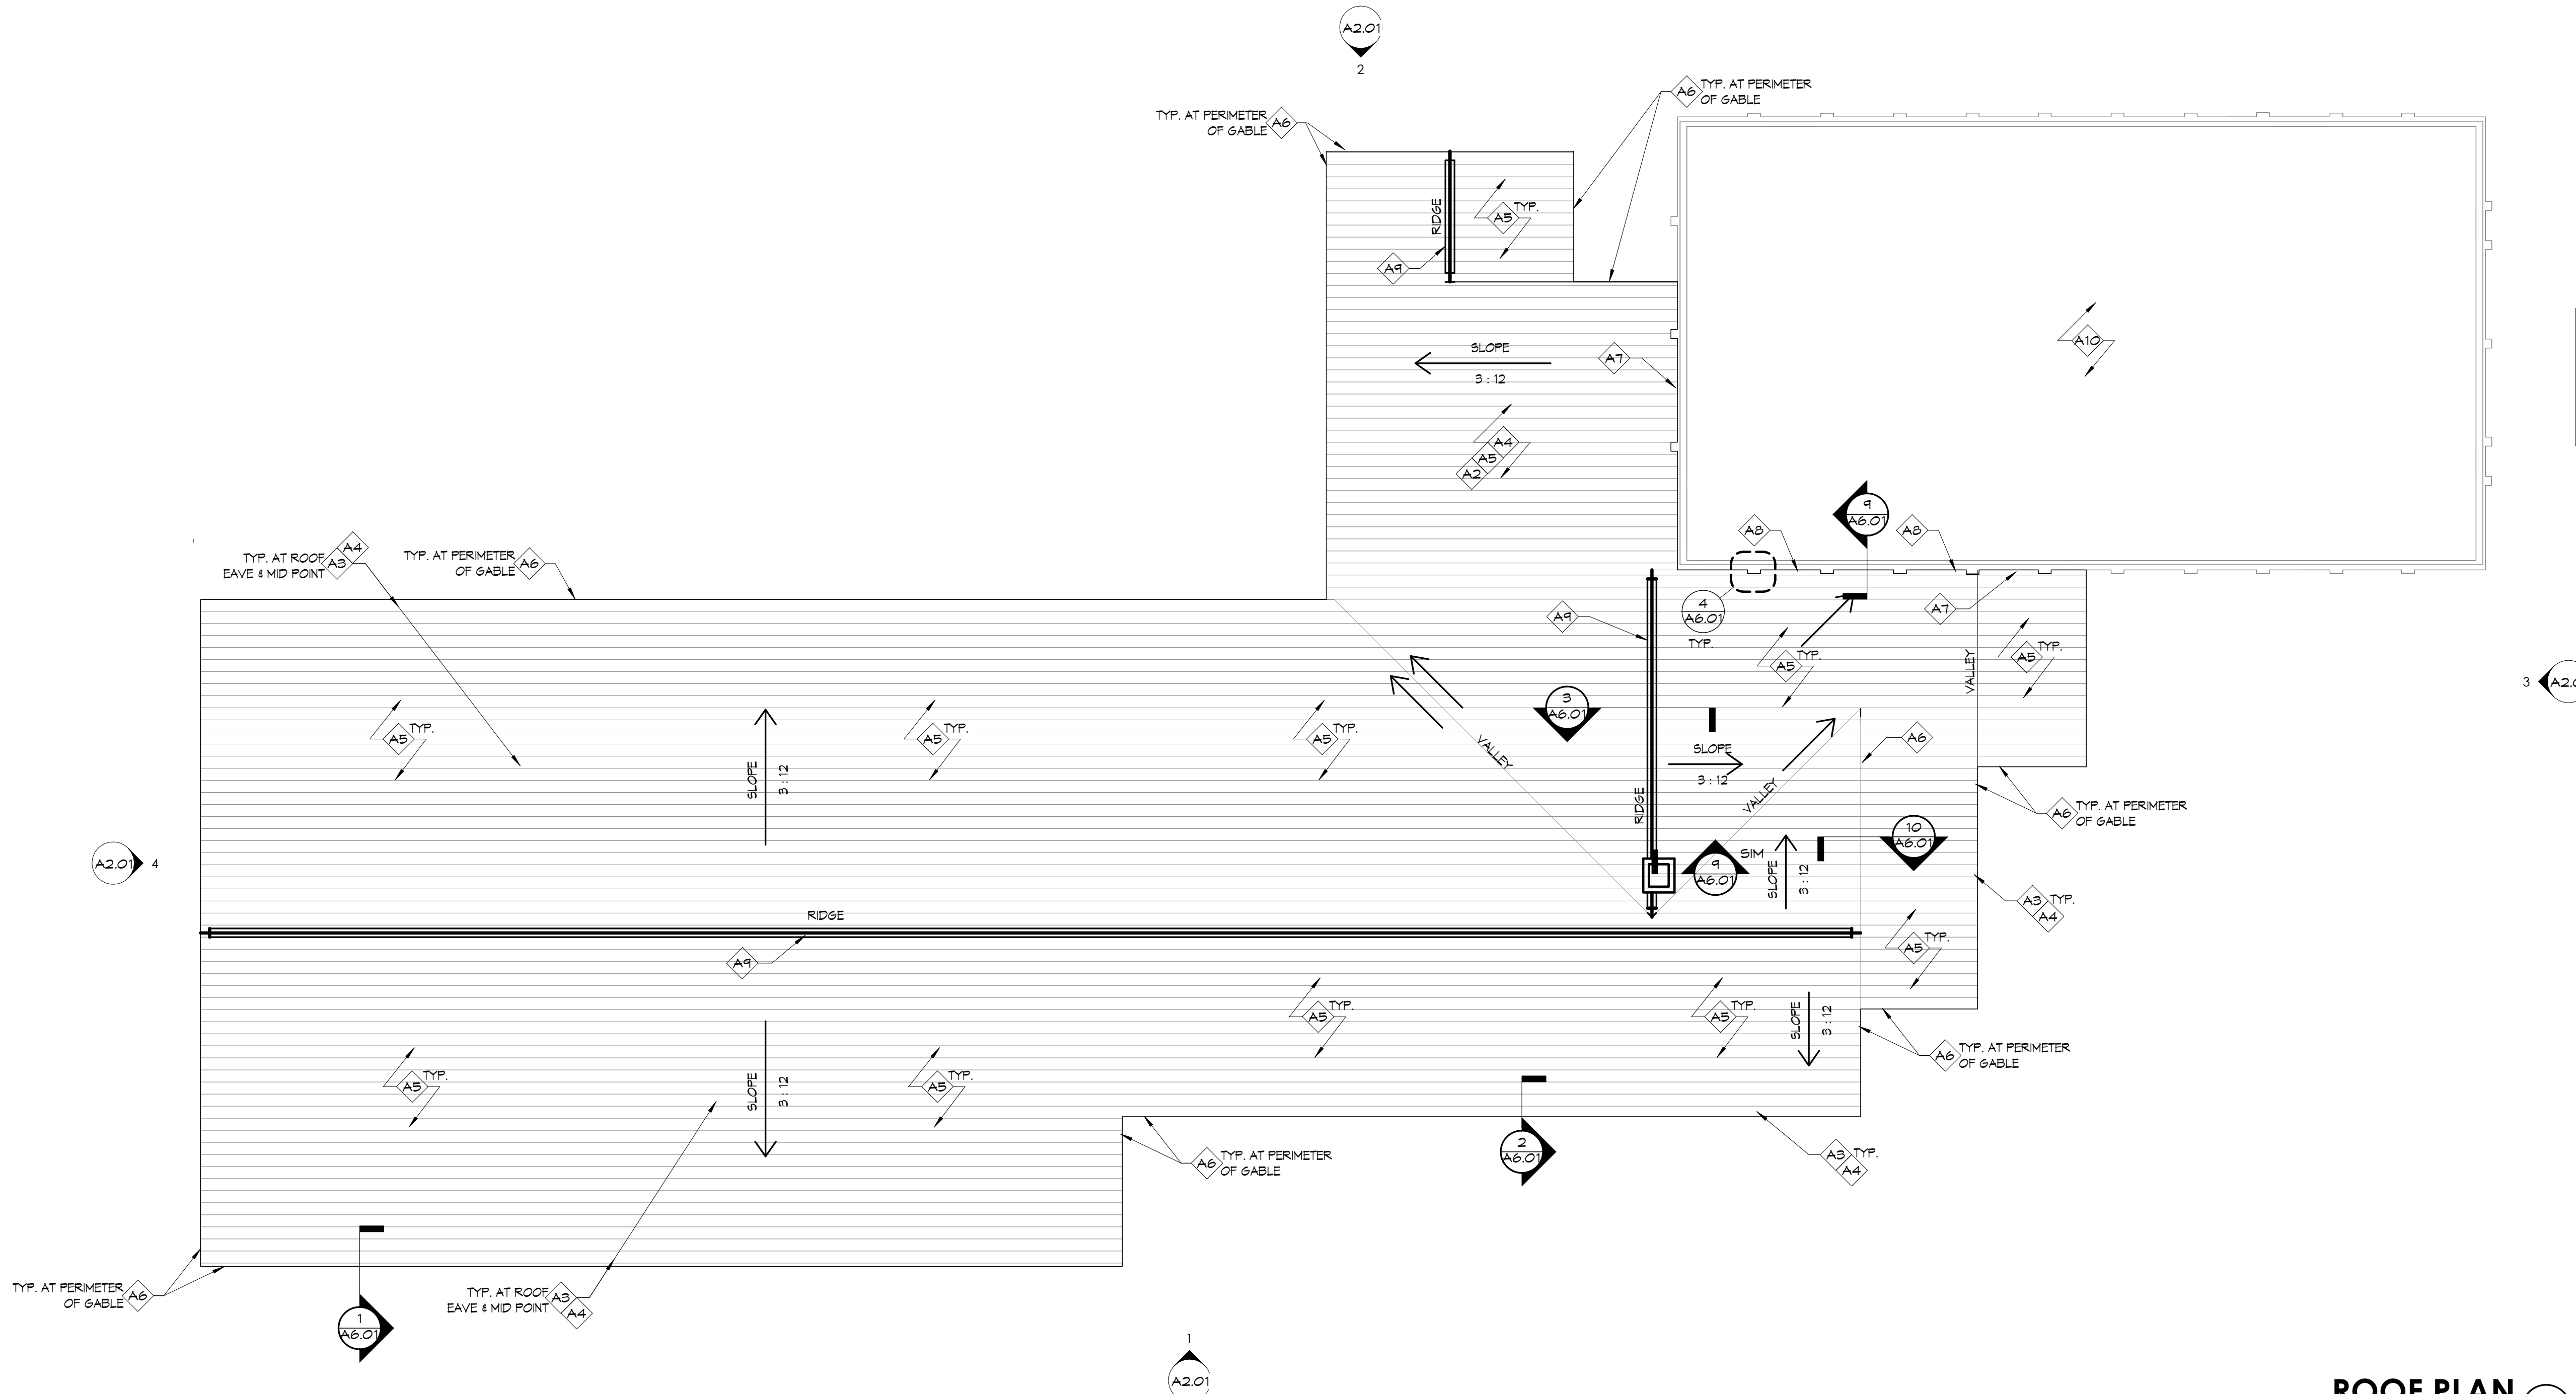
ROOF PLAN 1
3/32" = 1'-0"

GENERAL ROOF NOTES

1. REF. 10/A6.01 FOR TYP. VENT THROUGH ROOF DETAIL.
2. REF. 8/A6.01 FOR TYPICAL RIDGE VENT DETAIL

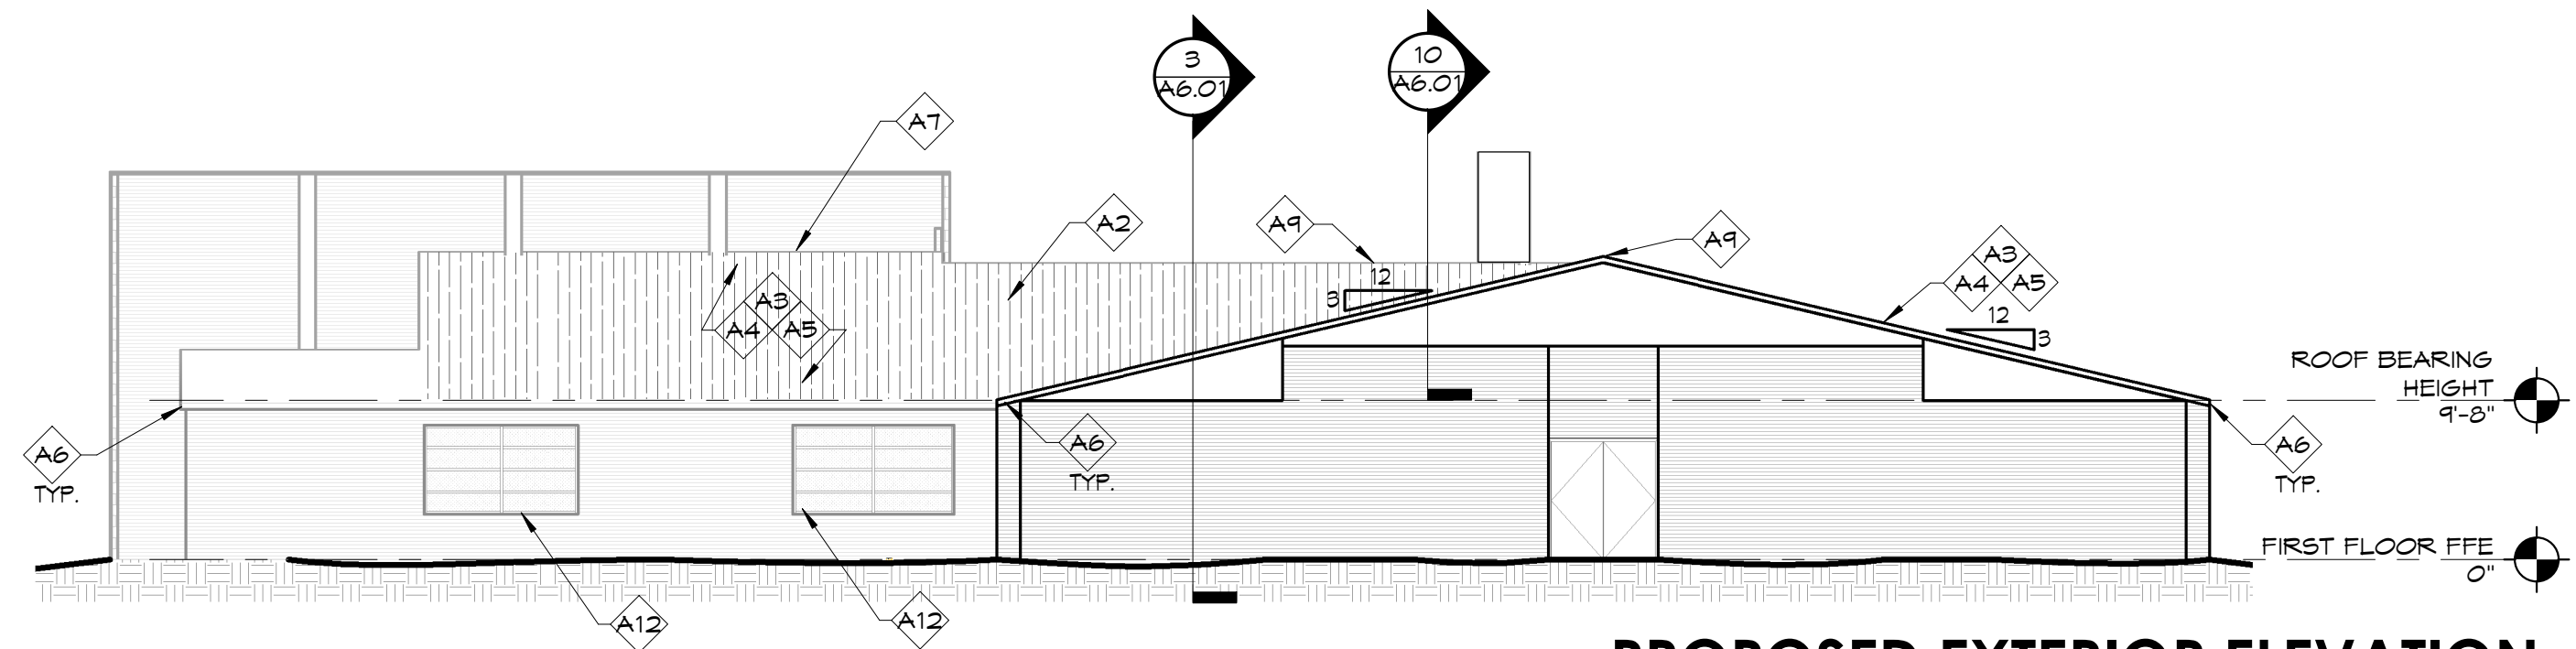
PROPOSED EXTERIOR ELEVATION 4
3/32" = 1'-0"

A12 – PROVIDE AND INSTALL NEW ALUM. STOREFRONT FRAMING & GLASS SYSTEM AS SCHEDULED.

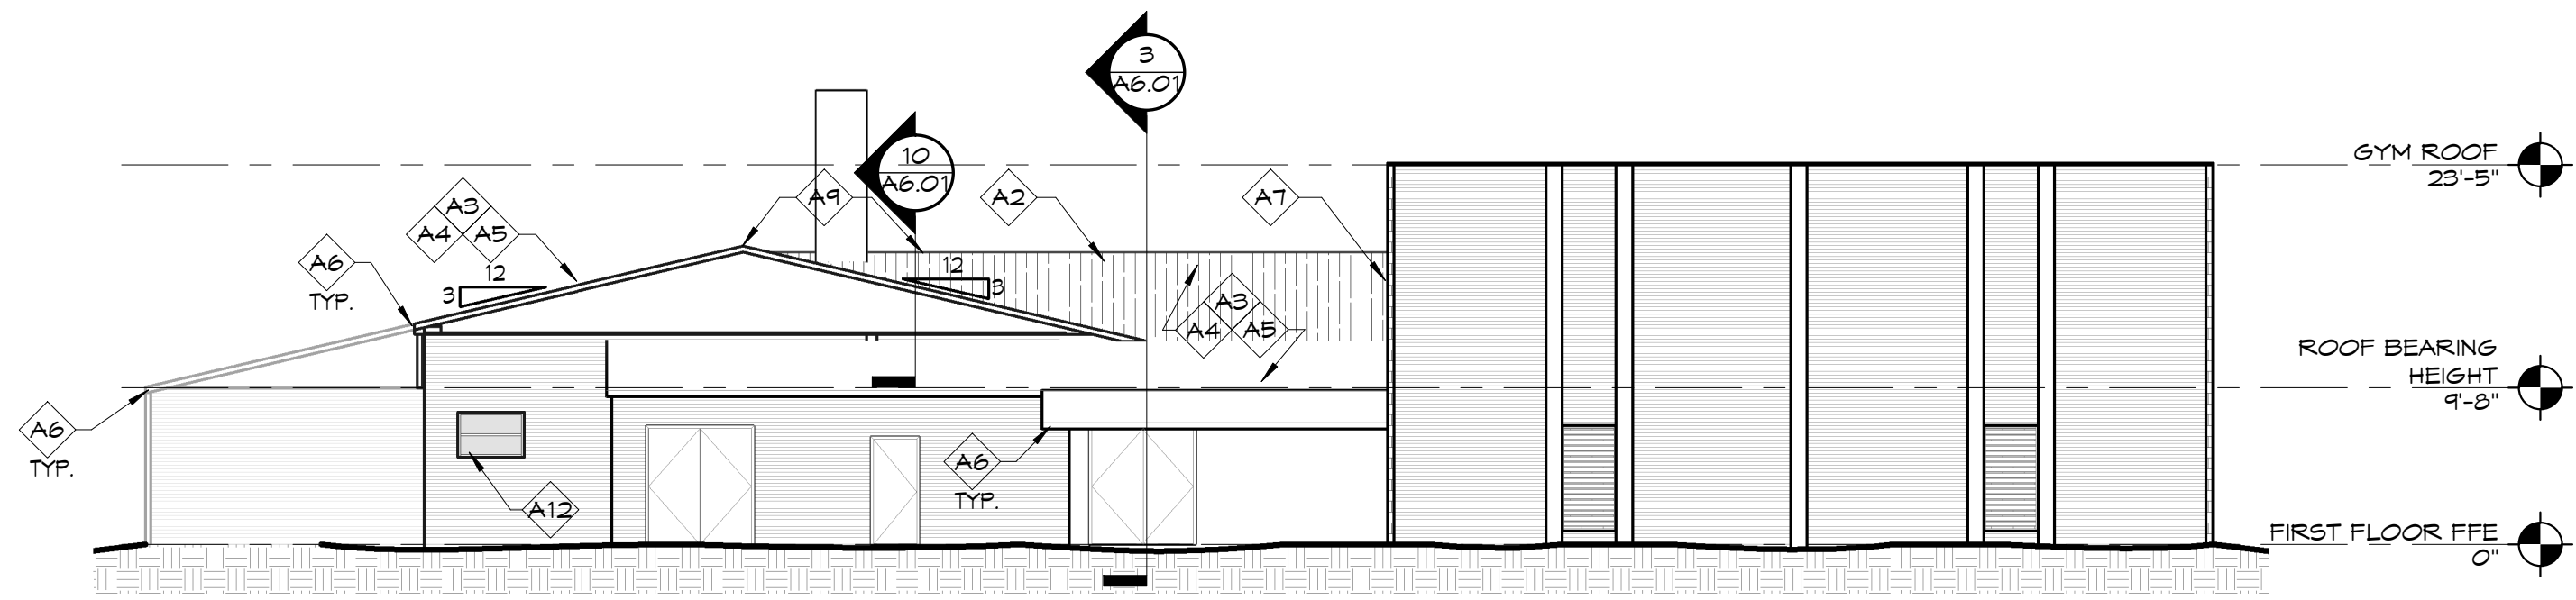
PROPOSED EXTERIOR ELEVATION 3
3/32" = 1'-0"

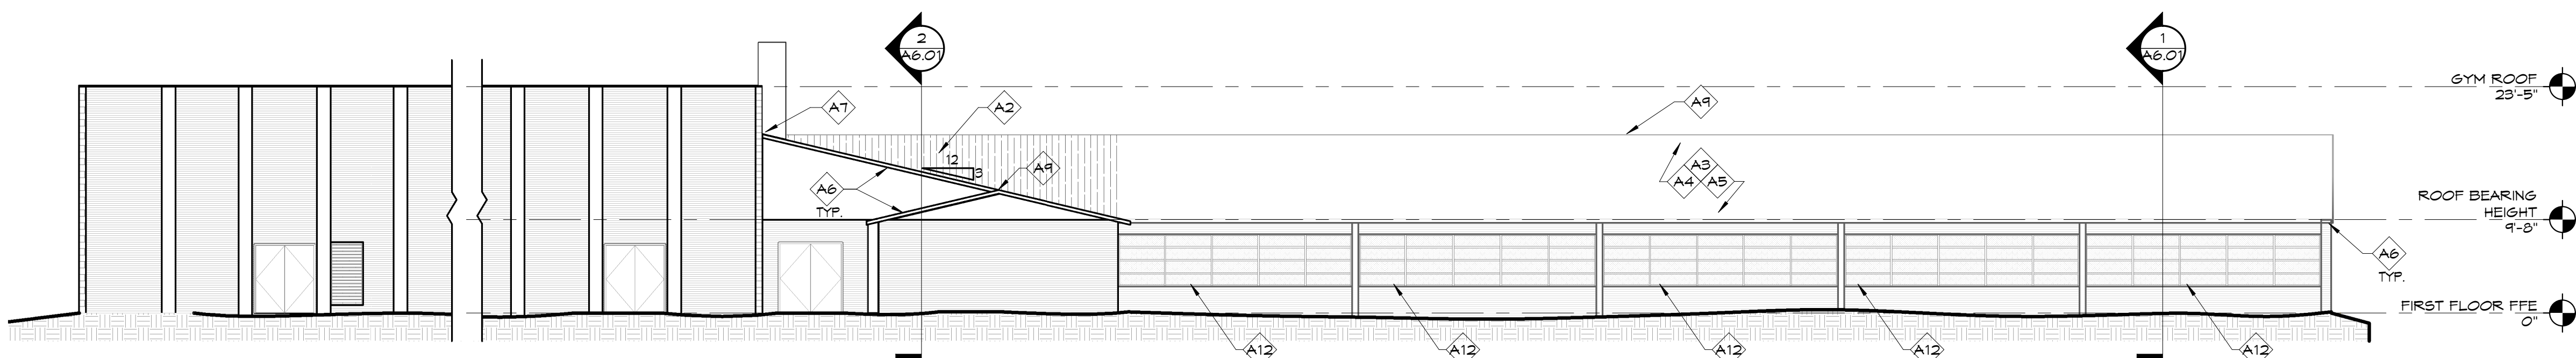
PROPOSED EXTERIOR ELEVATION 2
3/32" = 1'-0"

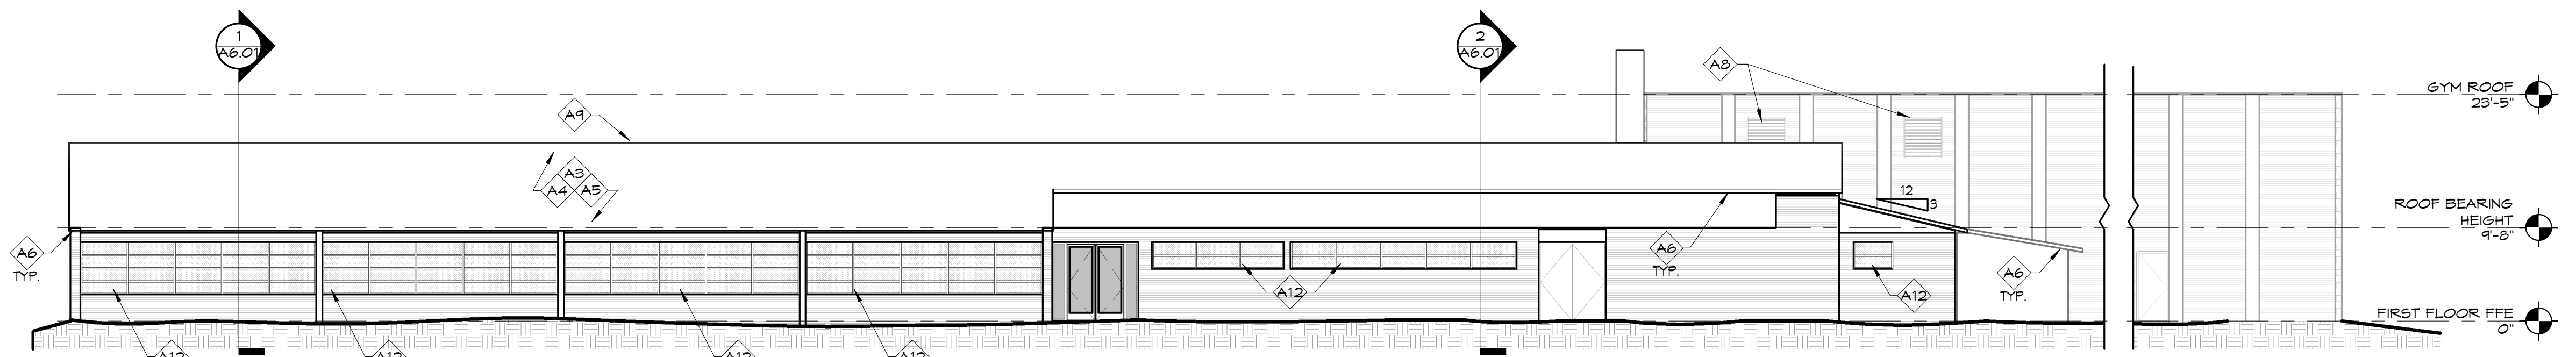
PROPOSED EXTERIOR ELEVATION 1
3/32" = 1'-0"

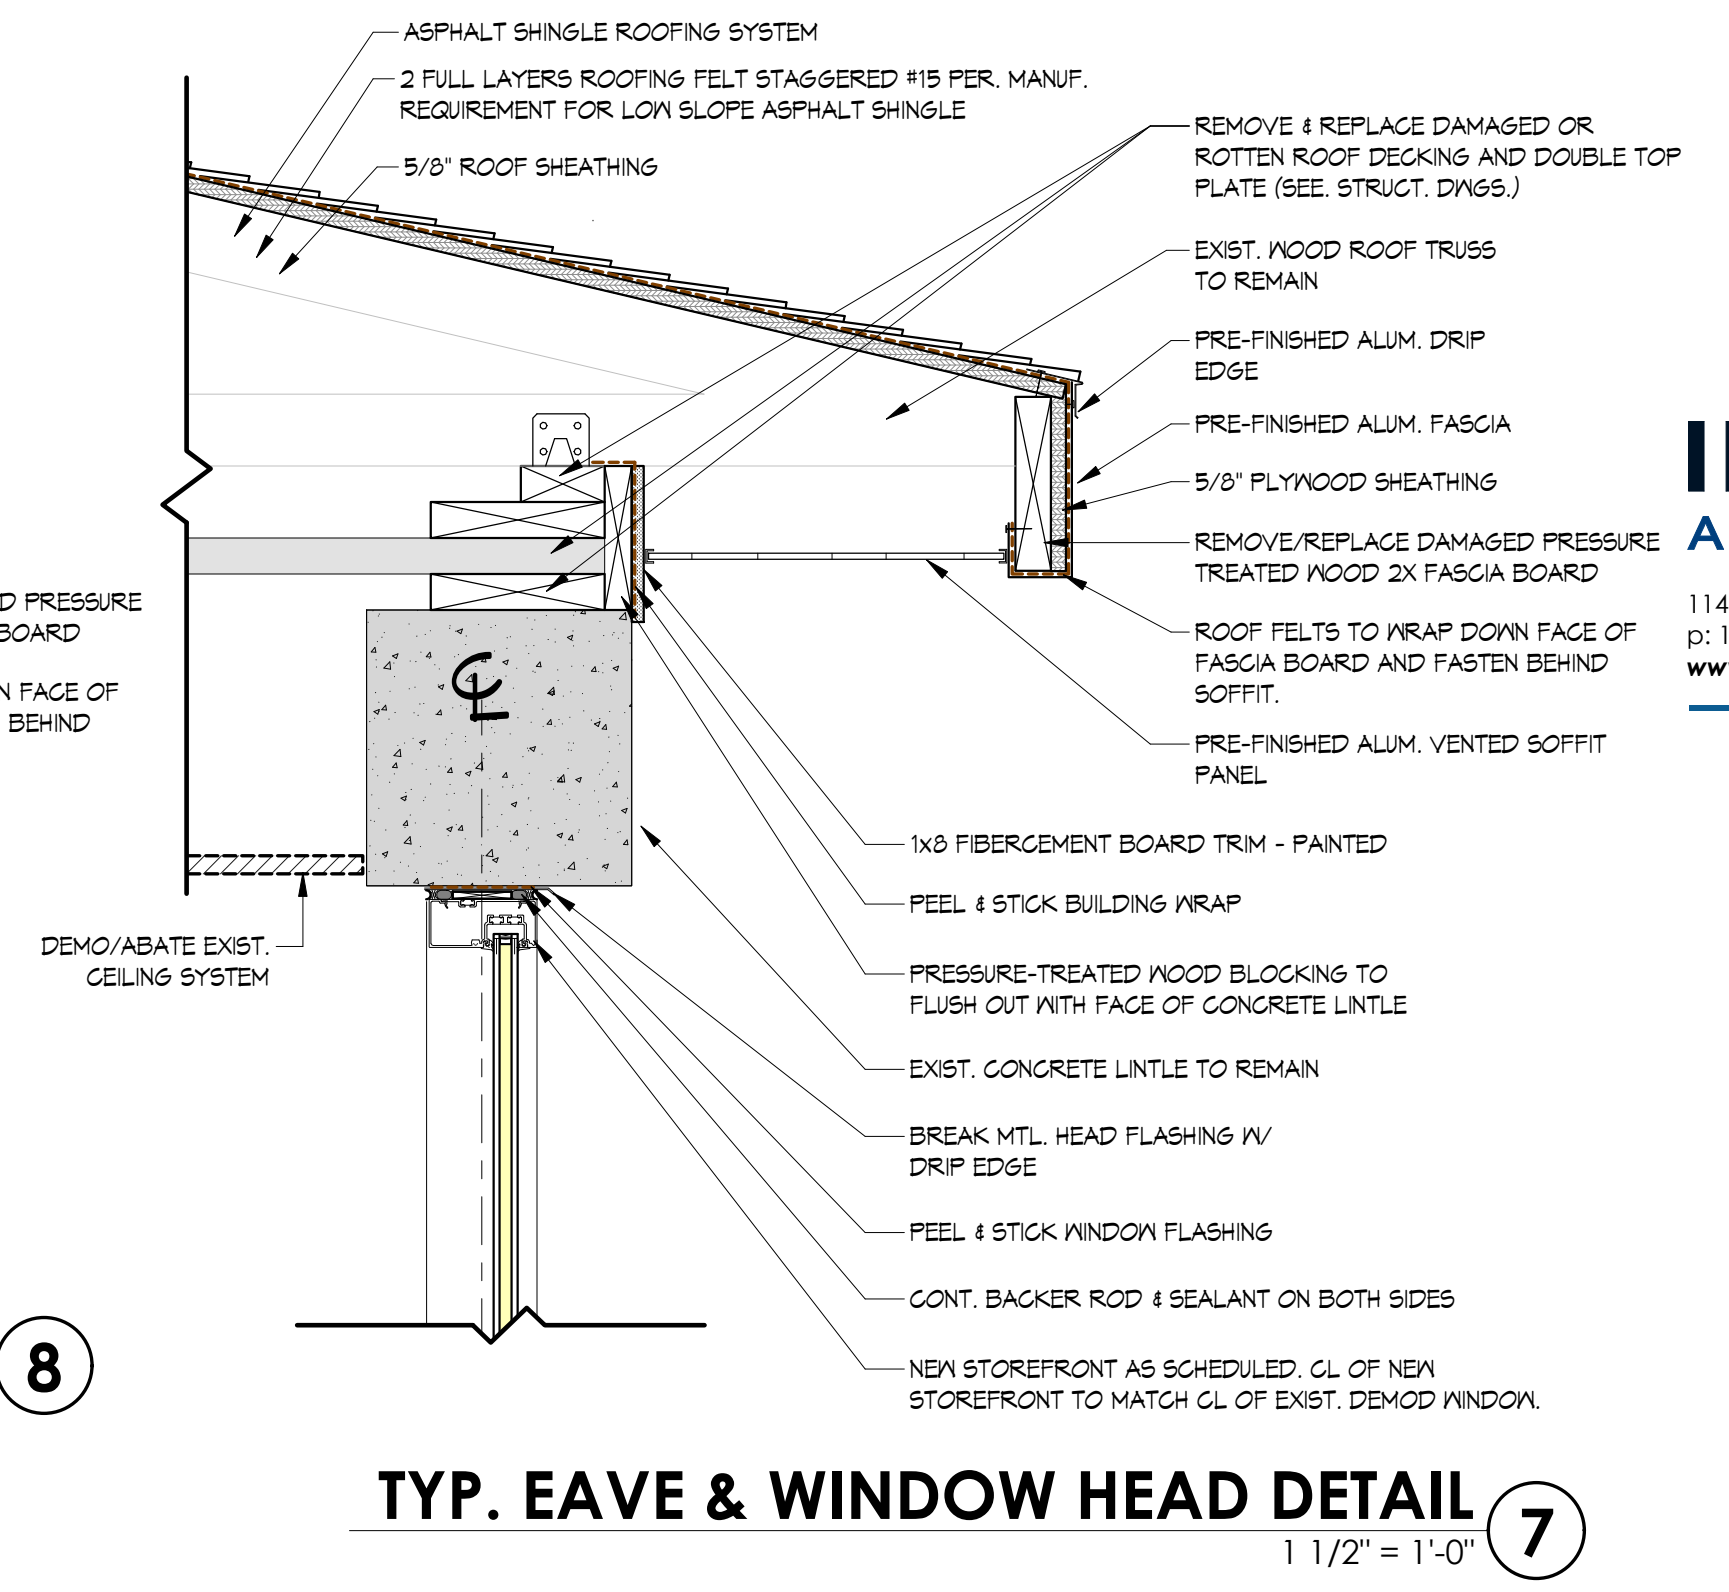
TYP. EAVE & WINDOW HEAD DETAIL 7
1 1/2" = 1'-0"

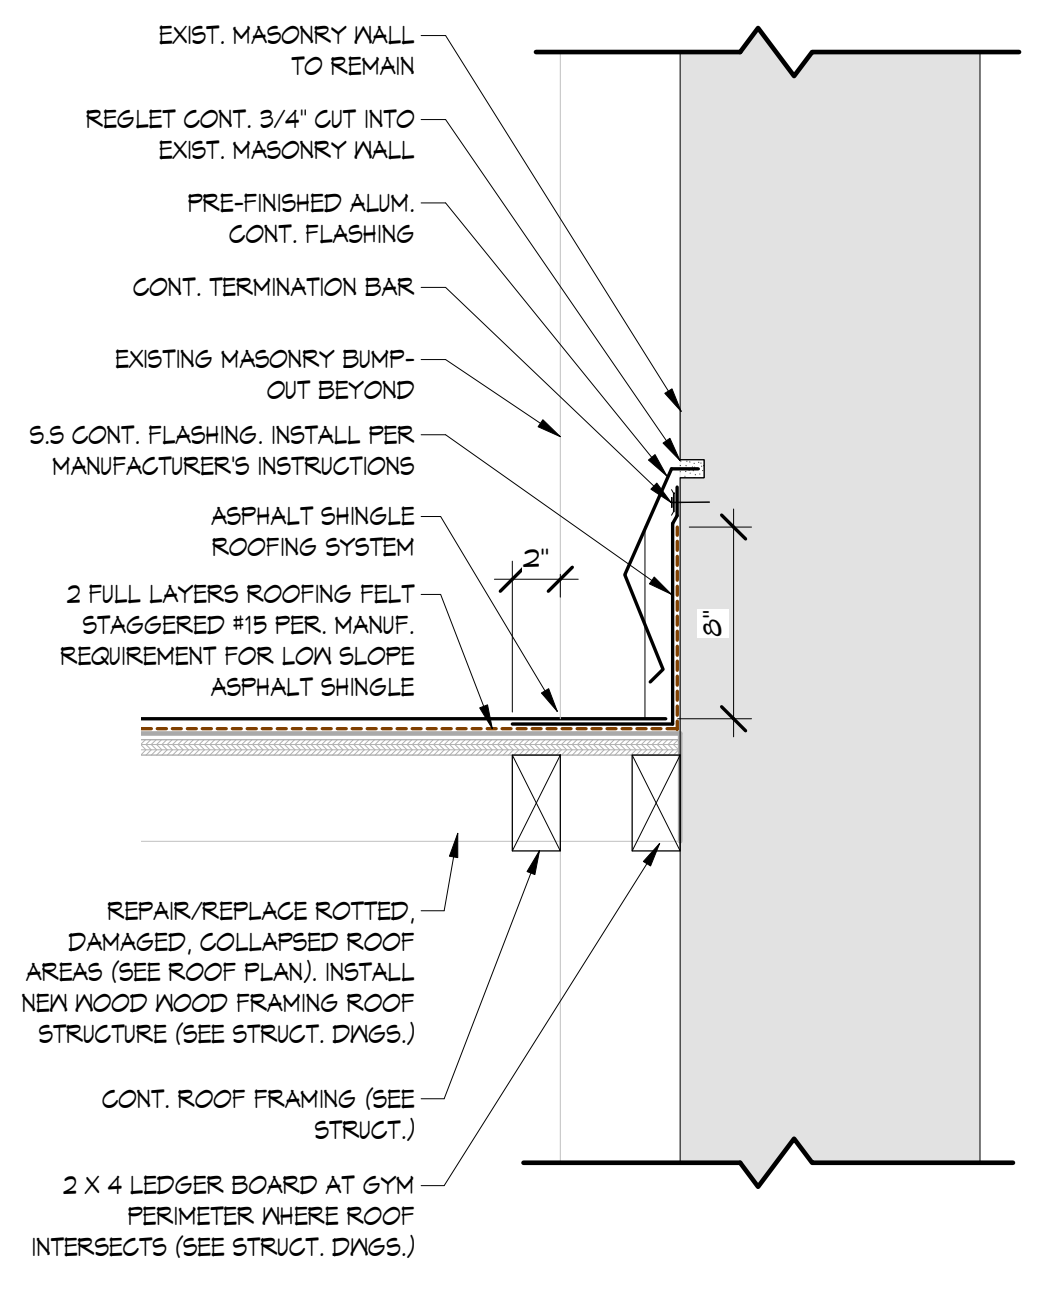
FLASHING DETAIL 9
1 1/2" = 1'-0"

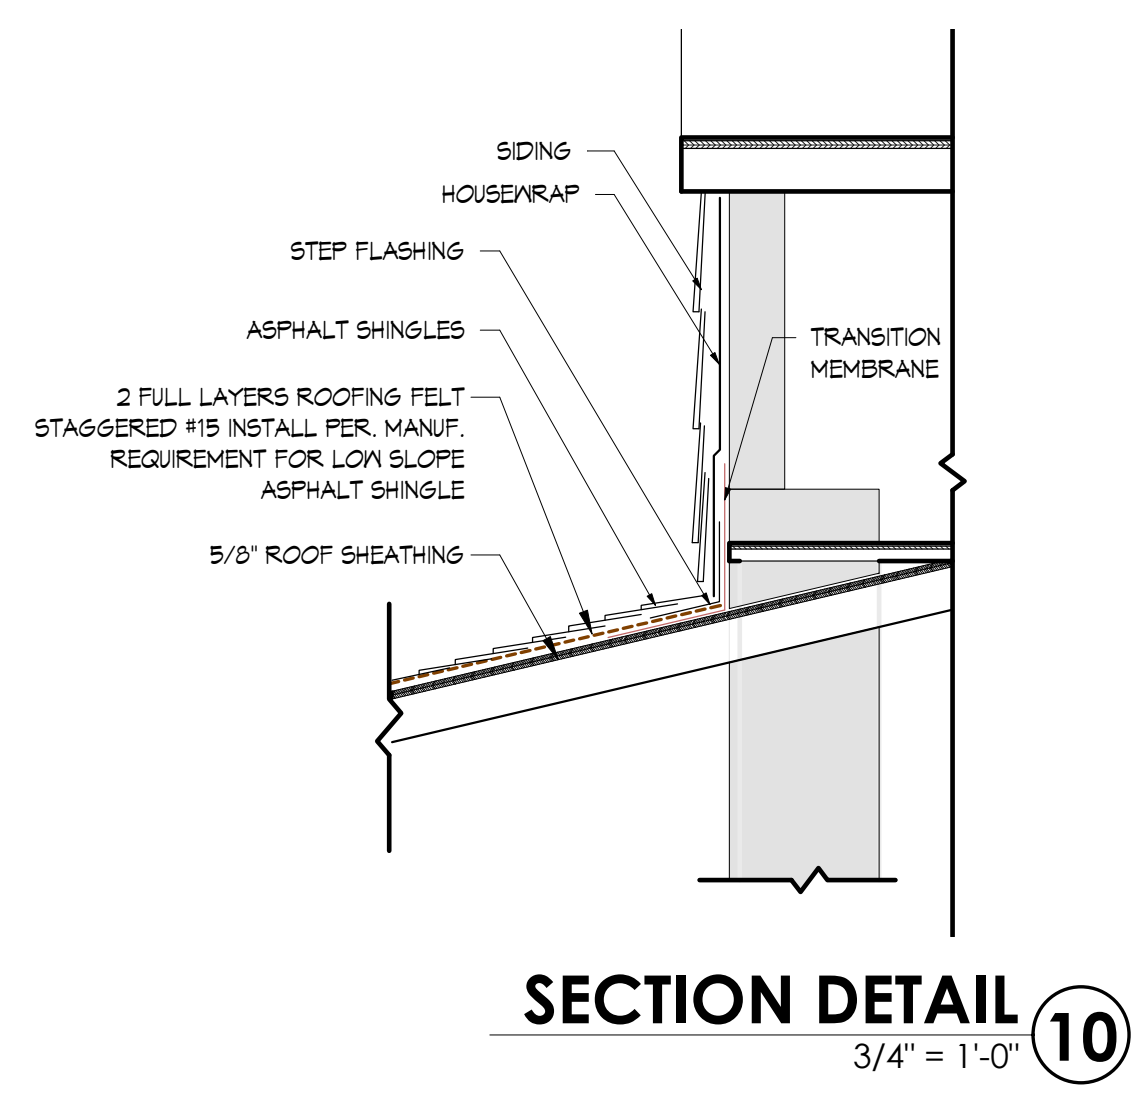
SECTION DETAIL 10
3/4" = 1'-0"

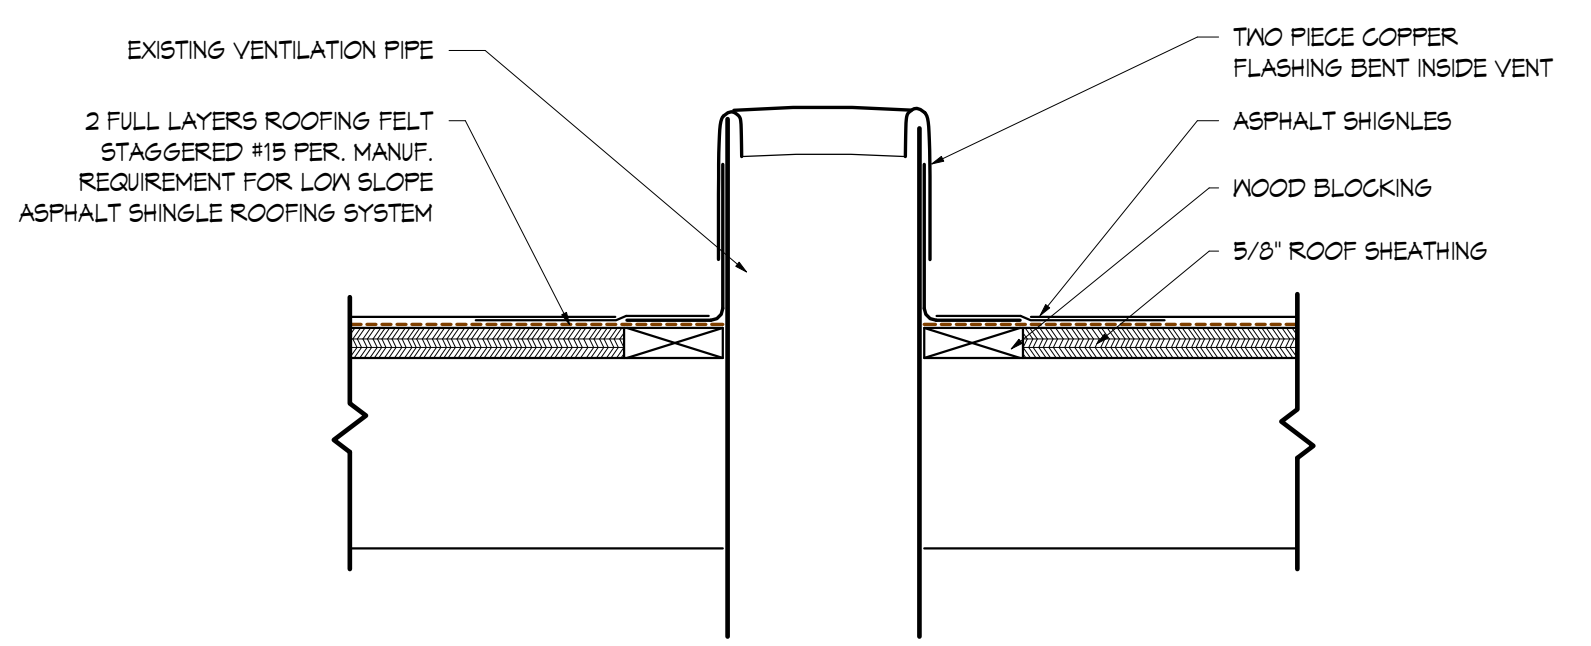
TYP. VENT THROUGH ROOF DETAIL 6
3" = 1'-0"

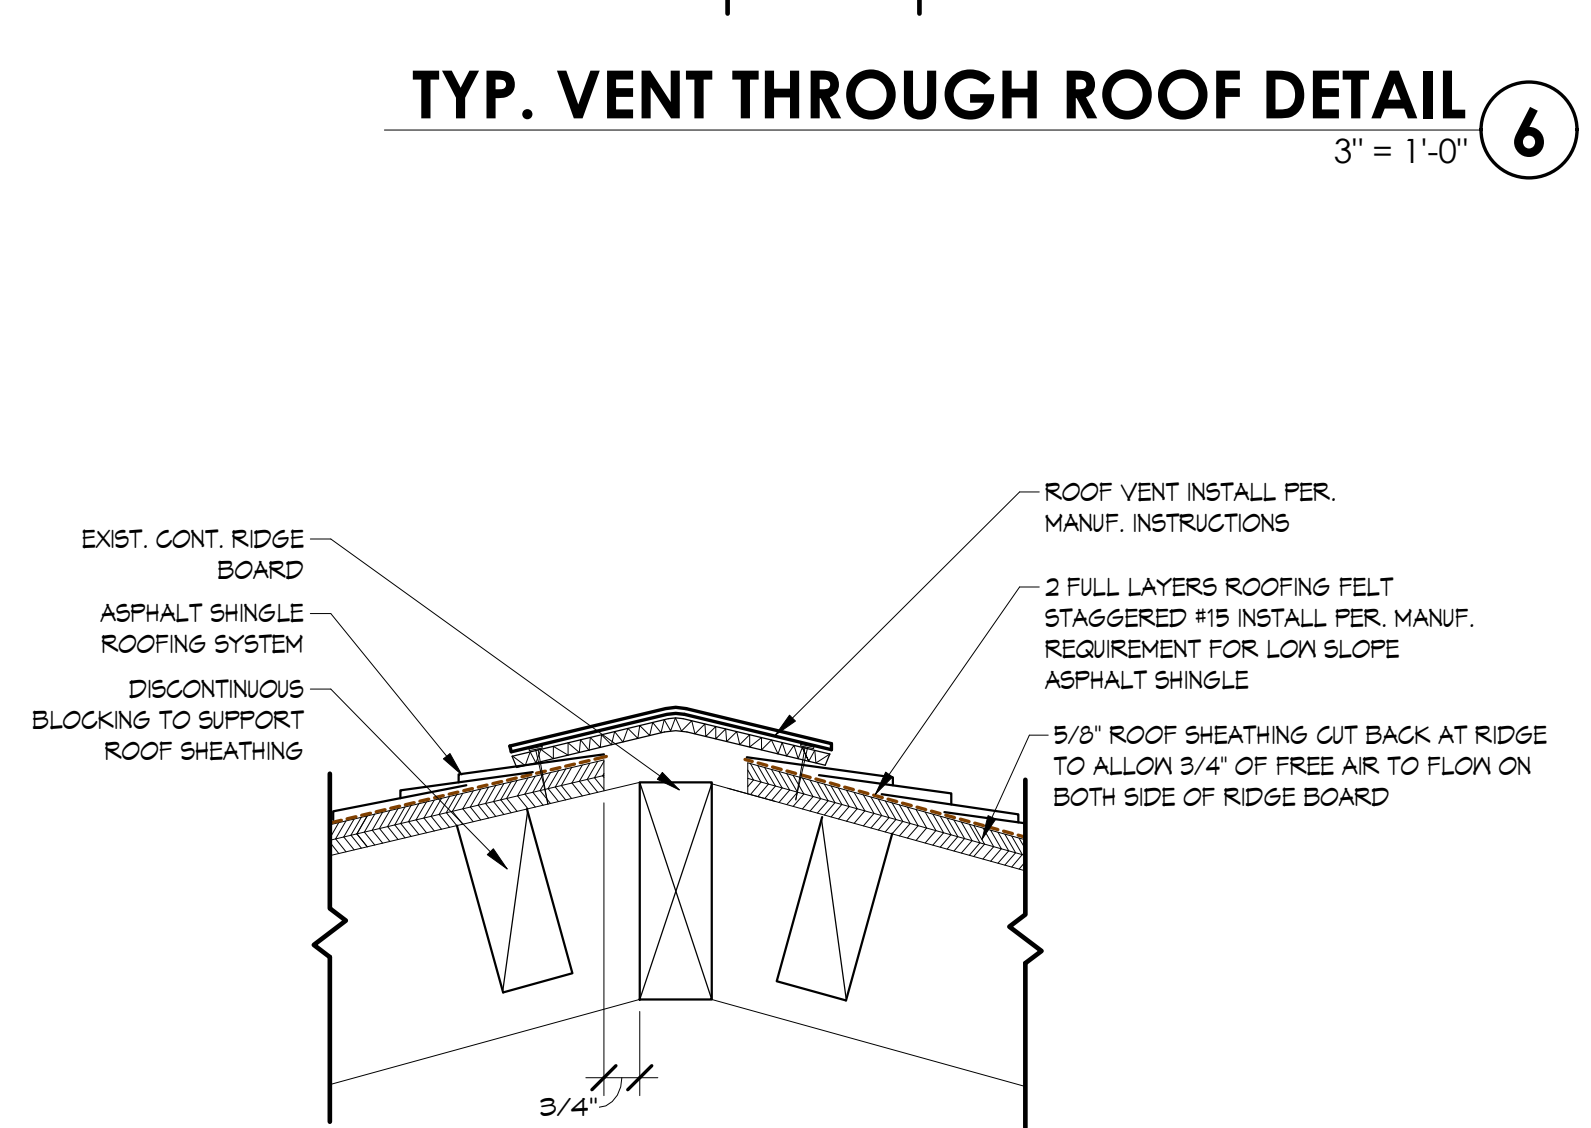
TYP. RIDGE VENT DETAIL 5
3" = 1'-0"

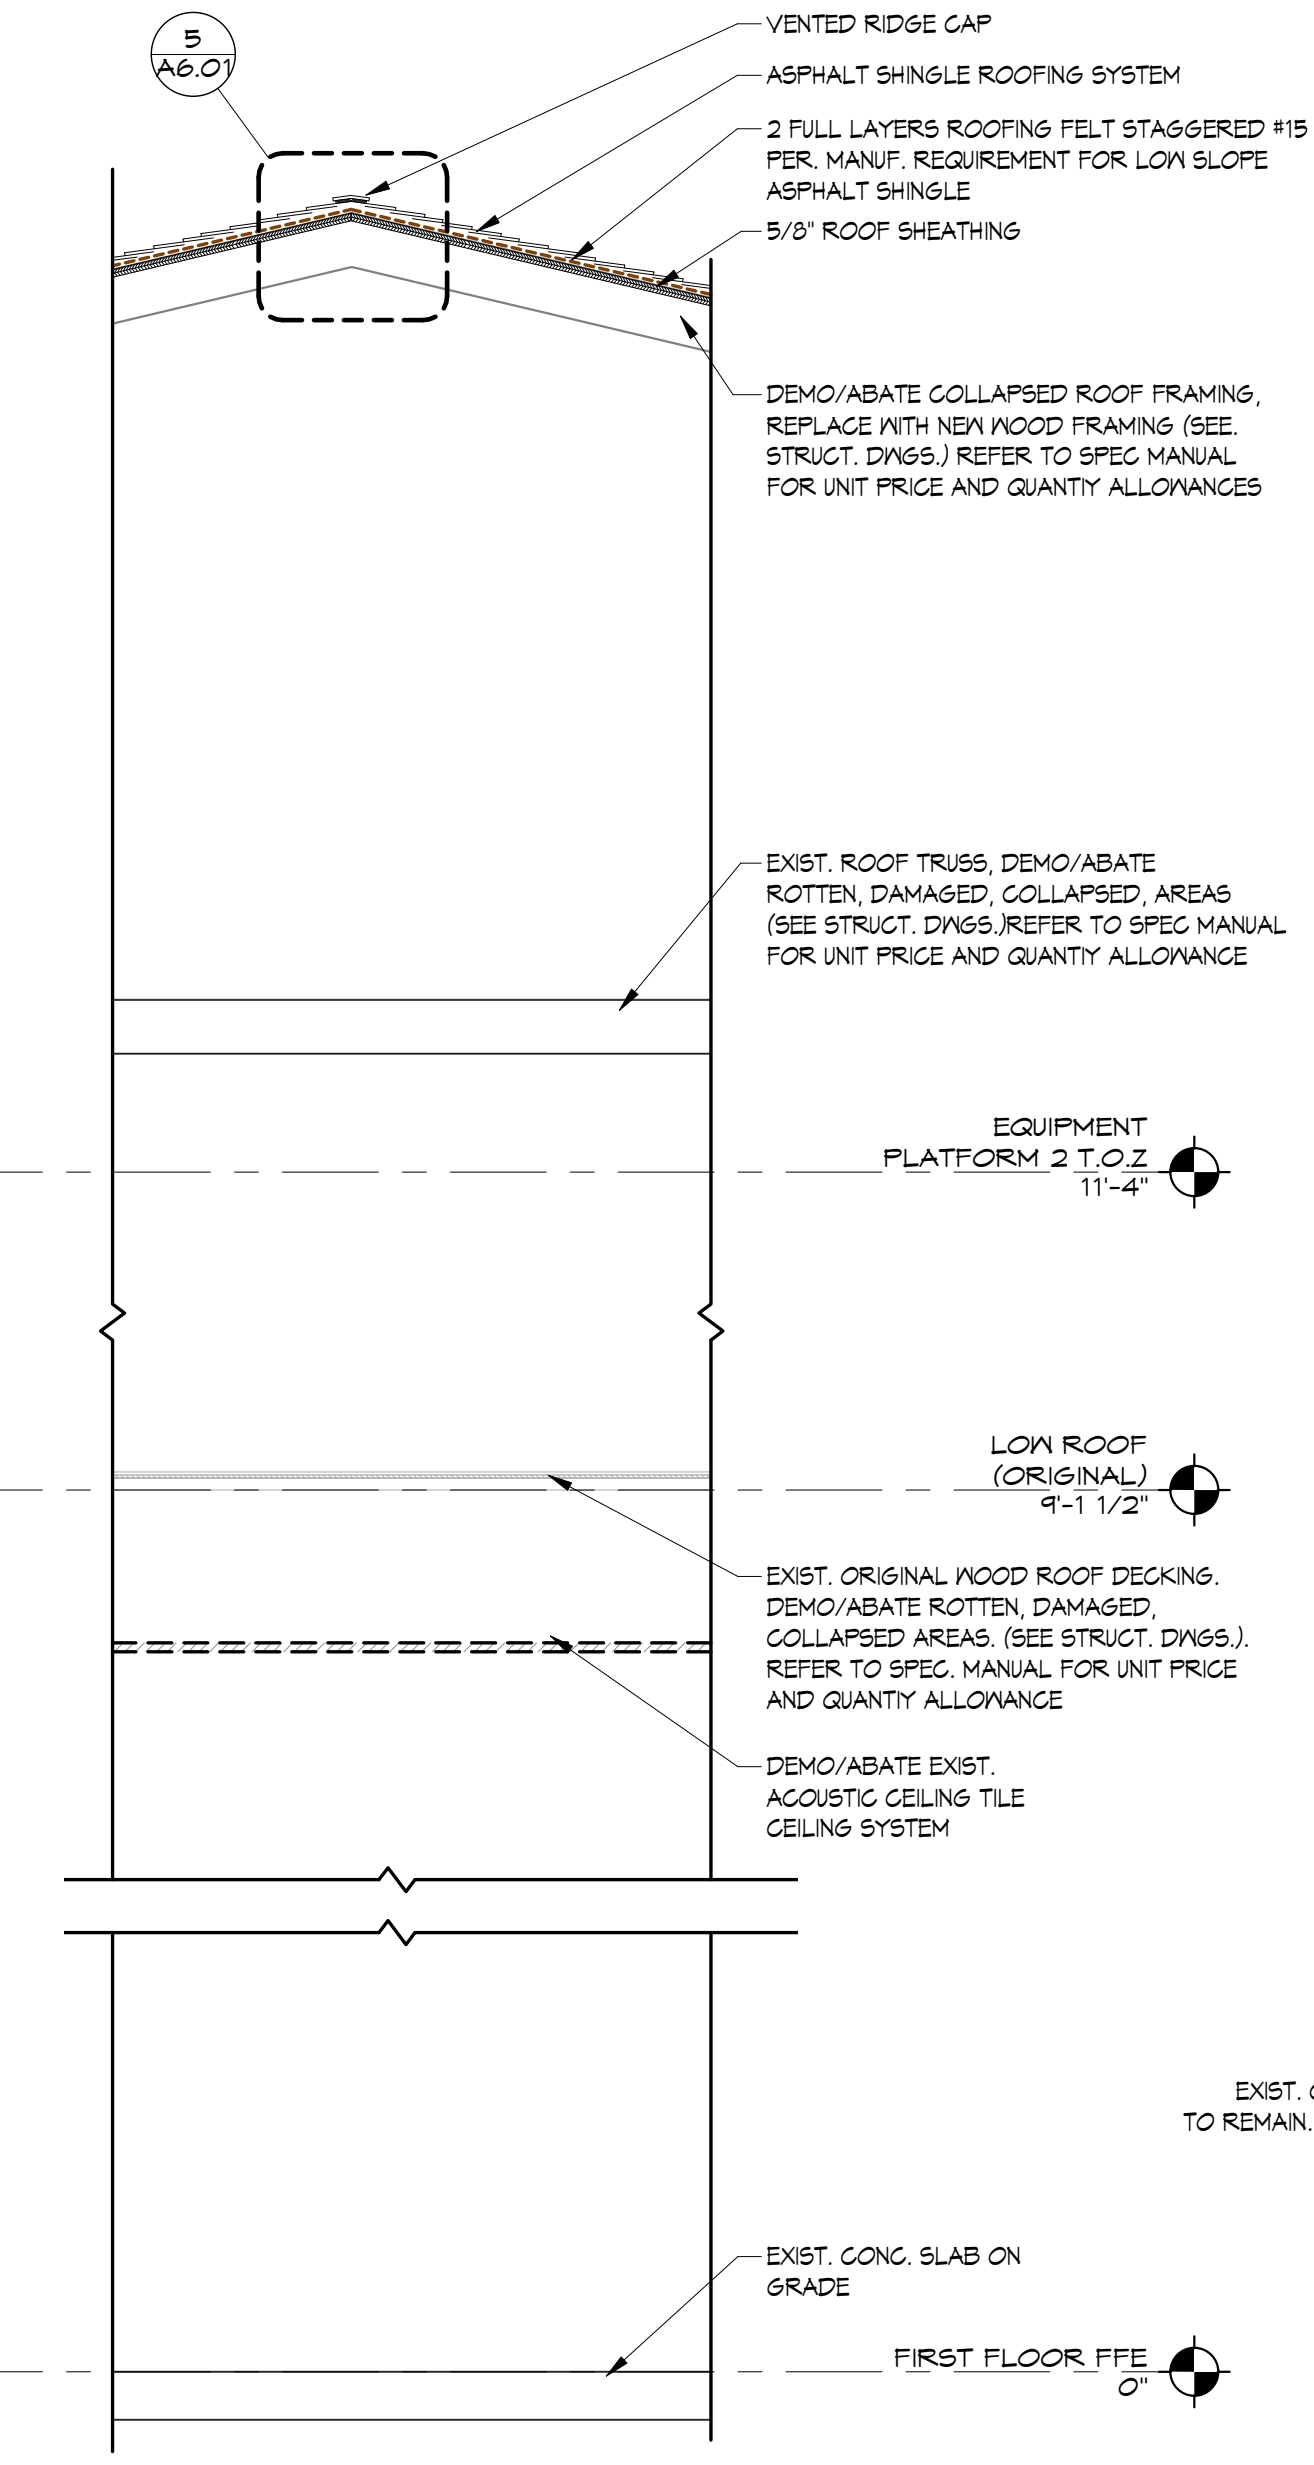
WALL SECTION 3
3/4" = 1'-0"
