**Environmental Review for Activity/Project that is Categorically
Excluded Subject to Section 58.5
Pursuant to 24 CFR 58.35(a)**

Project Name: Davis Ventures Community Center

Project Location: 33478 U.S. Highway 264, Engelhard, Hyde County, NC 27824

ROOF & BUILDING REPAIRS

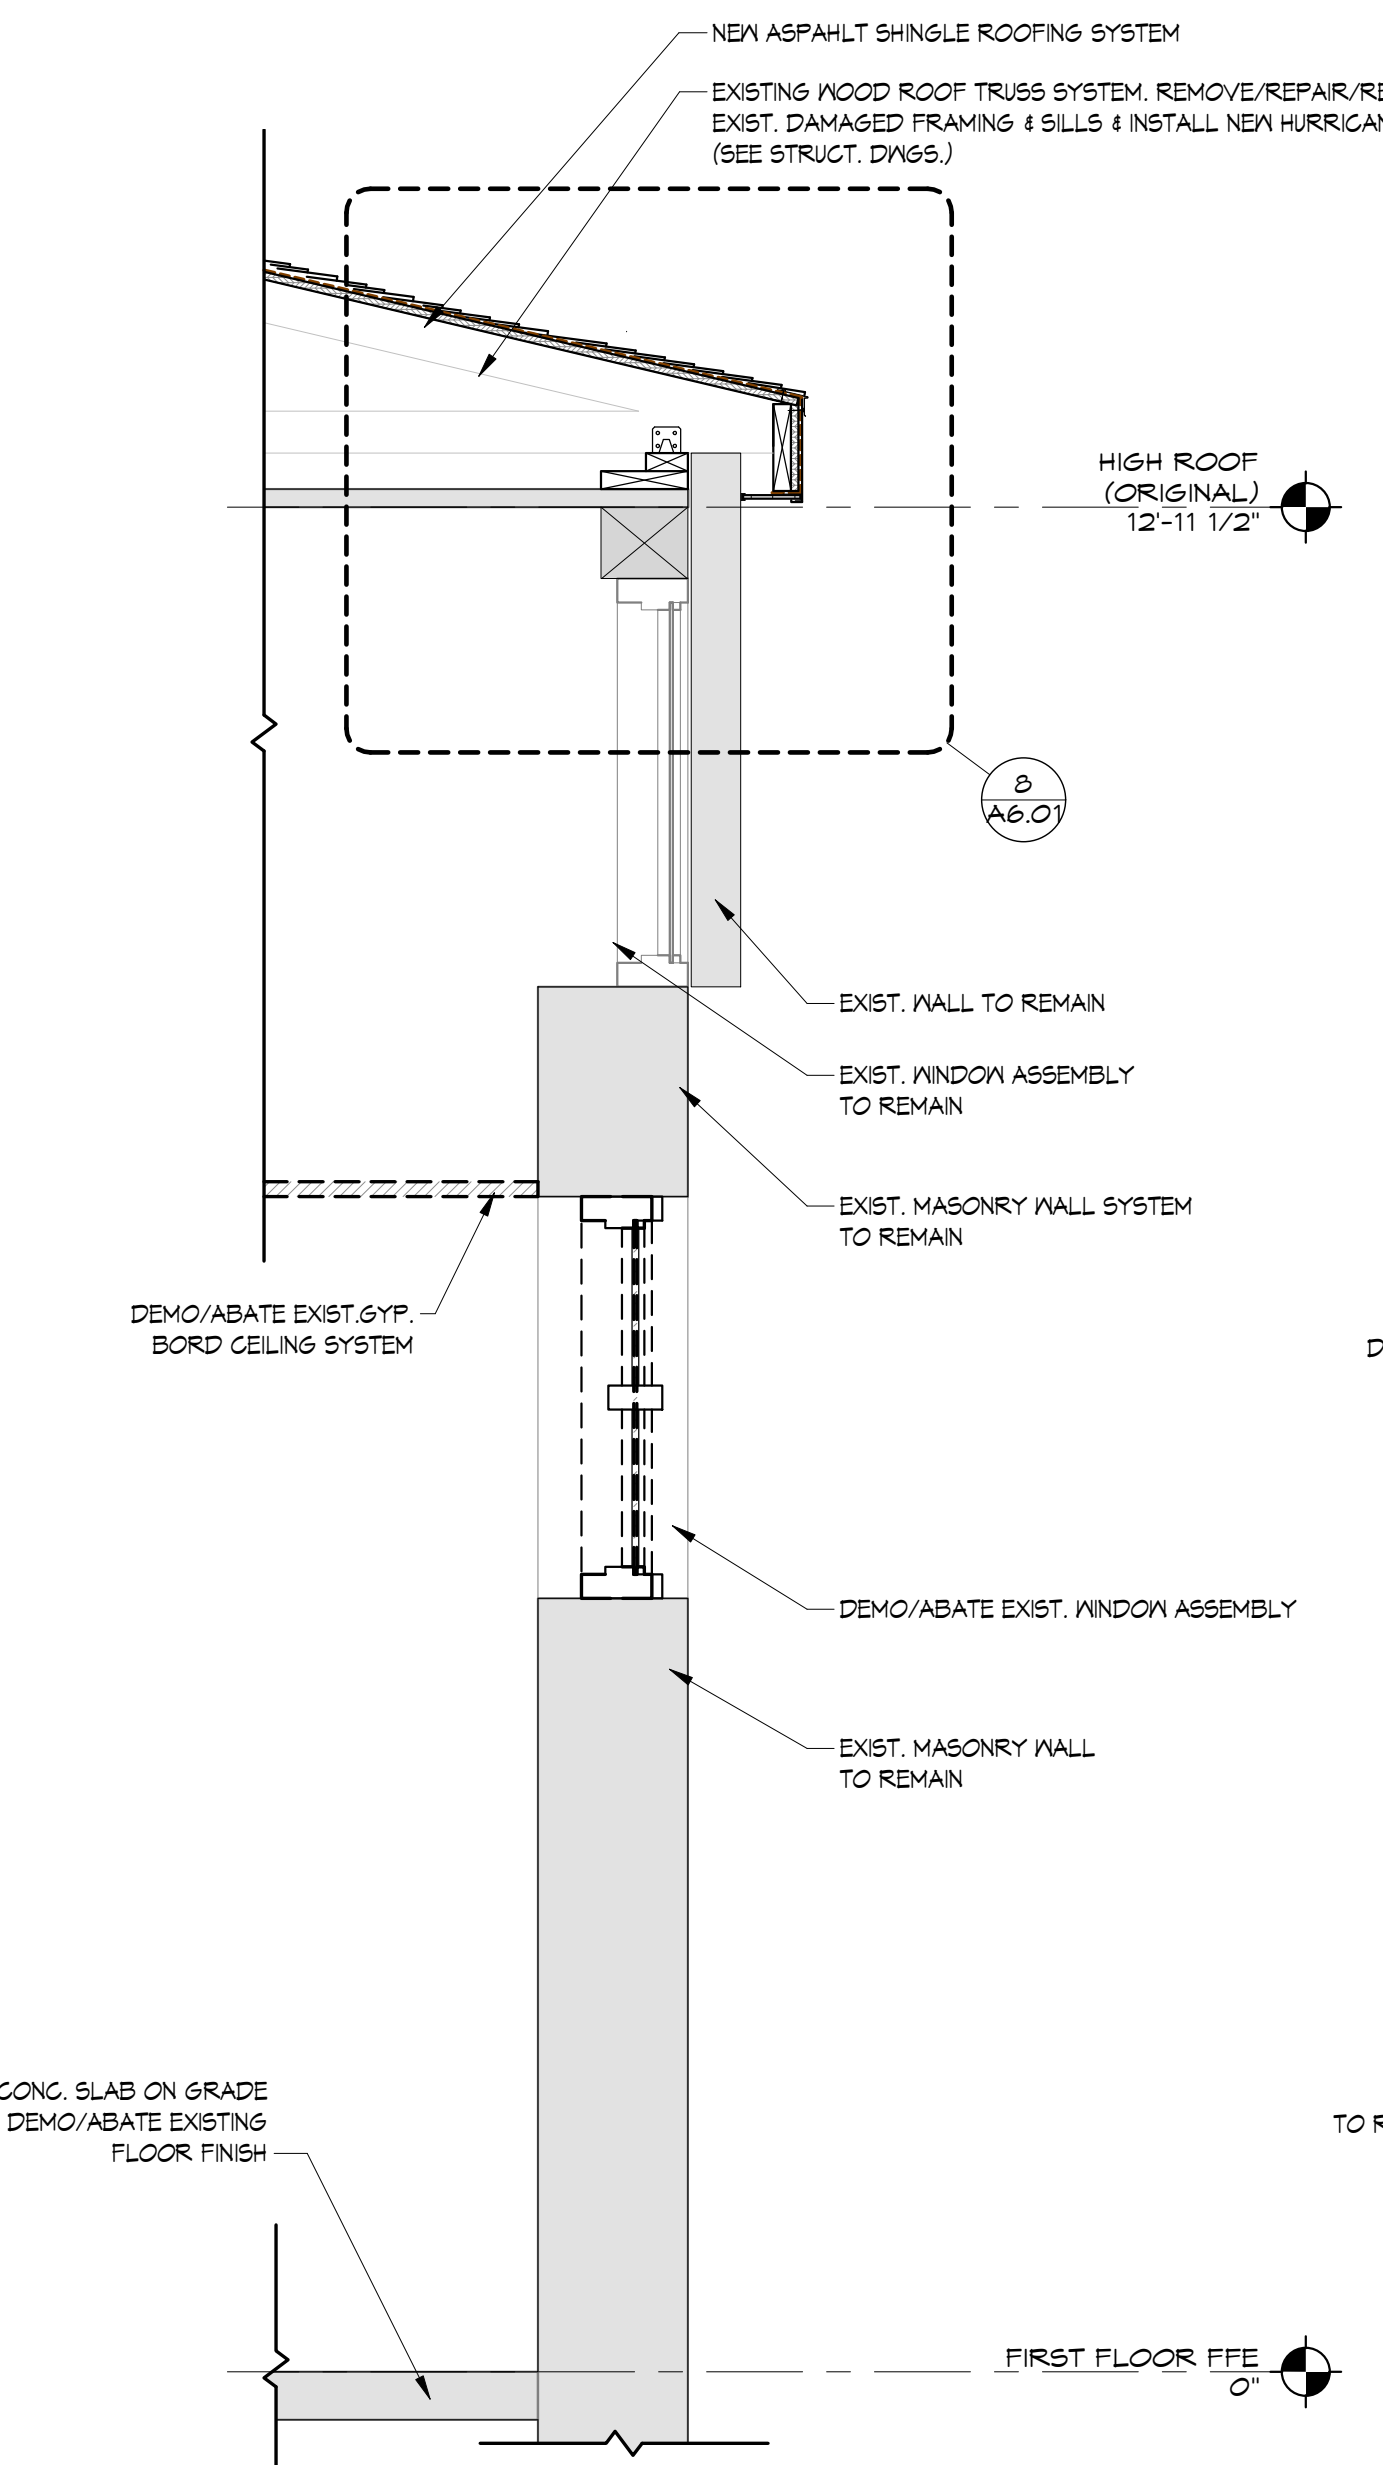
WALL SECTION 2
3/4" = 1'-0"

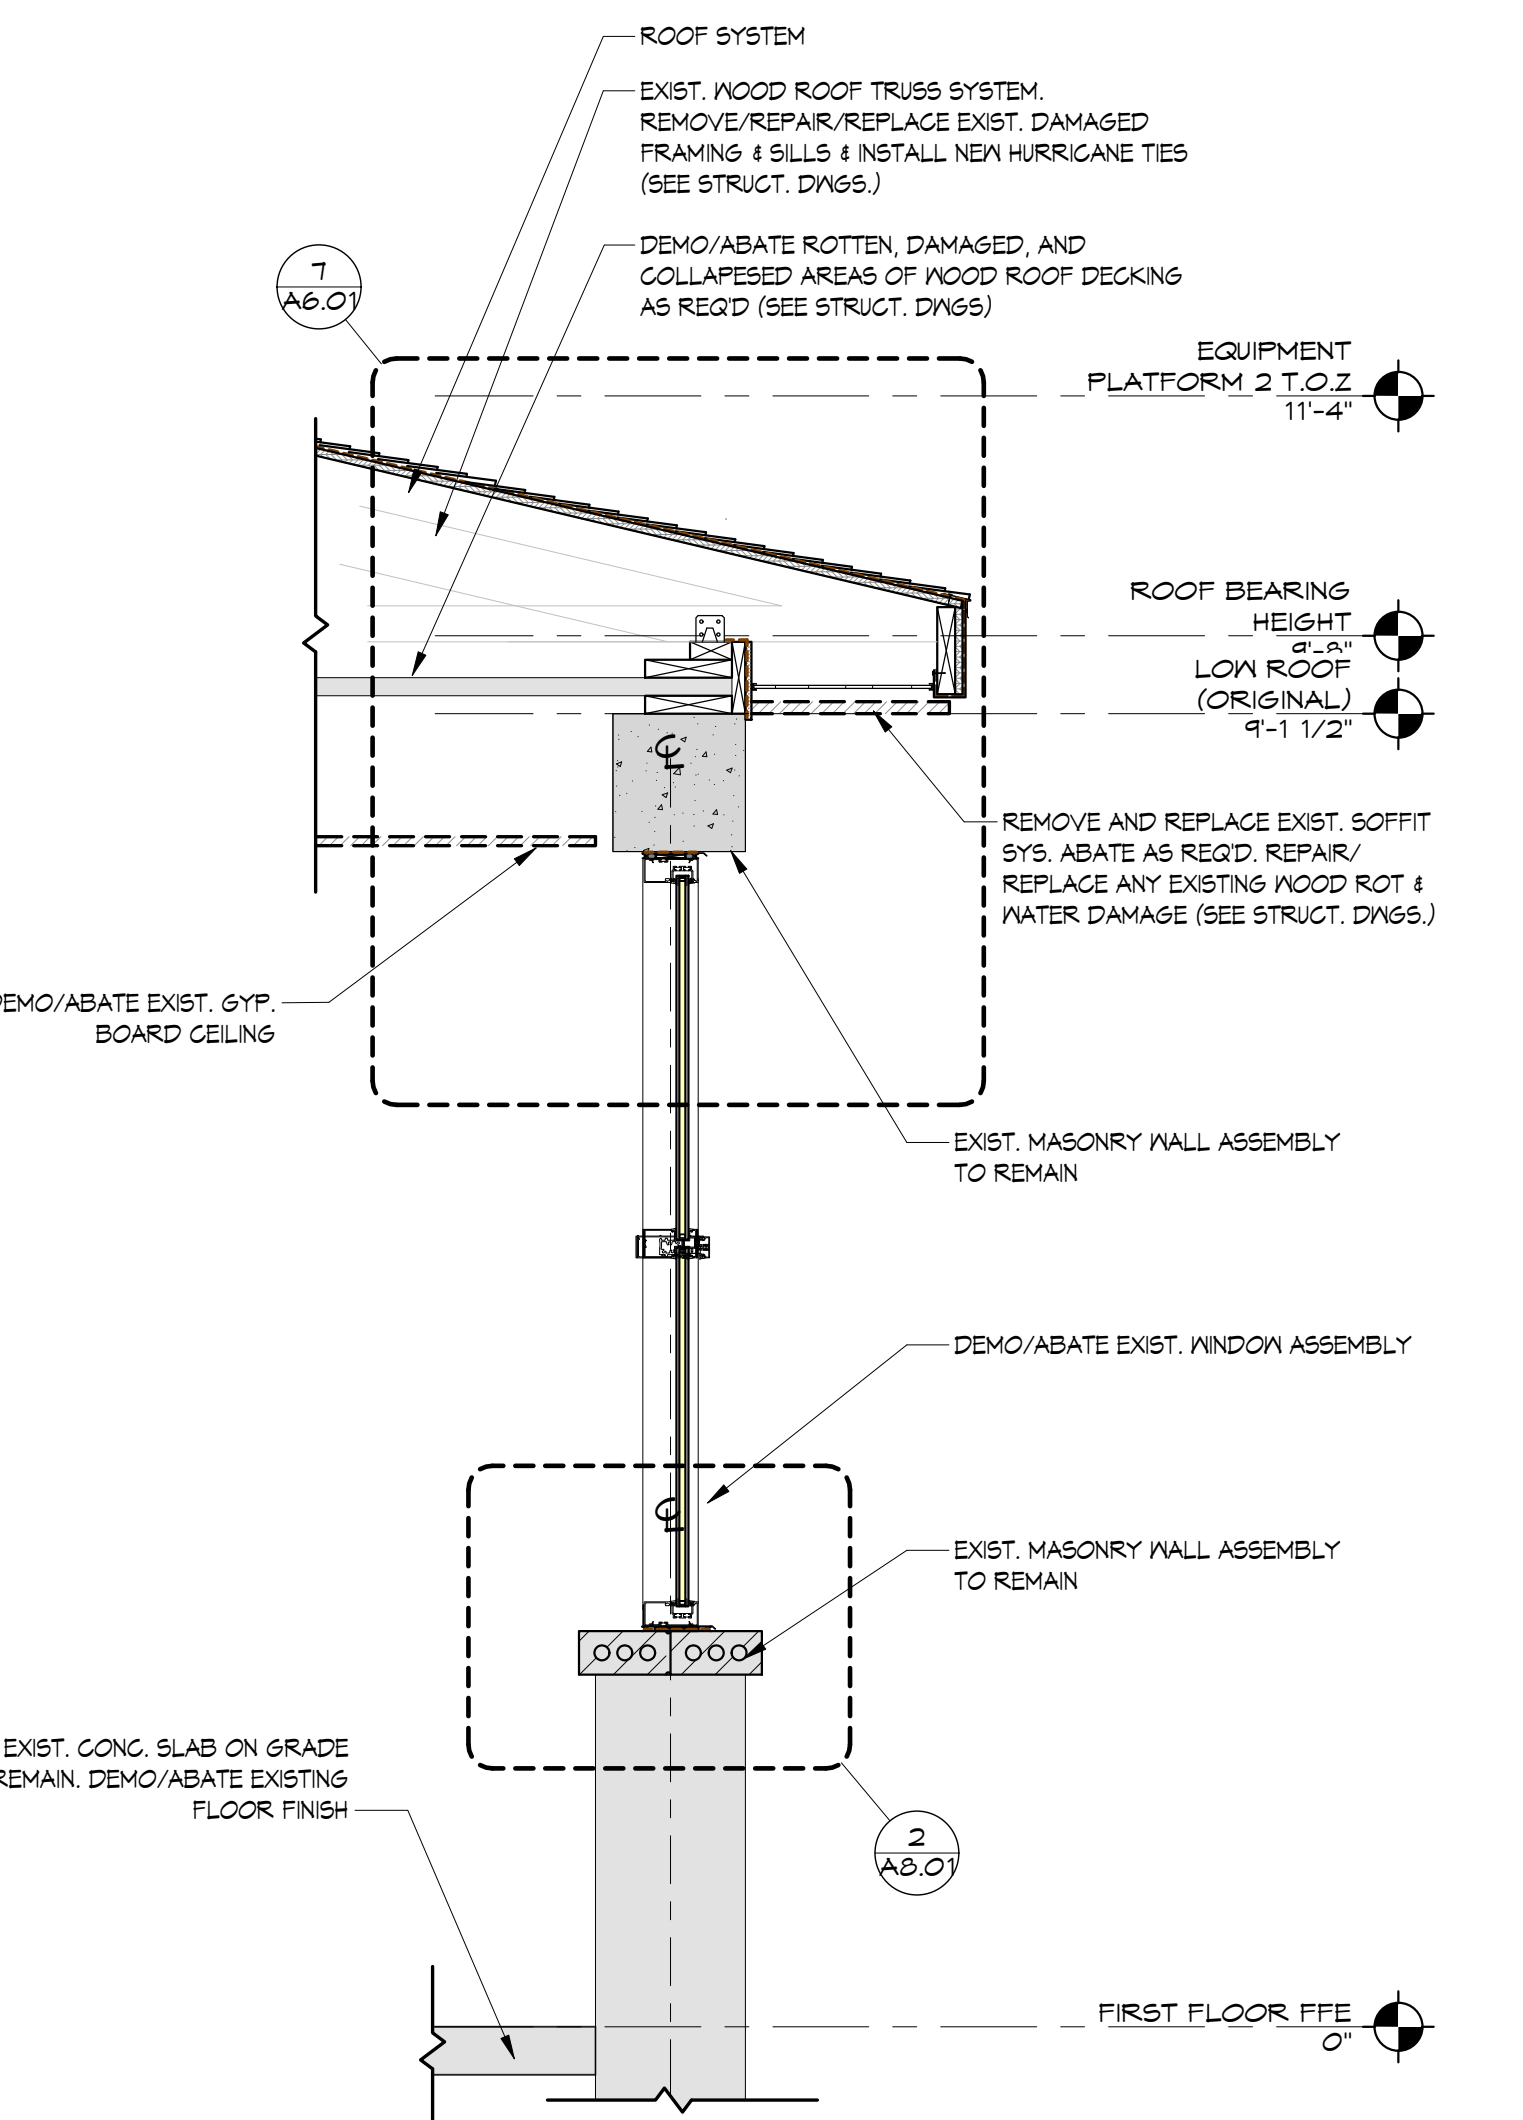
TYP. WALL SECTION 1
3/4" = 1'-0"

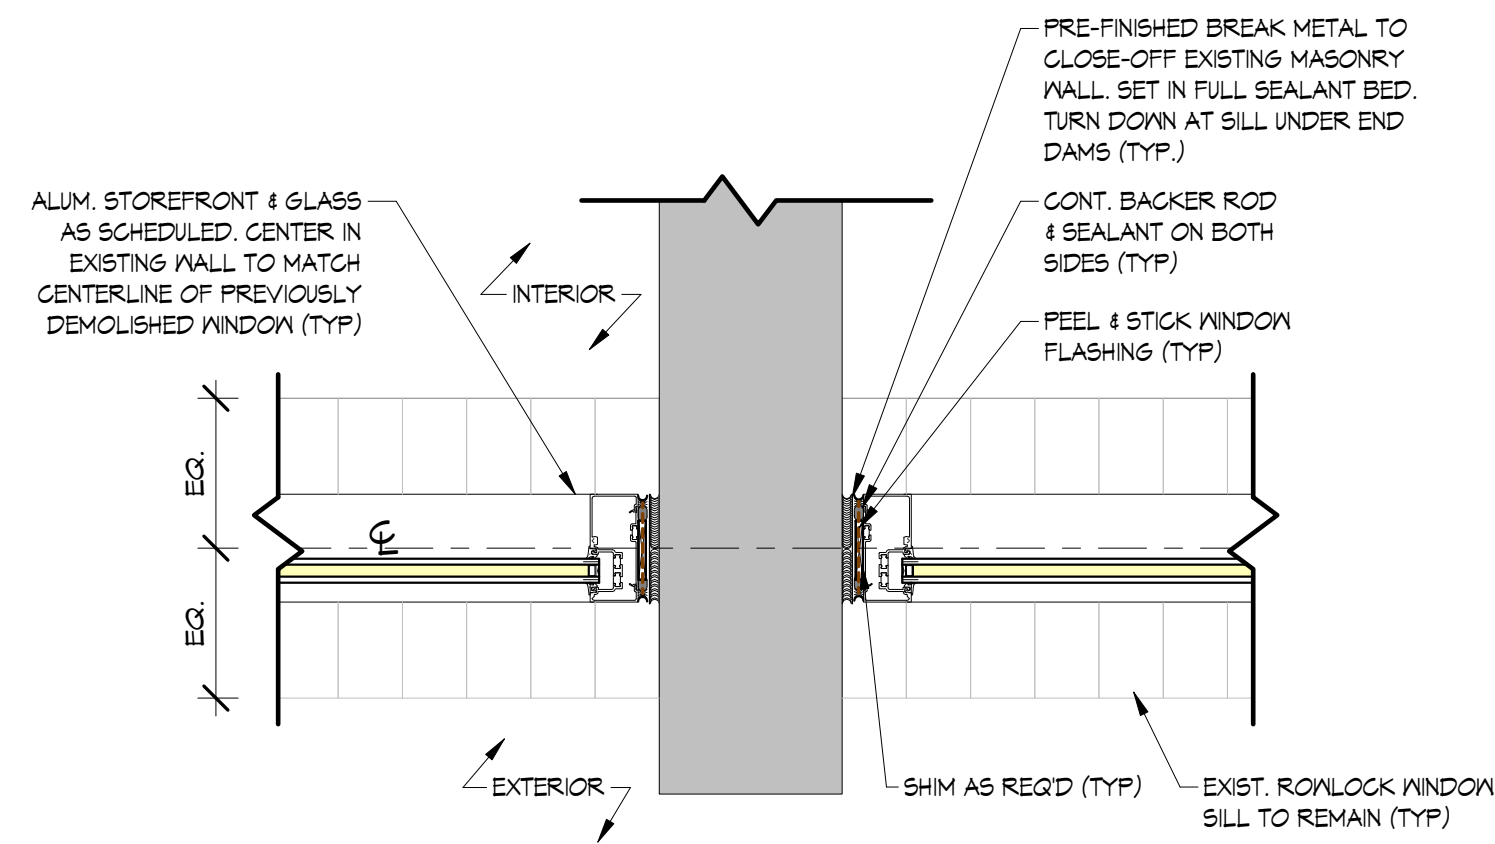
TYP. JAMB DETAIL 3
1 1/2" = 1'-0"

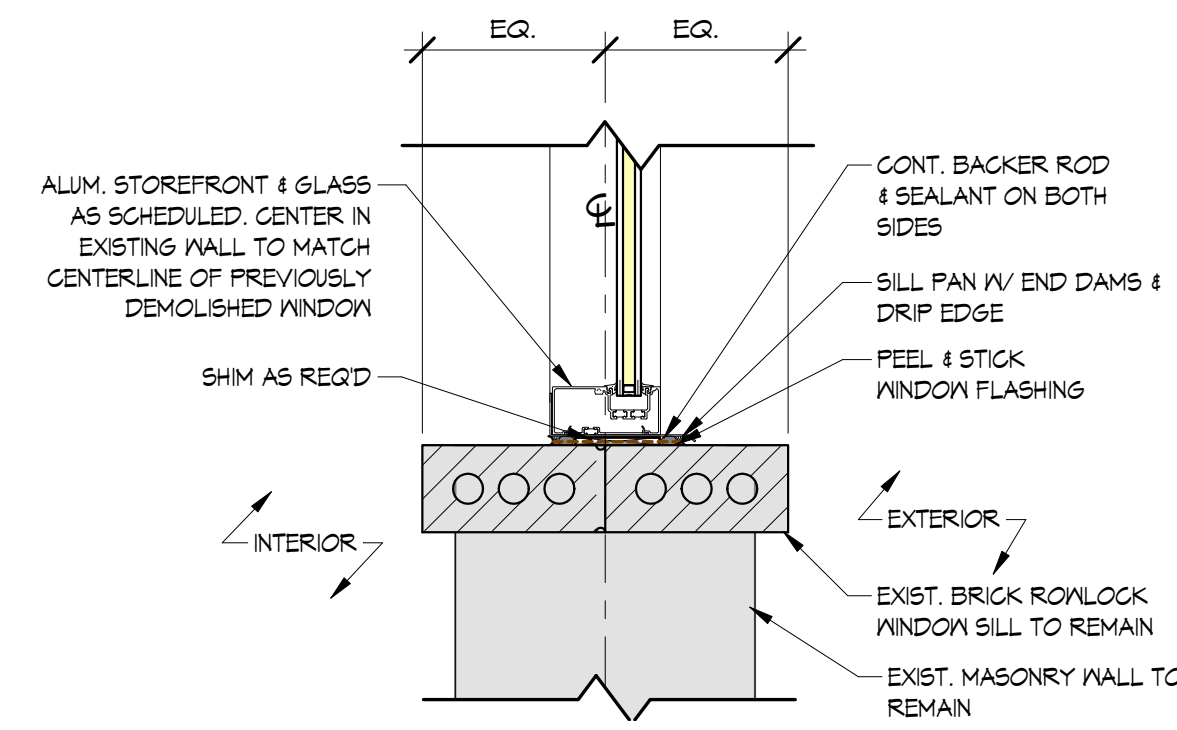
TYP. SILL DETAIL 2
1 1/2" = 1'-0"

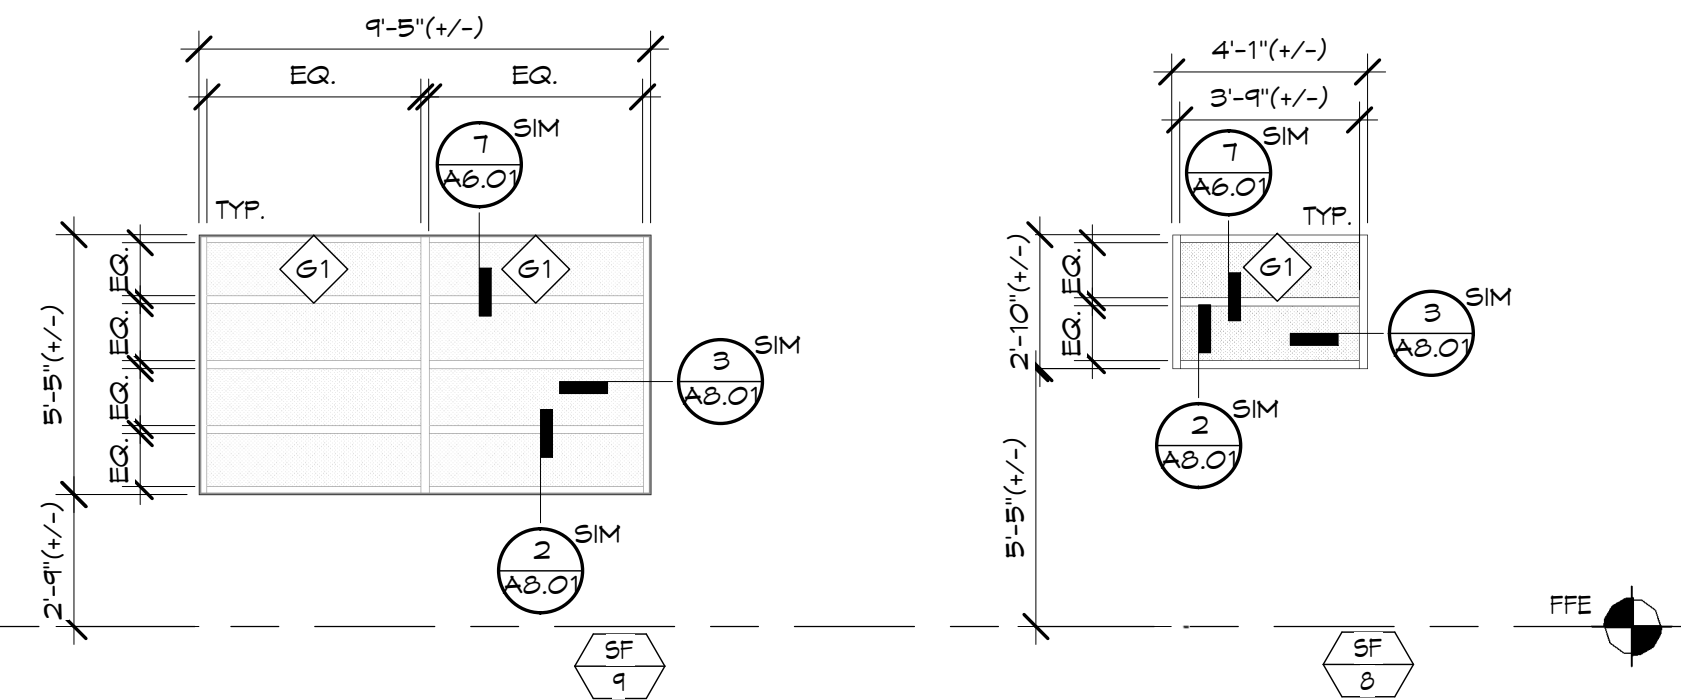
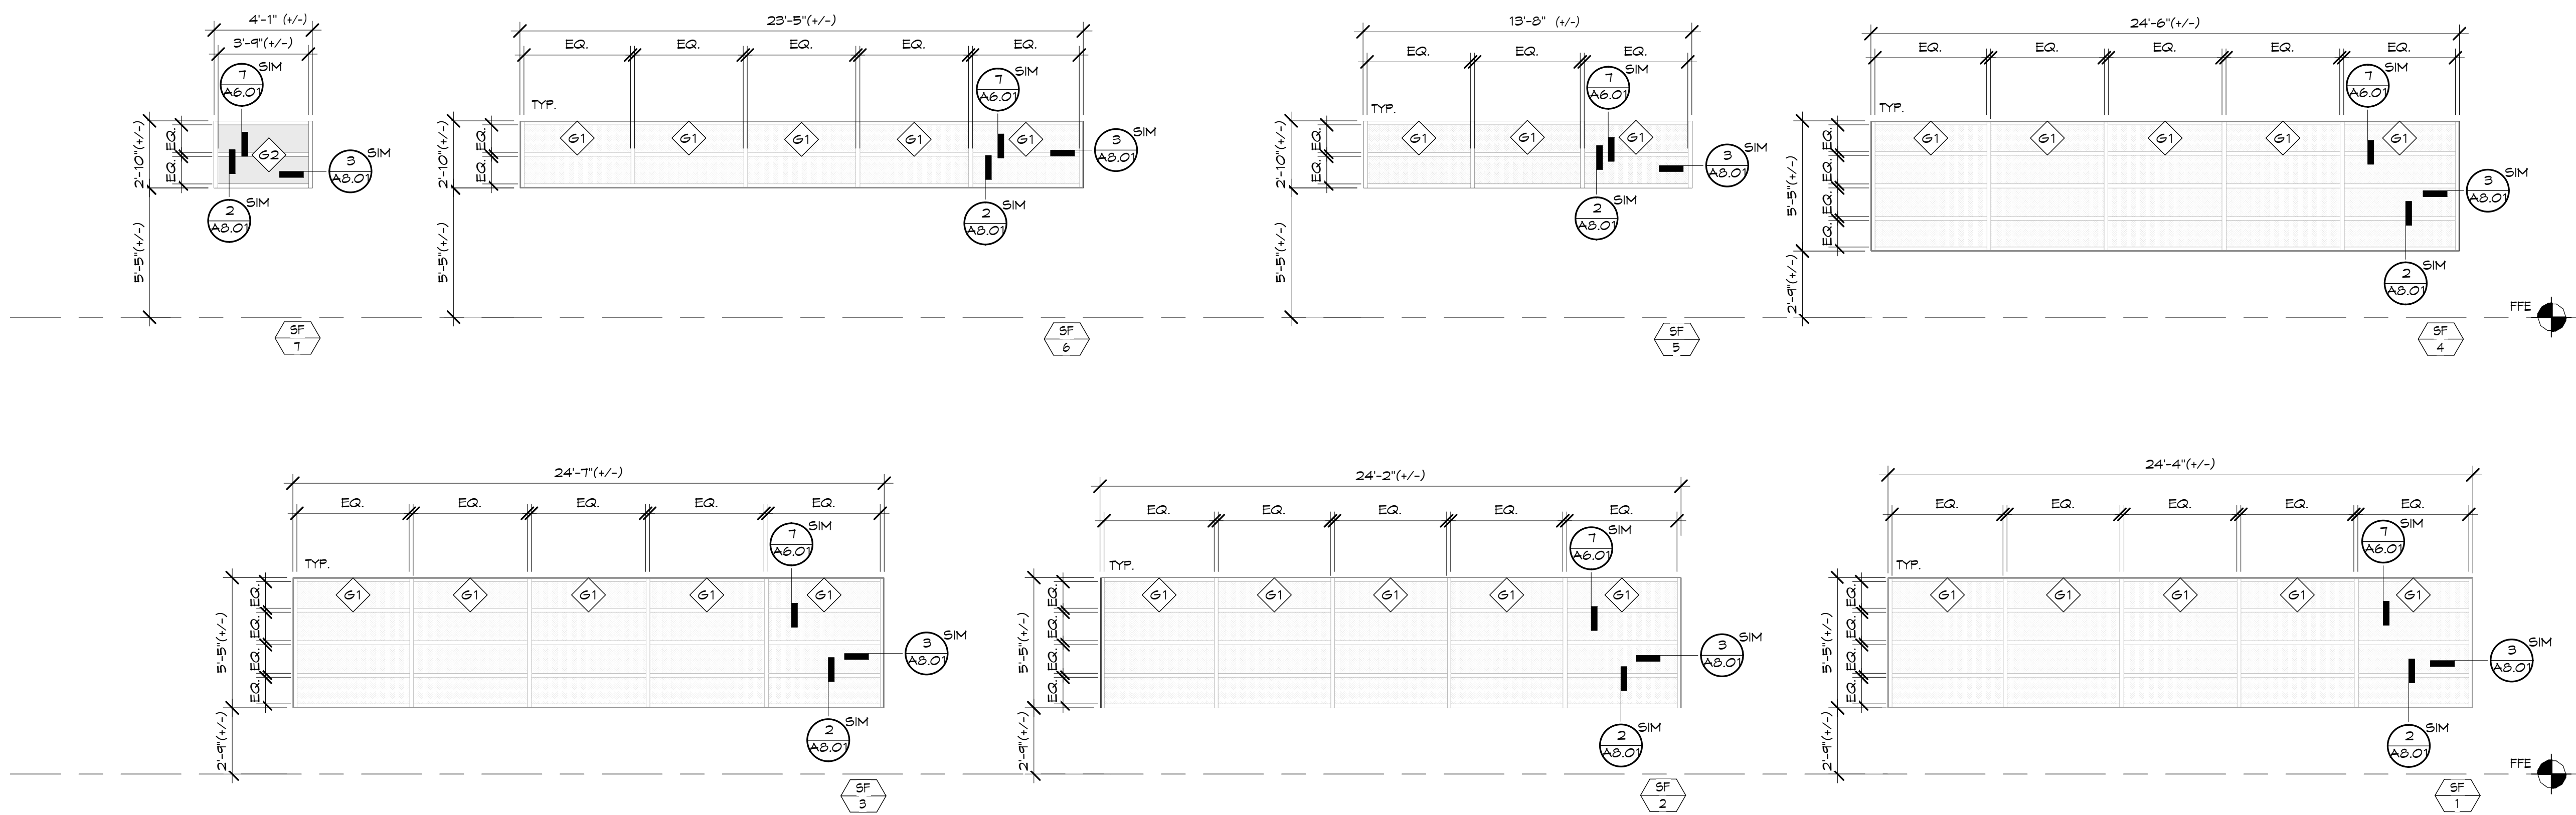
FRAME ELEVATIONS 1
1/4" = 1'-0"

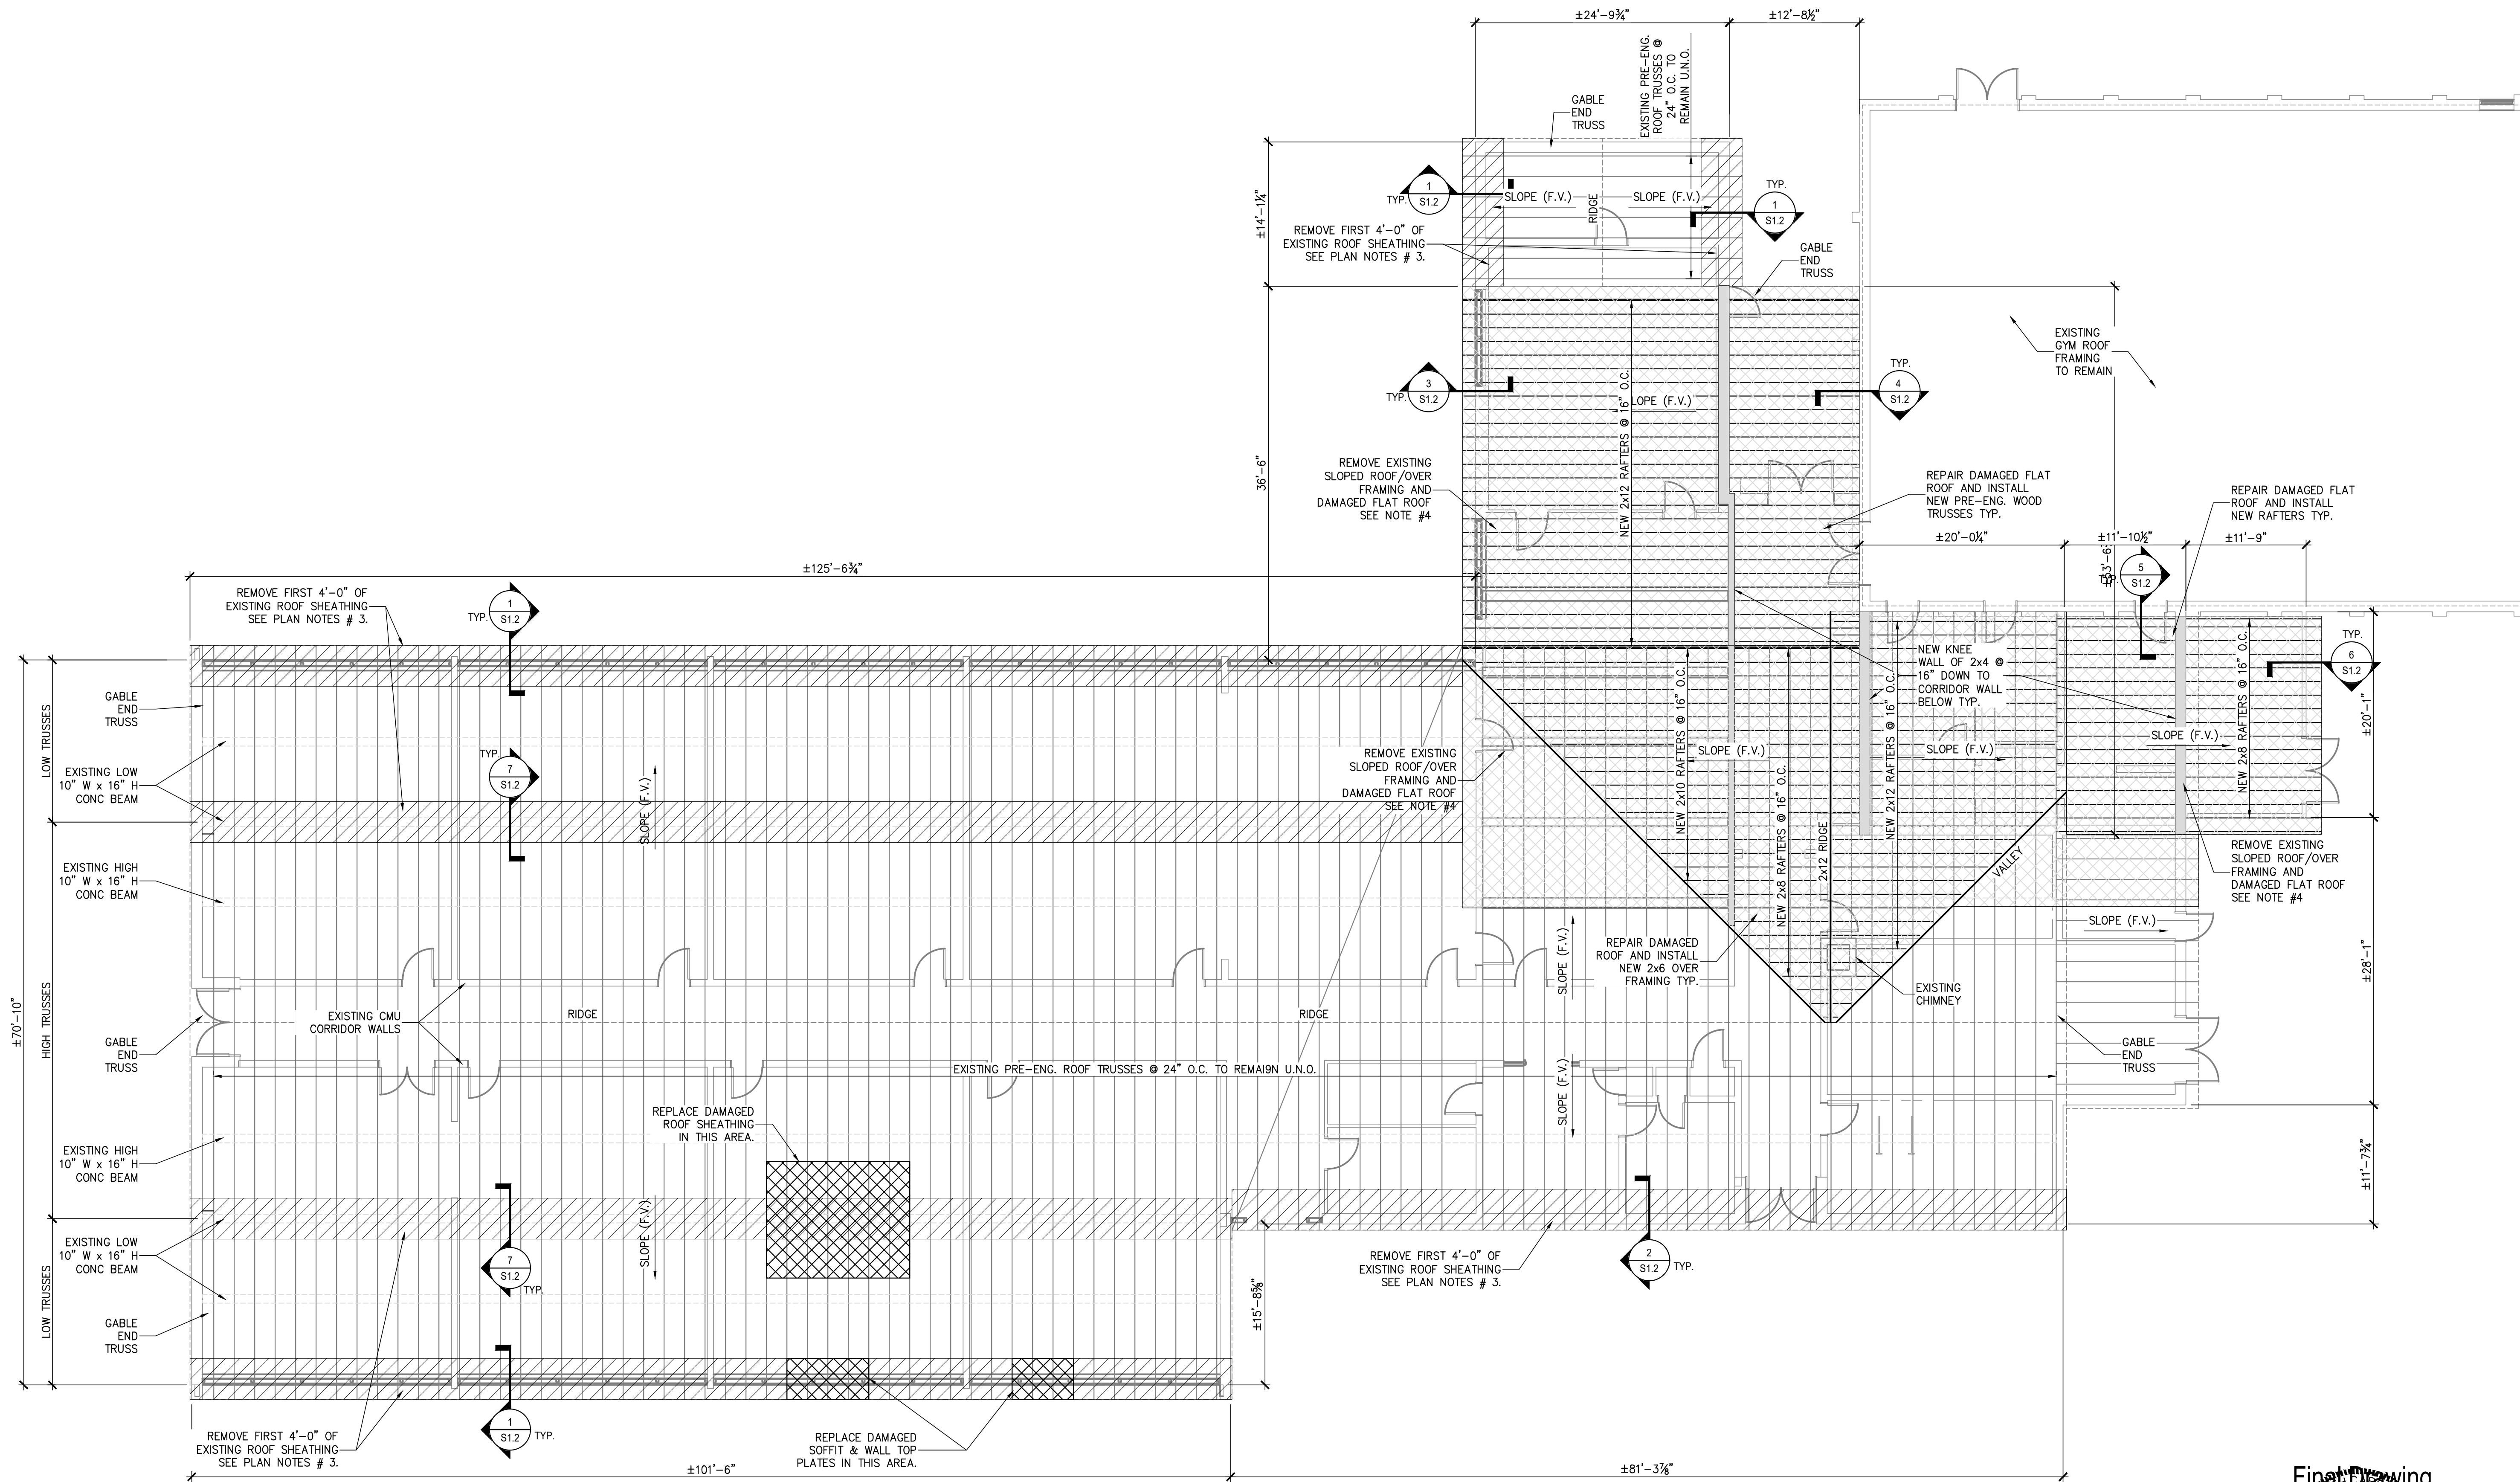
PARTIAL ROOF FRAMING PLAN
1/8" = 1'-0"

- ROOF FRAMING PLAN NOTES:**
- SEE SHEET S1.2 FOR DESIGN CRITERIA, GENERAL STRUCTURAL NOTES AND SCHEDULES.
 - ALL BUILDING DIMENSIONS ARE FROM FACE TO FACE OF STUD WALLS, U.N.O.
 - REMOVE FIRST 4'-0" OF ROOF SHEATHING TO EXPOSE TRUSS ENDS FOR INSTALLATION OF NEW HURRICANE TIES AT EA. TRUSS, U.N.O. AND REINSTALL ROOF SHEATHING TO MATCH EXISTING.
 - REMOVE EXISTING SLOPED ROOF OVER FRAMING AND DAMAGED FLAT ROOF (ORIGINAL ROOF) WOOD FRAMING IN THESE AREAS. REPAIR ORIGINAL ROOF, AND INSTALL NEW FRAMING AS SHOWN ON PLAN, TO MATCH EXISTING.
 - ± DENOTED FIELD VERIFY ALL DIMENSIONS WITH ARCHITECTURAL DRAWINGS.
 - U.N.O. DENOTES UNLESS NOTED OTHERWISE.

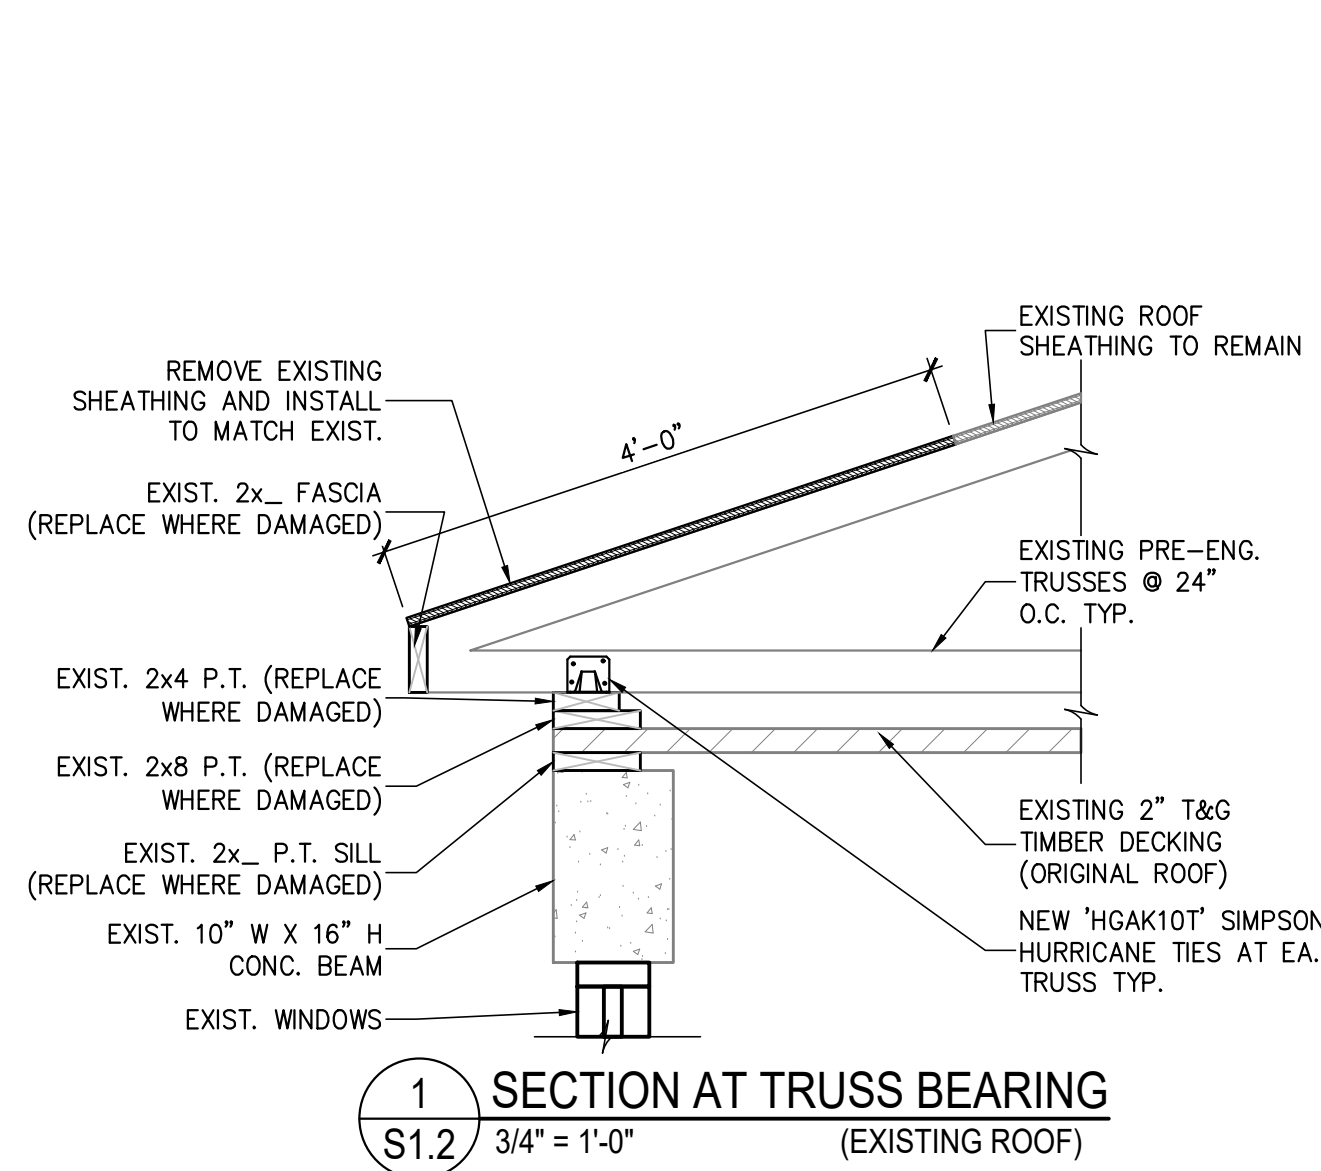
1 SECTION AT TRUSS BEARING
S1.2 3/4" = 1'-0" (EXISTING ROOF)

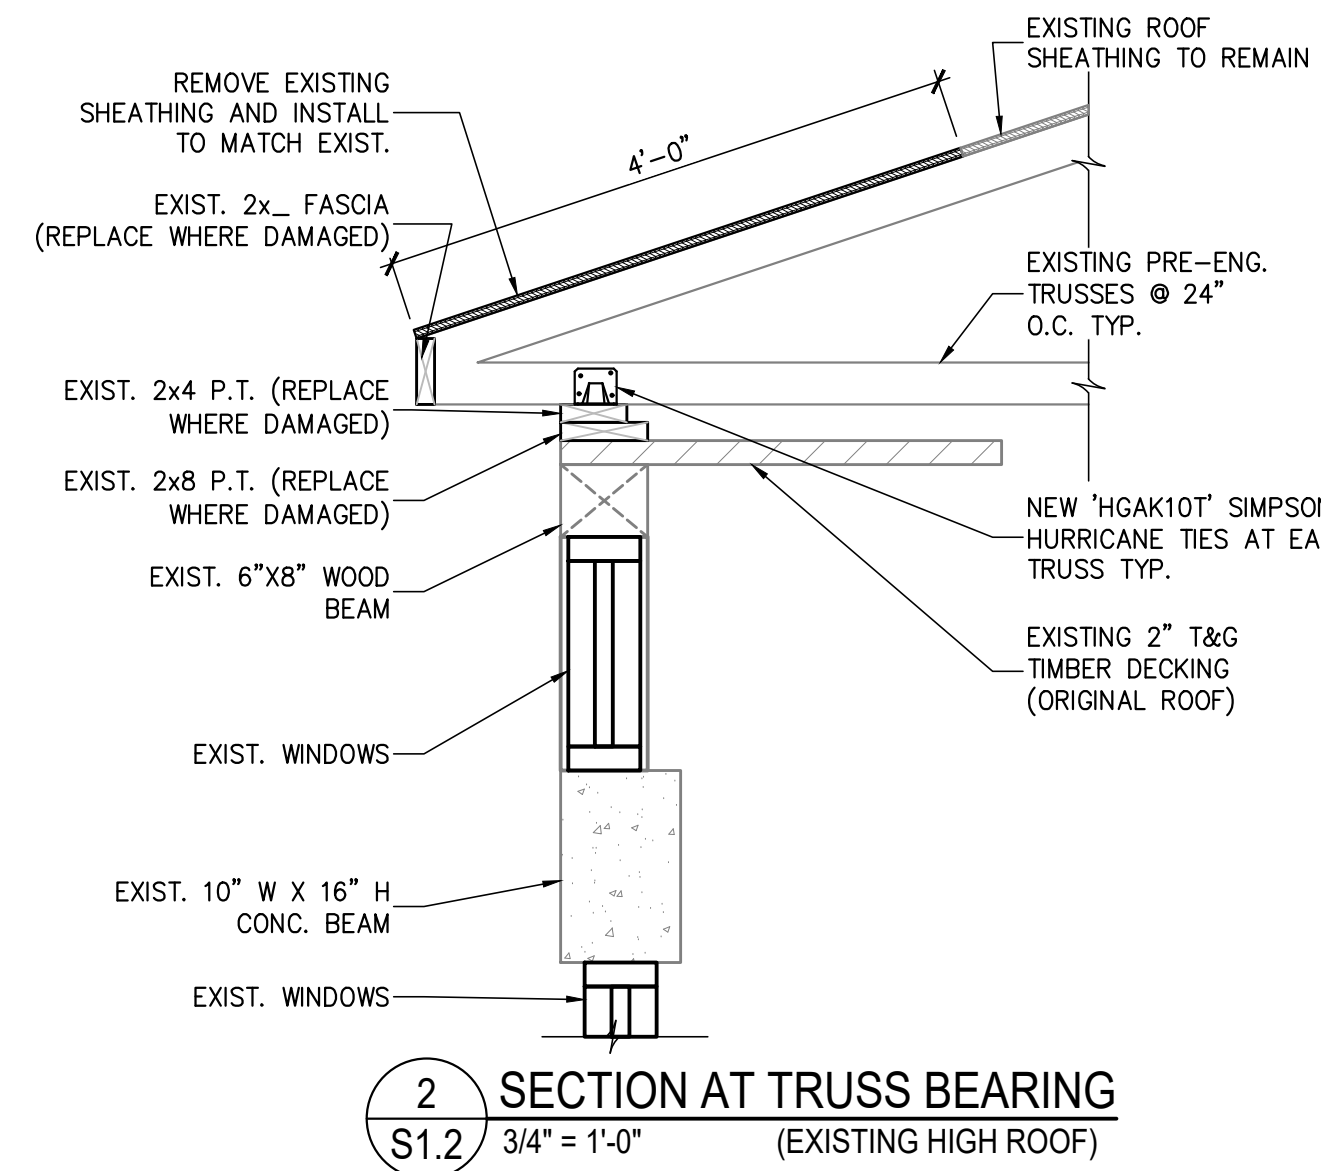
2 SECTION AT TRUSS BEARING
S1.2 3/4" = 1'-0" (EXISTING HIGH ROOF)

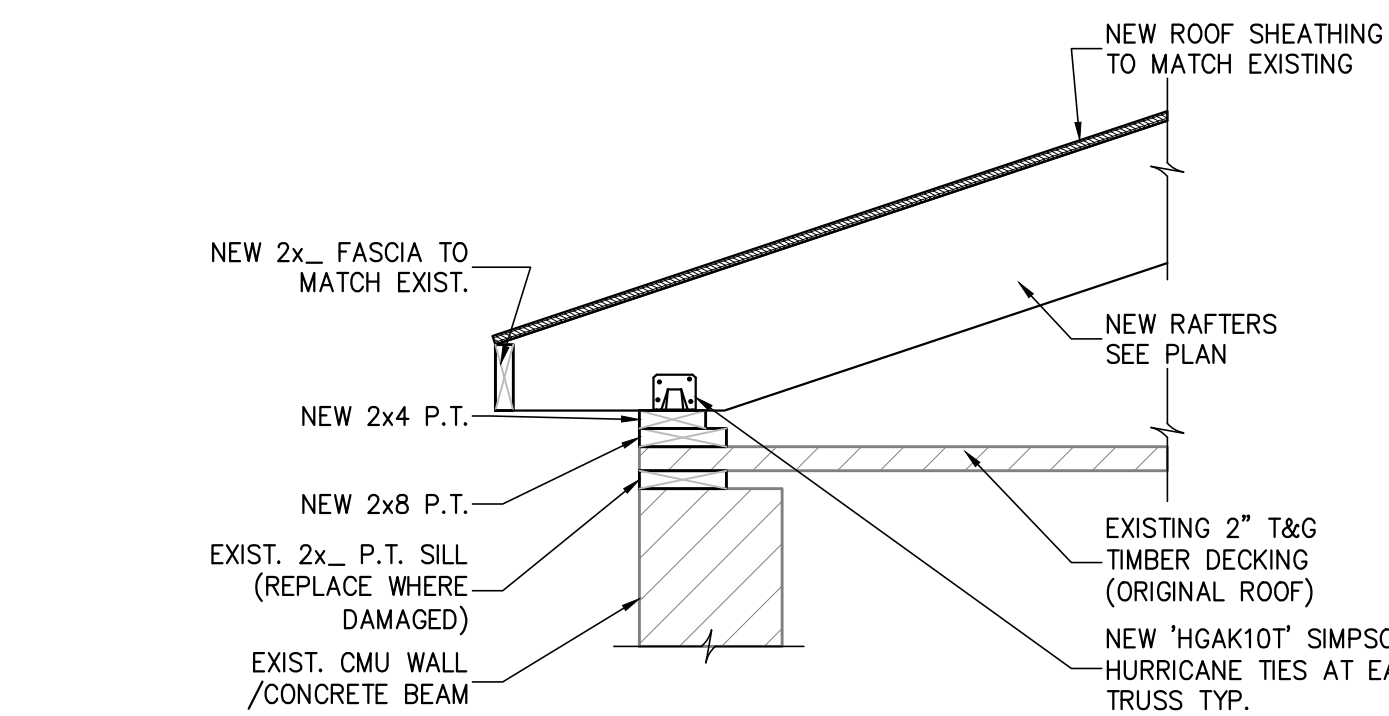
3 SECTION AT TRUSS BEARING
S1.2 3/4" = 1'-0" (ROOF REPLACEMENT)

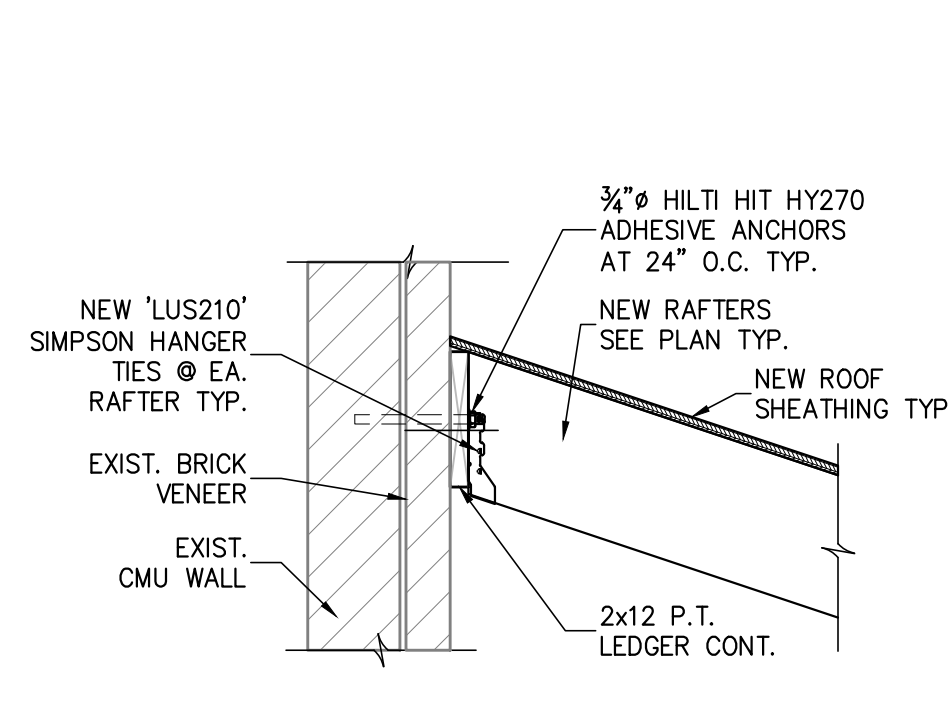
4 LEDGER CONN. TO EXIST. WALL
S1.2 3/4" = 1'-0"

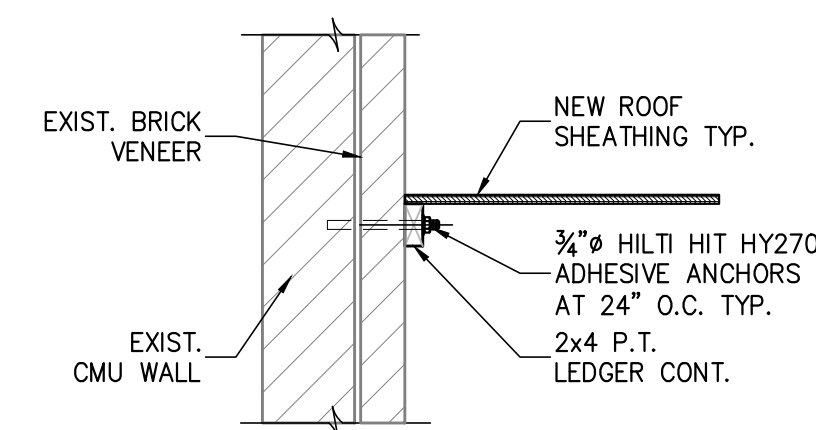
5 LEDGER CONN. TO EXIST. WALL
S1.2 3/4" = 1'-0"

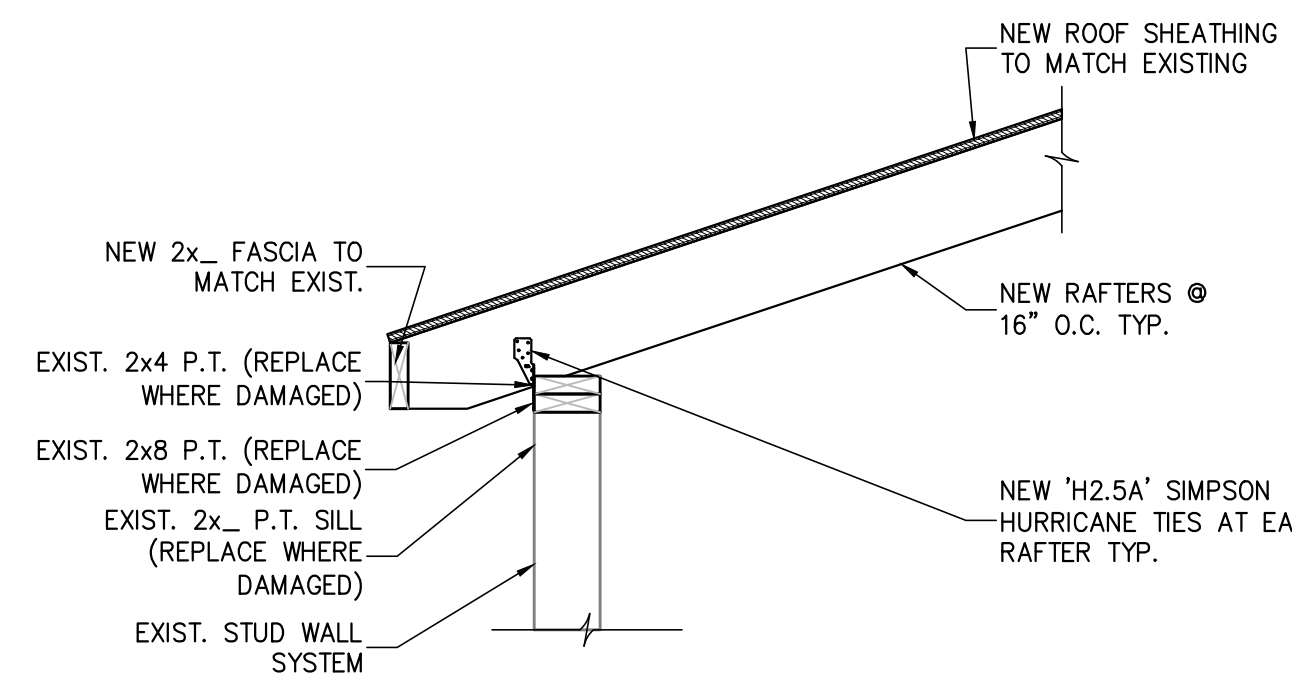
6 SECTION AT RAFTER BEARING
S1.2 3/4" = 1'-0" (LOW ROOF)
