**Environmental Review for Activity/Project that is Categorically
Excluded Subject to Section 58.5
Pursuant to 24 CFR 58.35(a)**

Project Name: Davis Ventures Community Center

Project Location: 33478 U.S. Highway 264, Engelhard, Hyde County, NC 27824

ROOF & BUILDING REPAIRS

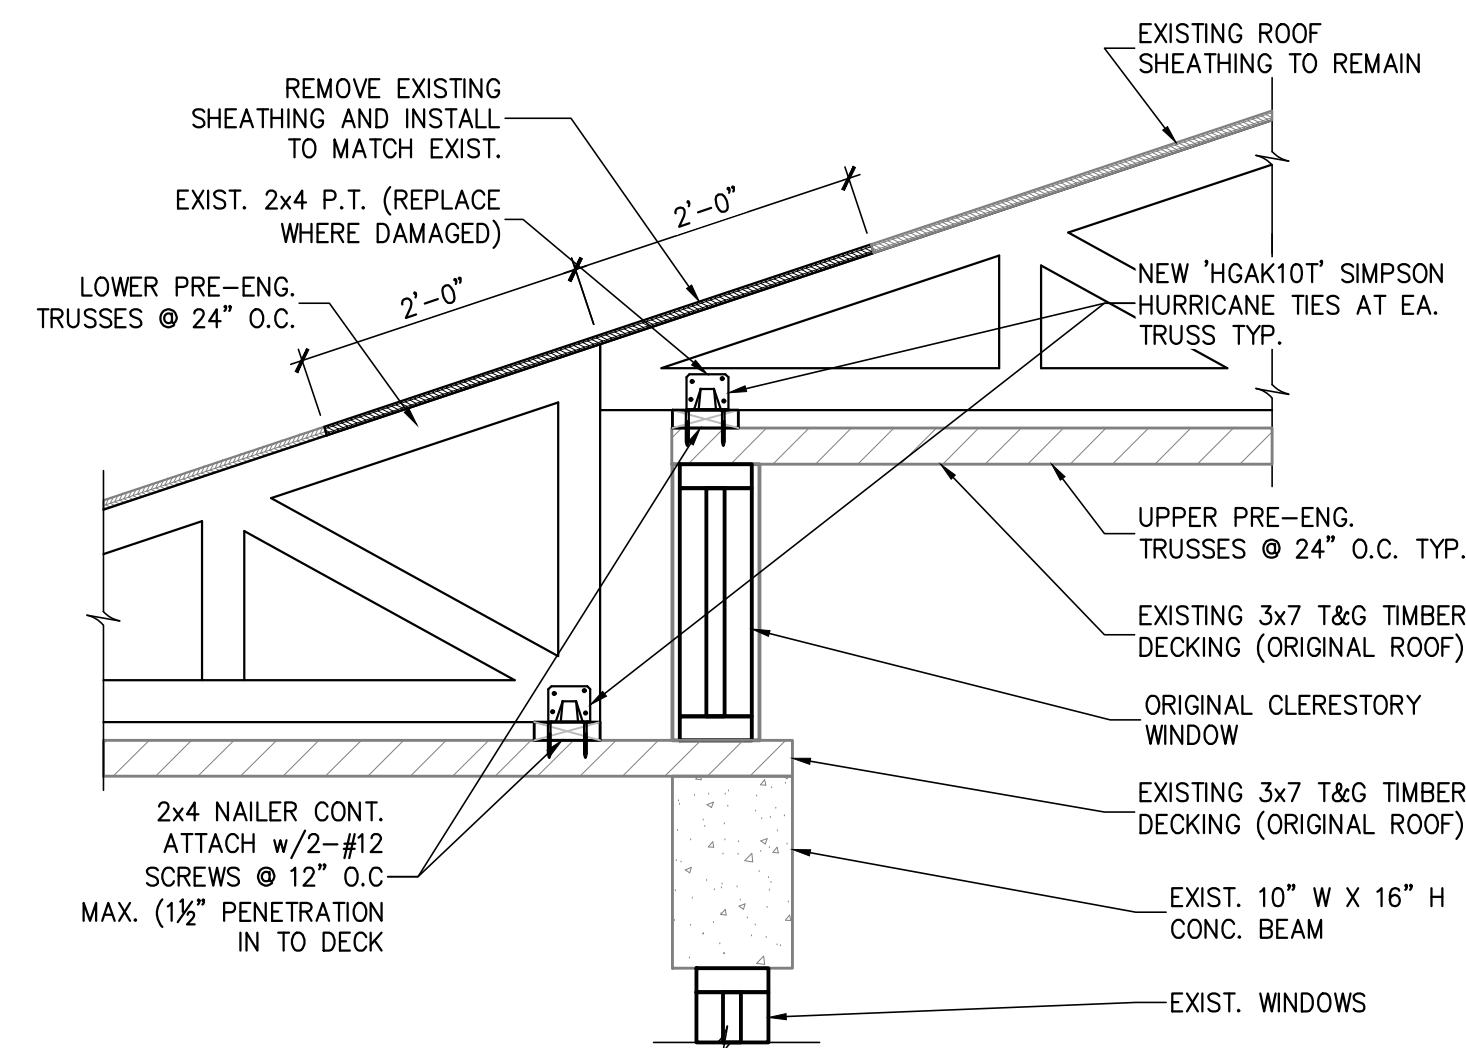
7 SECTION AT TRUSS TRANSITION
S1.2 3/4" = 1'-0"

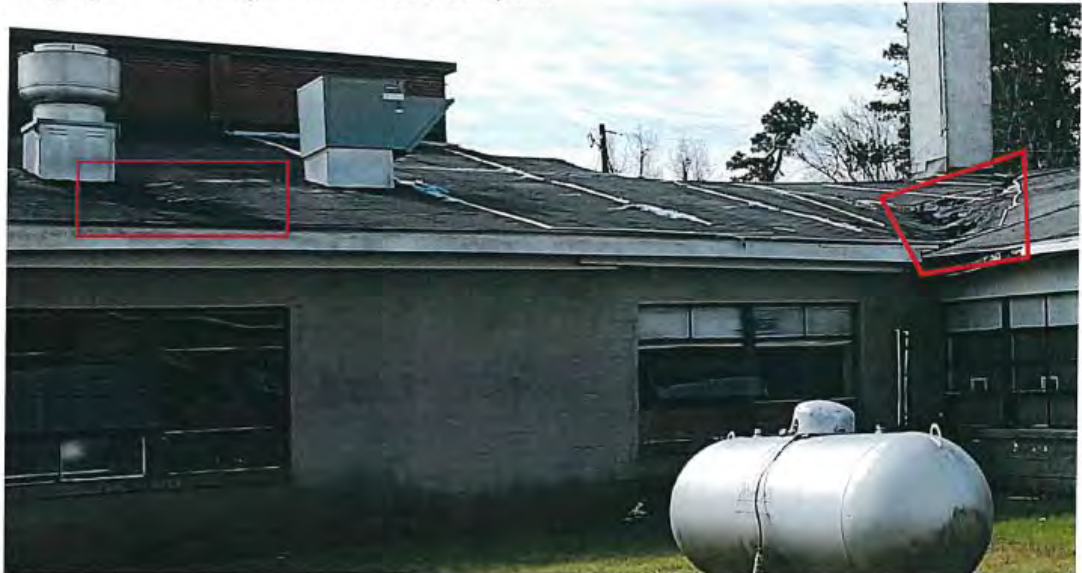
Photo 2: To the right can be seen the flashing which shows the original roof alignment. Near the ridge the roof has settled about two feet.

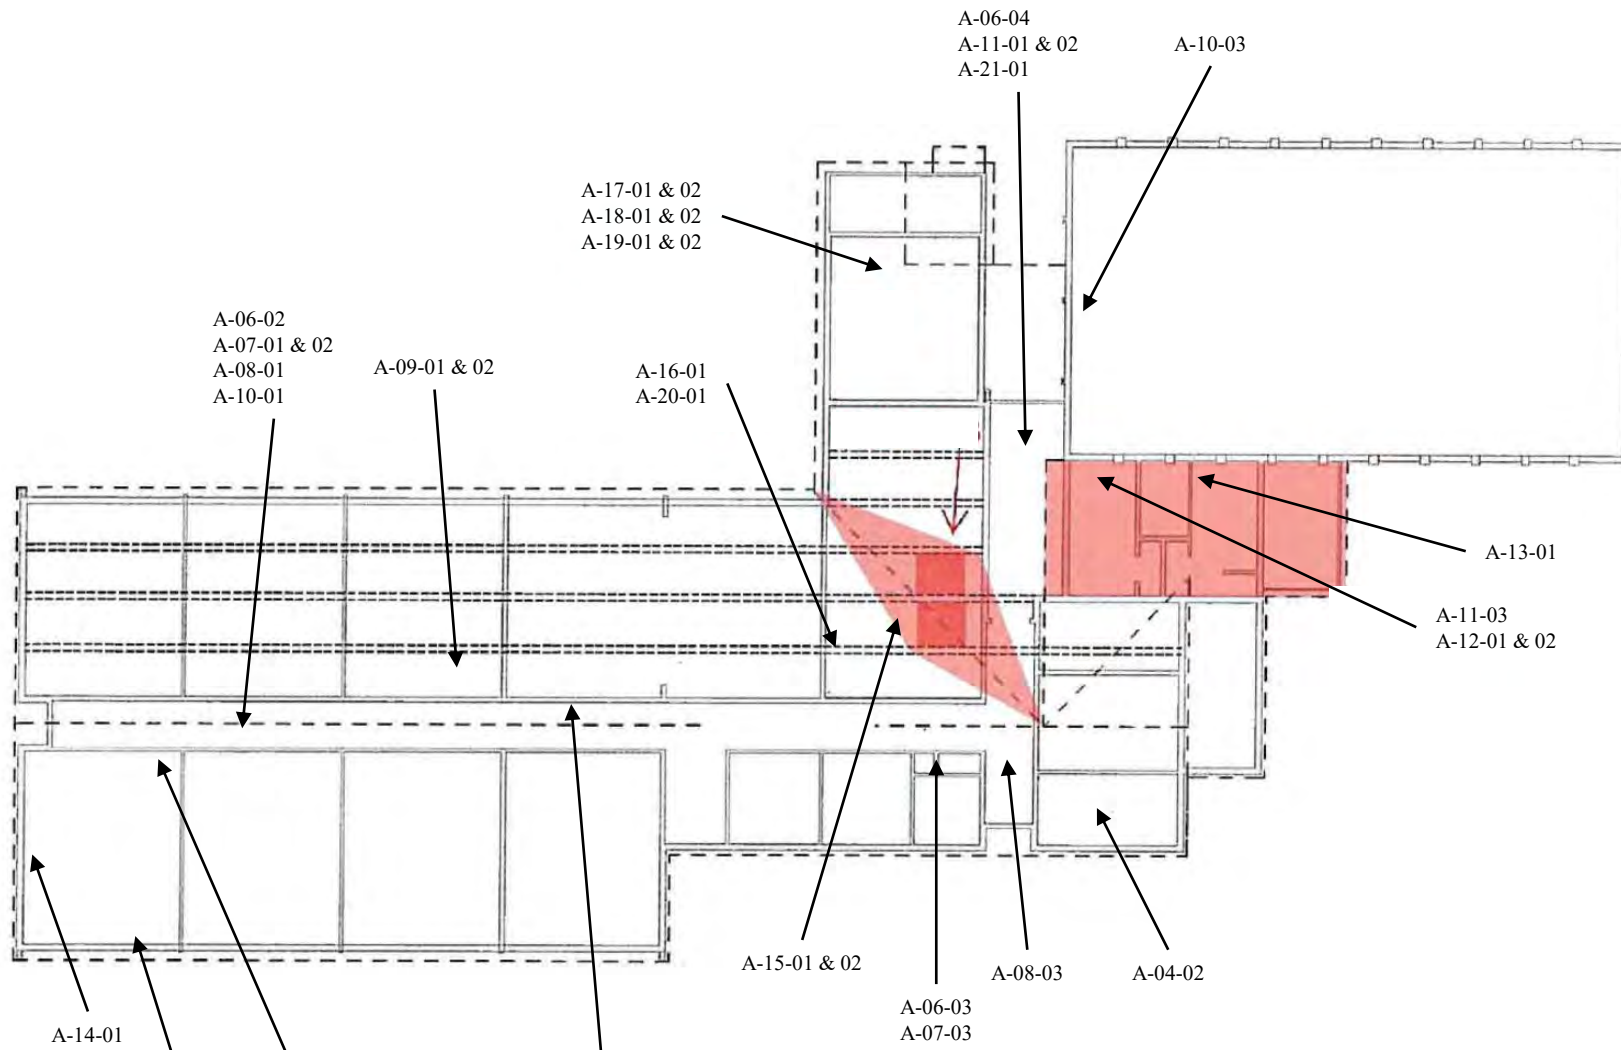
Asbestos Bulk Sampling Location Drawing

Asbestos Bulk Sampling Locations	
Davis Ventures Community Center	
Engelhard, NC	
Scale: No Scale	
Date: 1/14/2023	
Drawn by: MGC	
AEC #23009

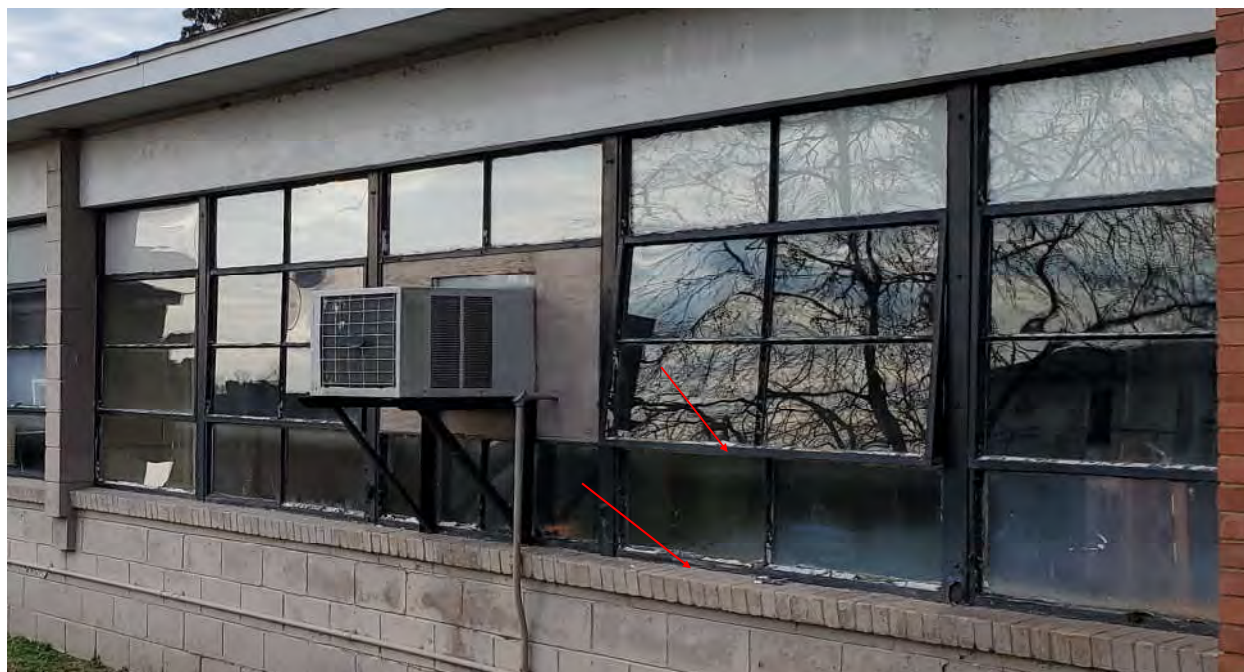
Photograph 1 - Homogeneous Areas A-01 & A-22—Typical Asbestos-Containing Exterior Window Glazing and Window Frame Caulking Located Throughout Main Building Window Units. (57 Window Units)

Photograph 1 - Homogeneous Areas A-01 & A-22—Typical Asbestos-Containing Exterior Window Glazing and Window Frame Caulking Located Throughout Main Building Window Units. (57 Window Units)

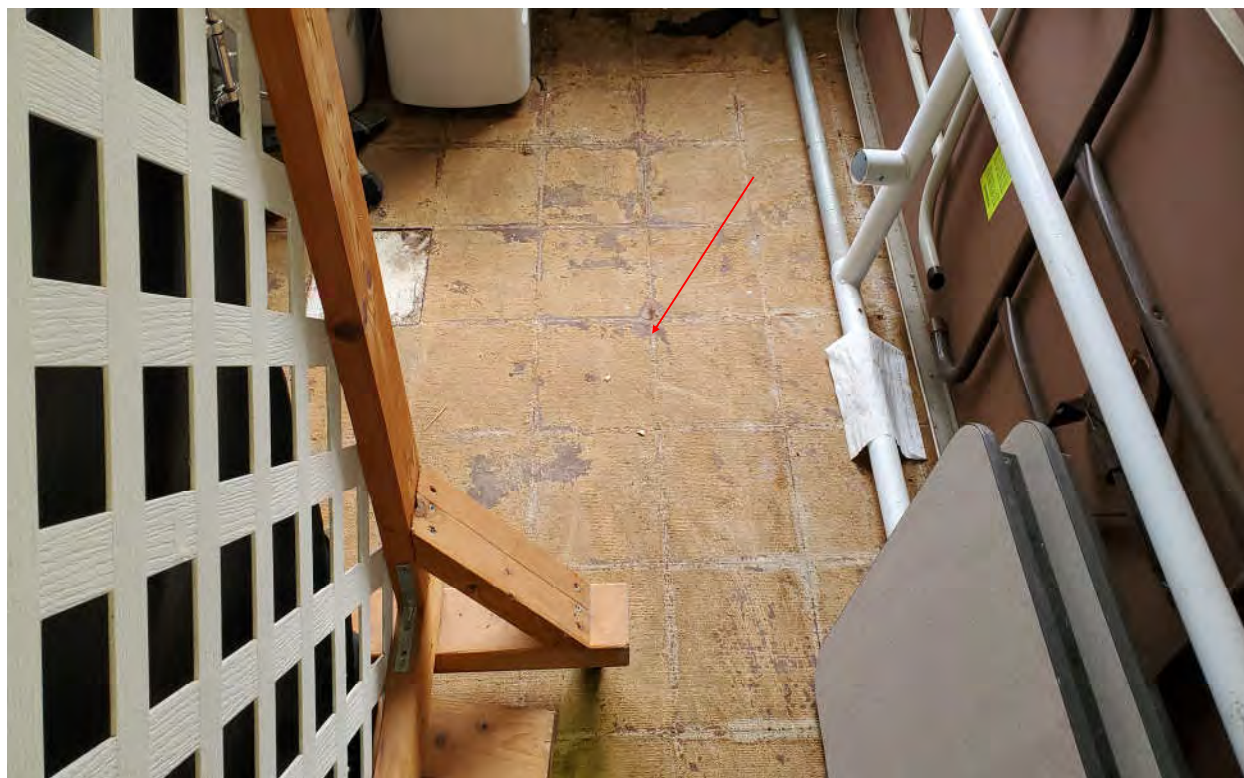
Photograph 2 - Homogeneous Area A-06—Typical Asbestos-Containing 9" x 9" Floor Tile & Black Mastic (Green & Brown Colors) Located as Underlayer Throughout Main Building Classrooms, Corridors, & Office Area Under Carpet or Non-ACM Floor Tile or Linoleum (9,700 SF)

Photograph 2 - Homogeneous Area A-06—Typical Asbestos-Containing 9" x 9" Floor Tile & Black Mastic (Green & Brown Colors) Located as Underlayer Throughout Main Building Classrooms, Corridors, & Office Area Under Carpet or Non-ACM Floor Tile or Linoleum (9,700 SF)

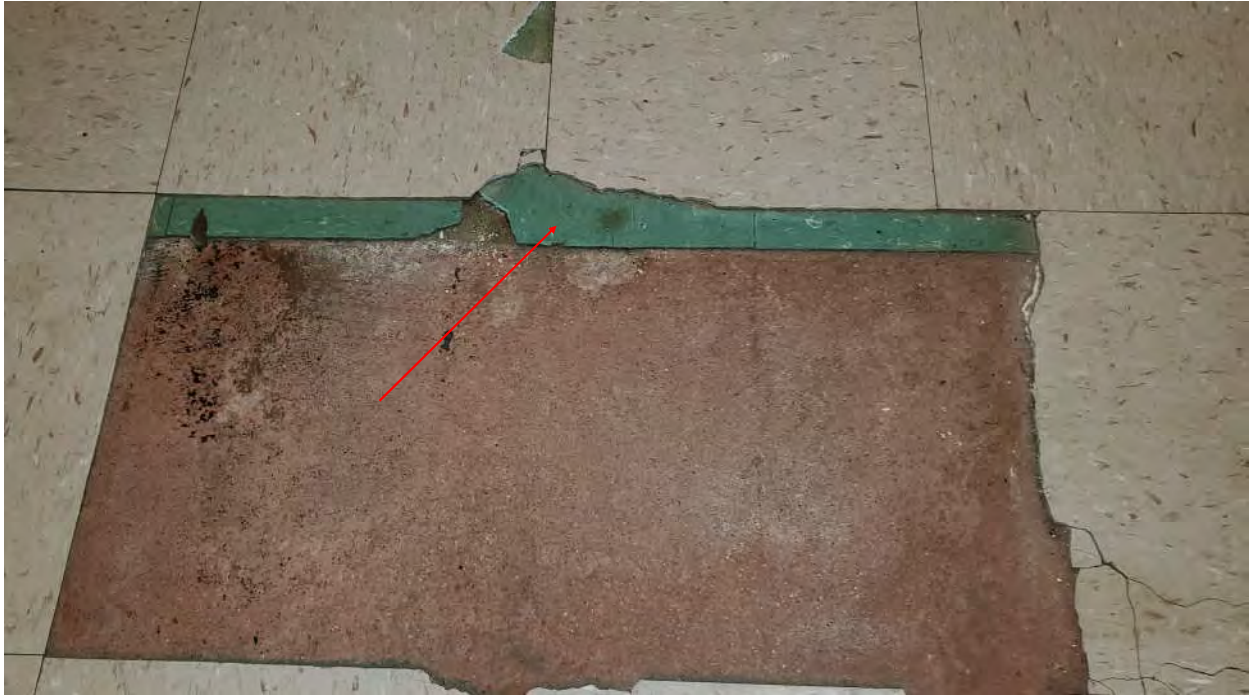
Photograph 3 - Homogeneous Area A-06 - Typical Asbestos-Containing 9" x 9" Floor Tile & Black Mastic (Green & Brown Colors) Located as Underlayer Throughout Main Building Classrooms, Corridors, & Office Area Under Carpet or Non-ACM Floor Tile or Linoleum

Photograph 3 - Homogeneous Area A-06 - Typical Asbestos-Containing 9" x 9" Floor Tile & Black Mastic (Green & Brown Colors) Located as Underlayer Throughout Main Building Classrooms, Corridors, & Office Area Under Carpet or Non-ACM Floor Tile or Linoleum

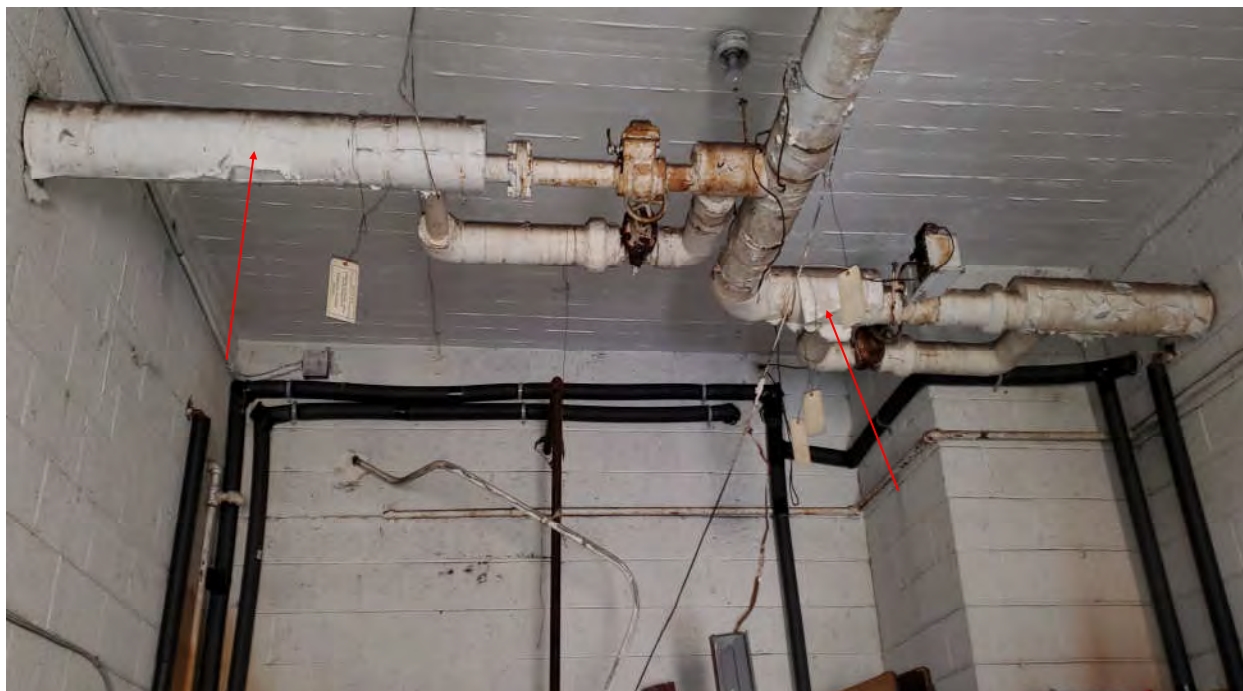
Photograph 5 - Homogeneous Area A-23 - Asbestos-Containing “Air-Cell” Straight Run Pipe Insulation Located Overhead in the Mechanical Room. (10 LF)

Photograph 5 - Homogeneous Area A-23 - Asbestos-Containing “Air-Cell” Straight Run Pipe Insulation Located Overhead in the Mechanical Room. (10 LF)

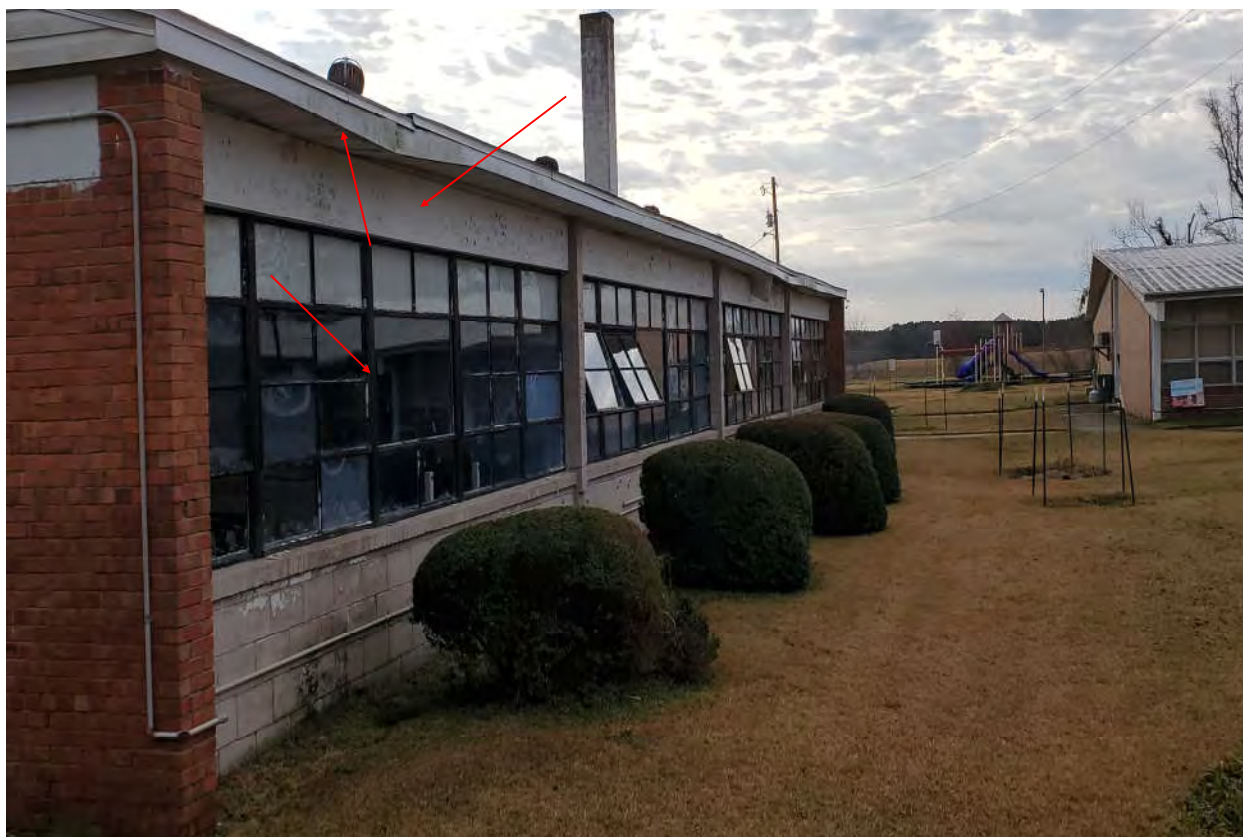
Photograph 6 - Typical Lead-Based Paint Throughout Interior and Exterior Metal Window Components (Sashes & Casings), Concrete Window Headers, & Wooden Eaves of Main Building.

Photograph 6 - Typical Lead-Based Paint Throughout Interior and Exterior Metal Window Components (Sashes & Casings), Concrete Window Headers, & Wooden Eaves of Main Building.

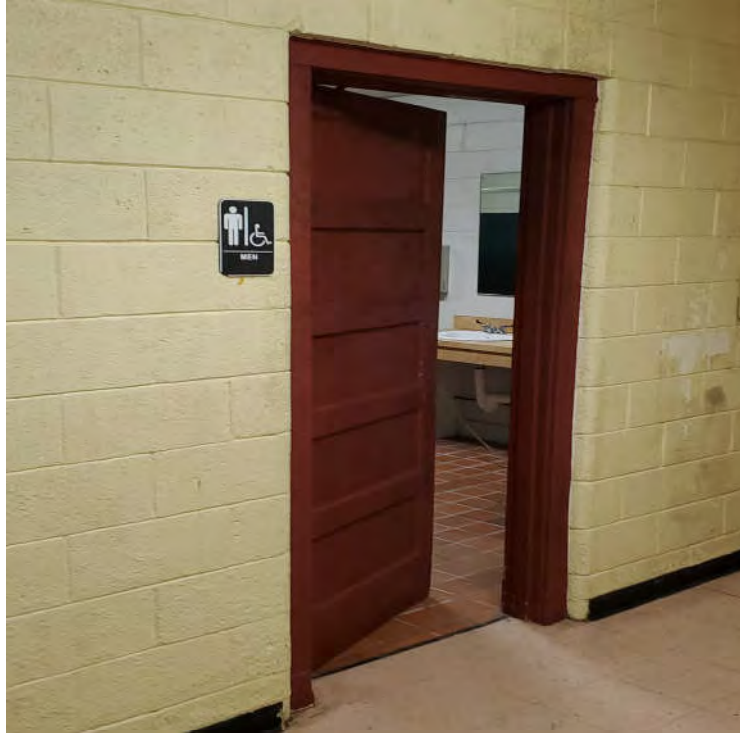
Photograph 7 - Typical Lead-Based Paint on Red Doors and Dooring Casings in Restrooms of Main Building.

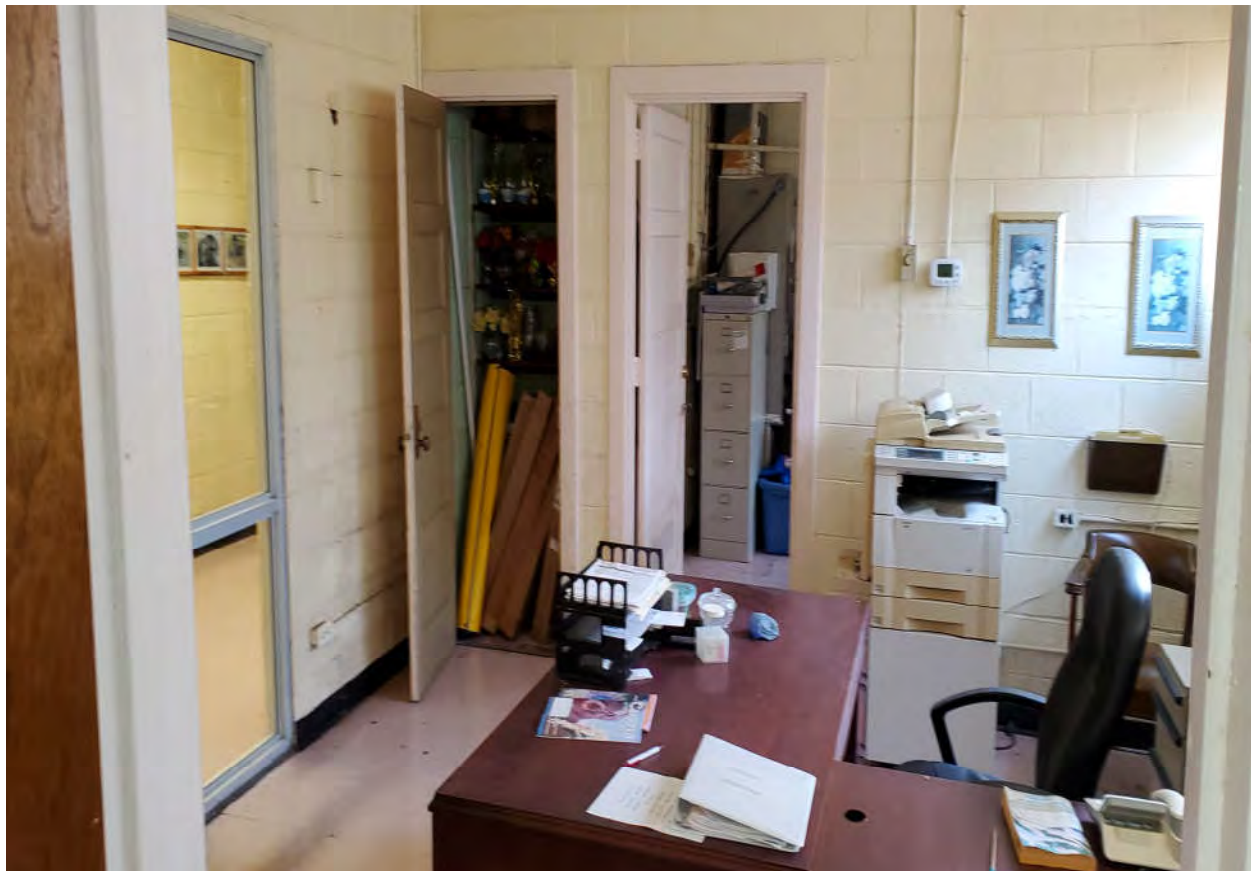
Photograph 8 - Typical Lead-Based Paint on CMU Walls in This One Room Only in Office Area in Main Building.

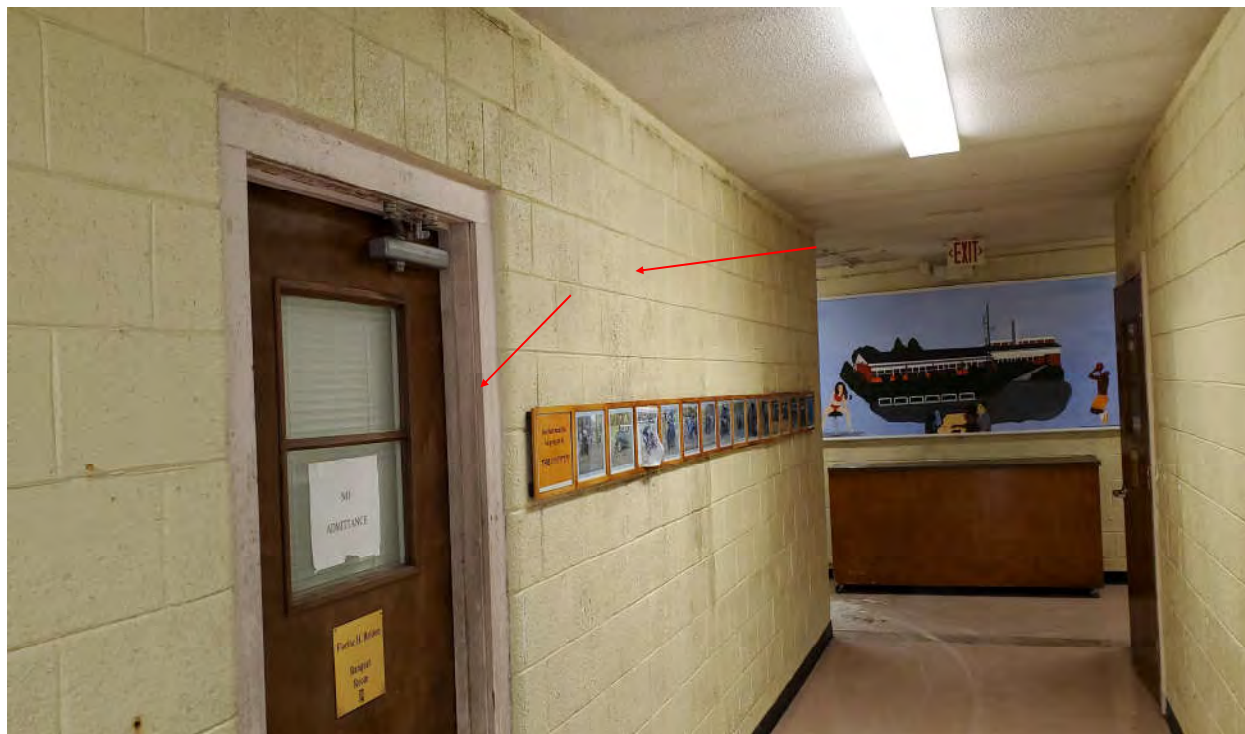
Photograph 9 - Typical Mold Growth on Walls, Door Components, & Other Surfaces Located Throughout the Main Building.

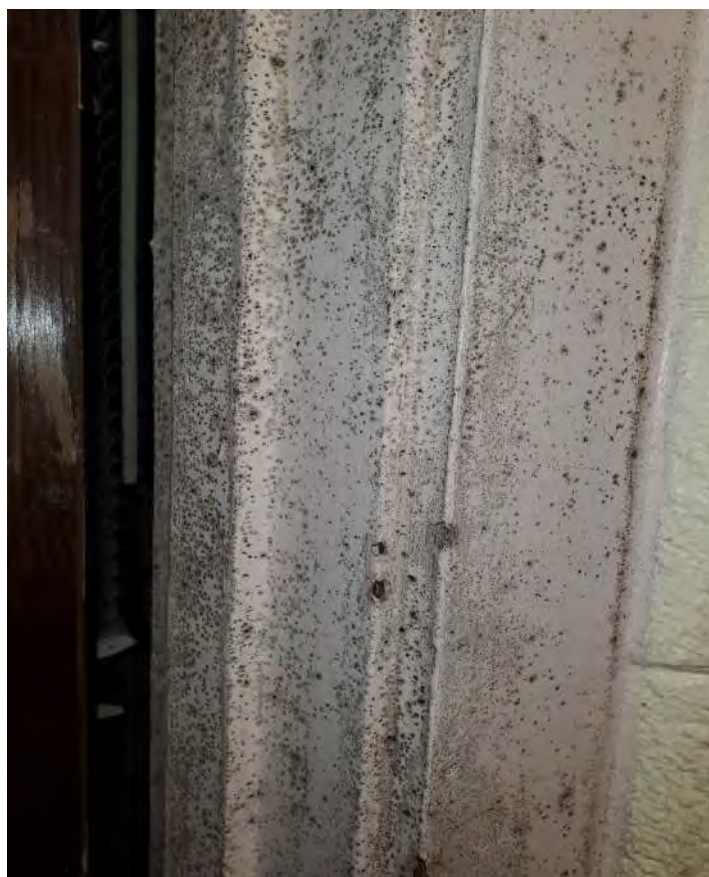
Photograph 10 - Typical Mold Growth on Walls, Door Components, & Other Surfaces Located Throughout the Main Building.

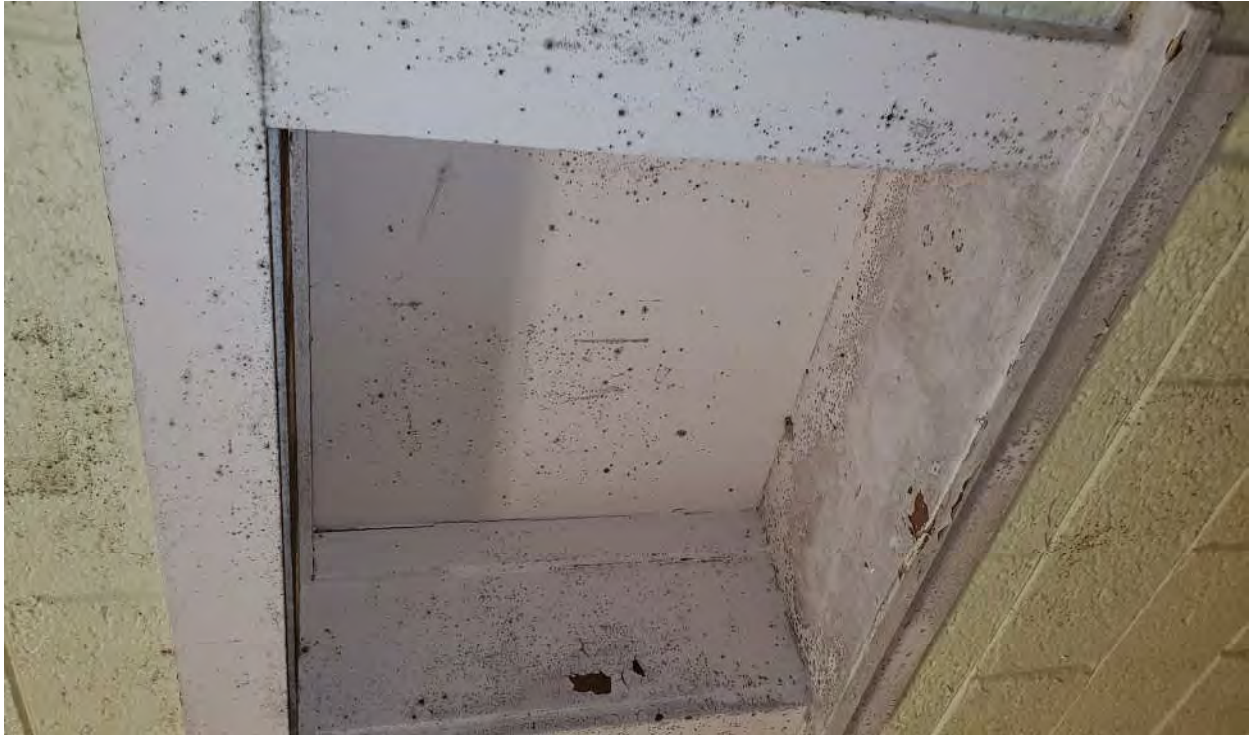
Photograph 11 - Typical Mold Growth on Walls, Door Components, & Other Surfaces Located Throughout the Main Building.

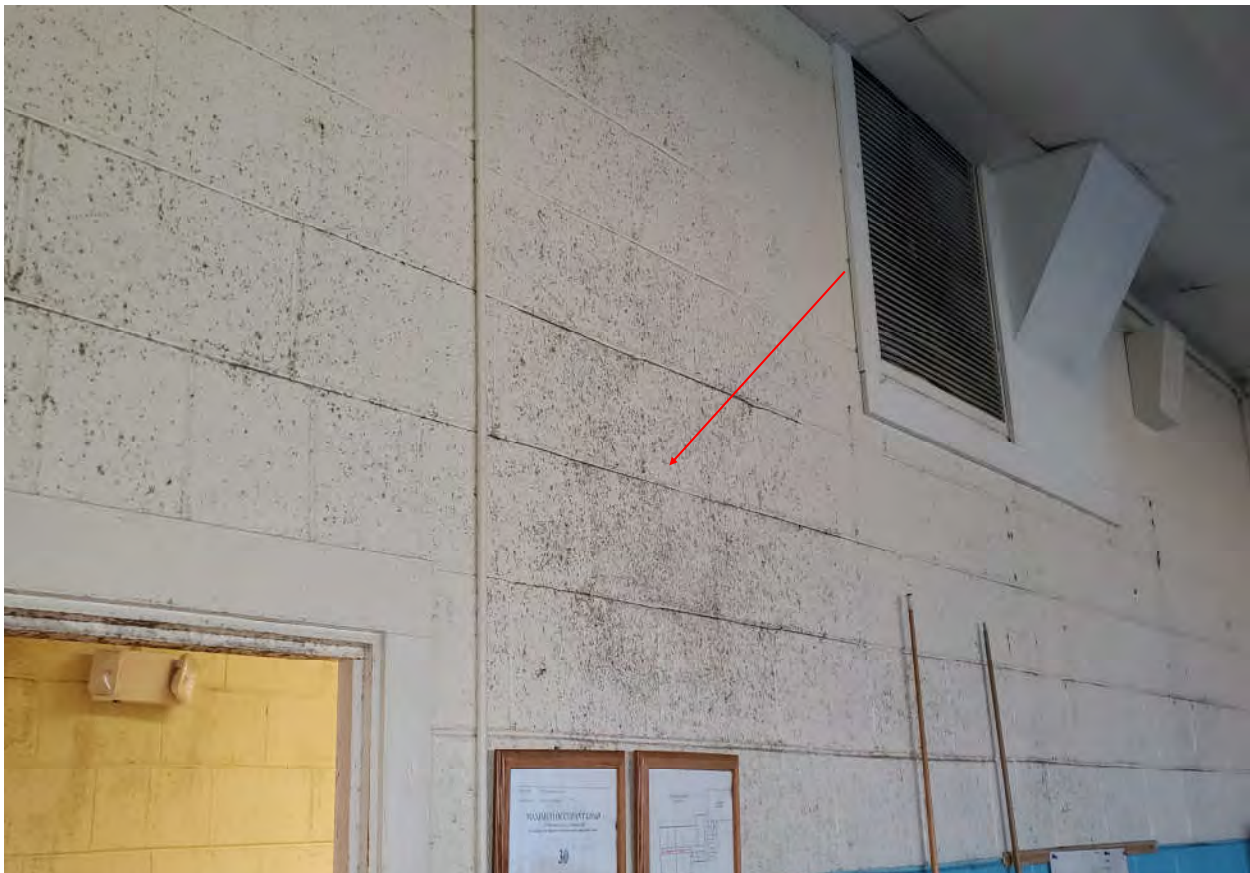
Photograph 12 - Typical Mold Growth on Walls, Door Components, & Other Surfaces Located Throughout the Main Building.

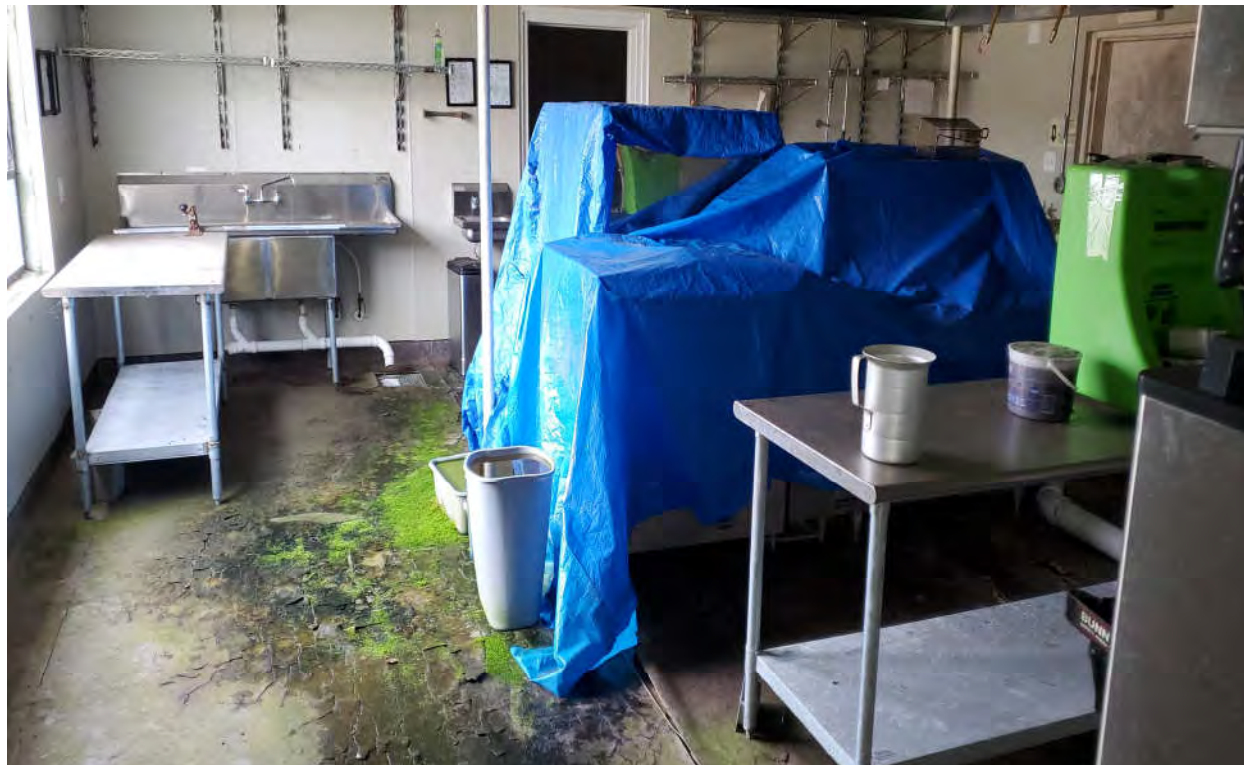
Photograph 13 - Typical Moisture Damage & Mold Growth in Cafeteria from Damaged Roof.

1. The roof was observed to be in poor condition throughout. There are numerous tarps on section of the roof. The roof is caved in over the cafeteria dining room and adjacent gym corridor. There are various water damaged ceiling tiles located throughout the building.
2. Visible mold growth was observed on surfaces throughout the building. **(Photos #9, 10, 11, 12, 13, & 14).**
3. The ceilings are badly damaged in the cafeteria, gym corridor, and gym locker rooms from water damage. **(Photos #13, 14, 15, & 16).**

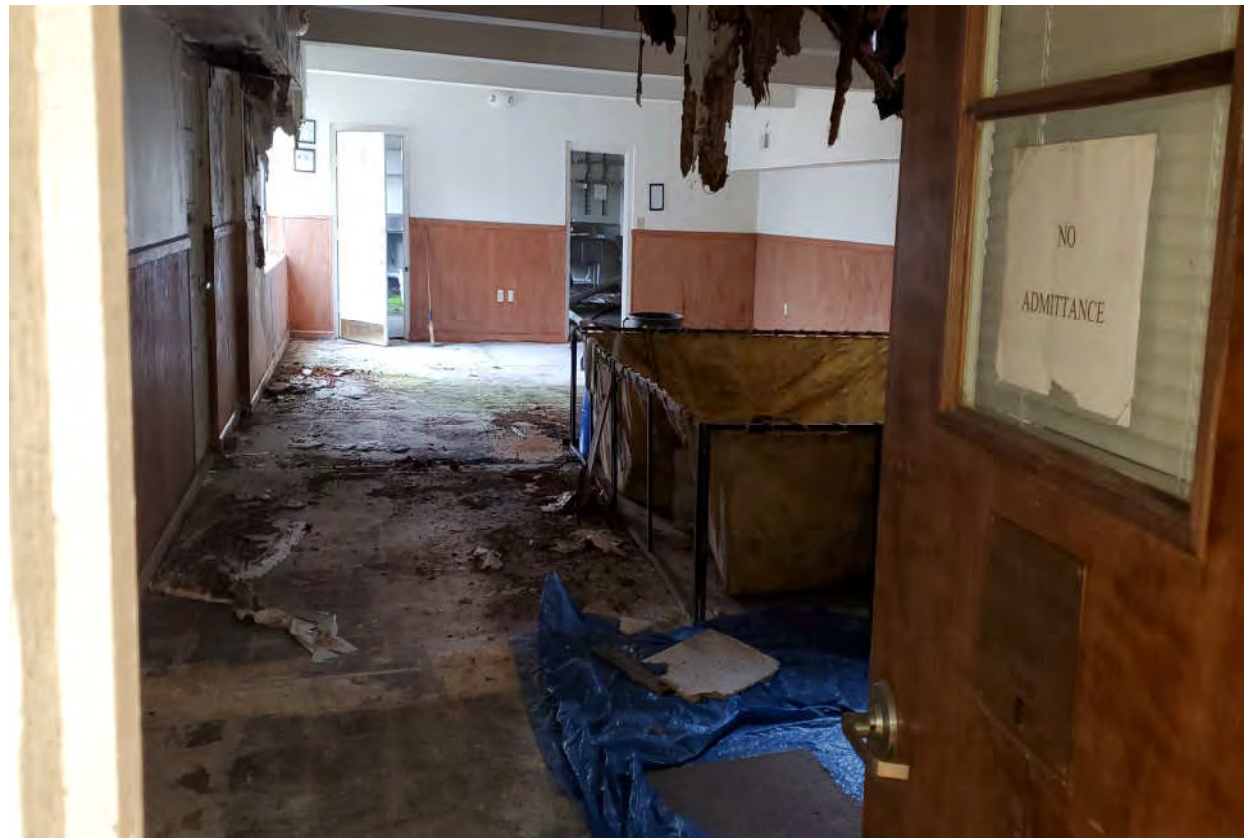
Photograph 14 - Typical Moisture Damage & Mold Growth on Walls, Door Components, & Other Surfaces in the Cafeteria from Damaged Roof.

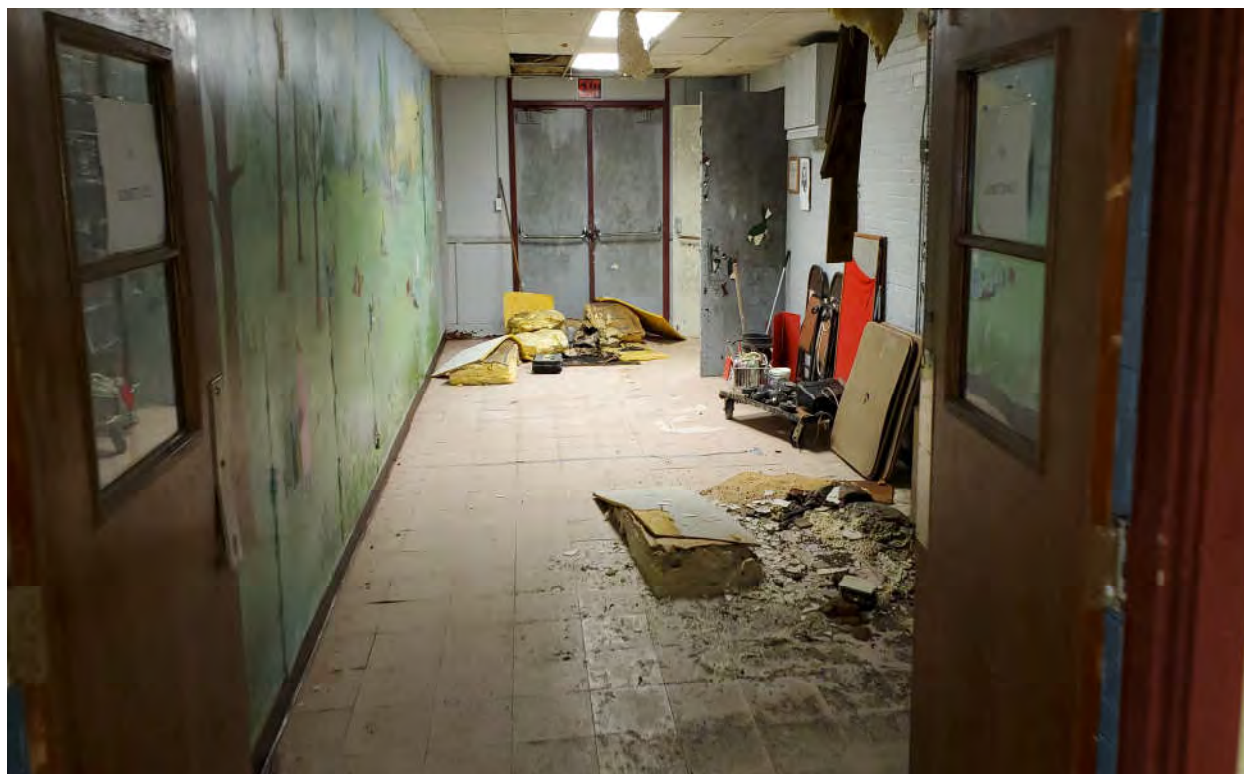
Photograph 15 - Typical Water Damage & Mold Growth in Gym Corridor from Damaged Roof.

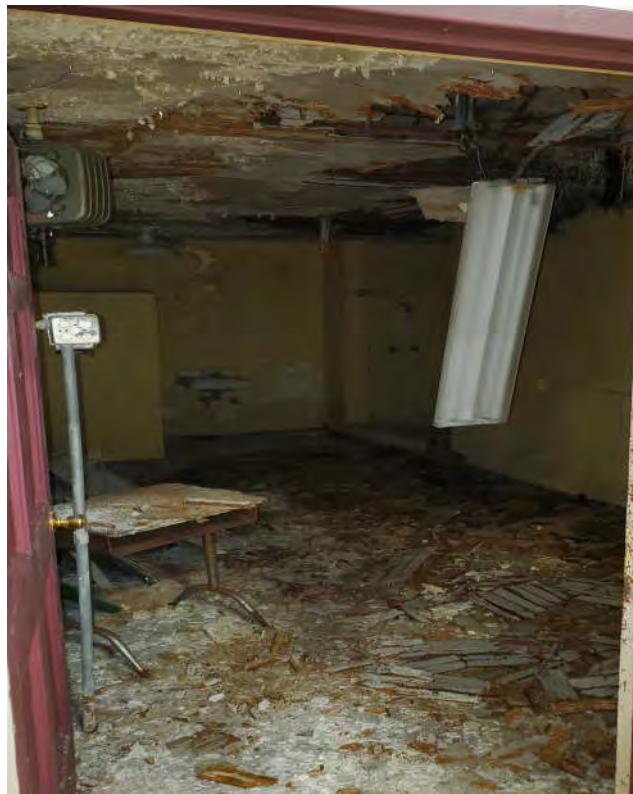
Photograph 16 - Typical Moisture Damage & Mold Growth on Walls, Door Components, & Other Surfaces in the Gym Locker Rooms from Damaged Roof.

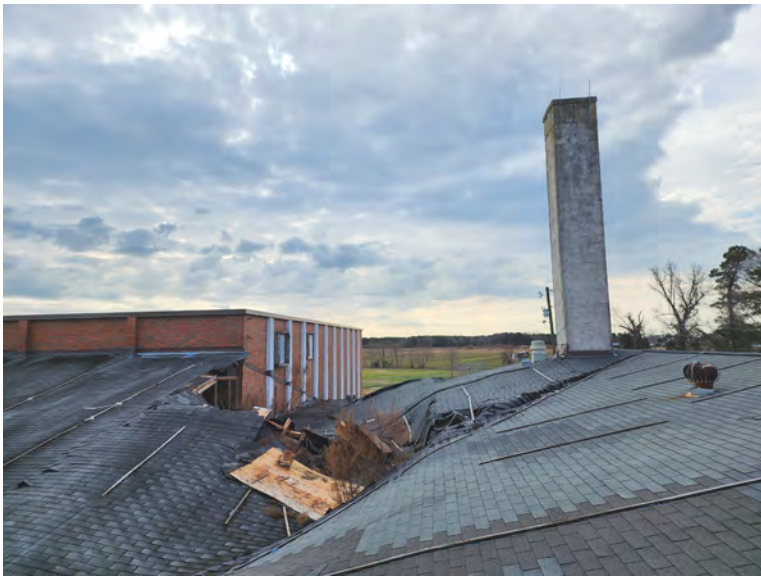
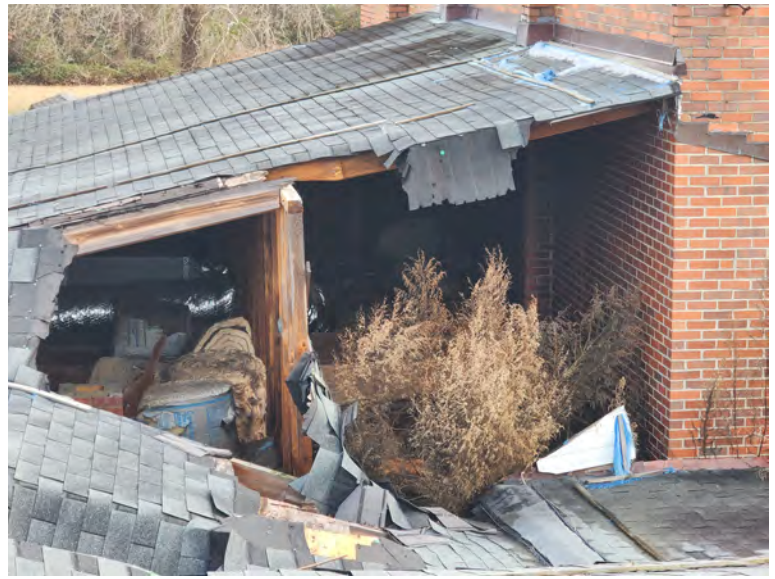
Roof collapse view from the roof.

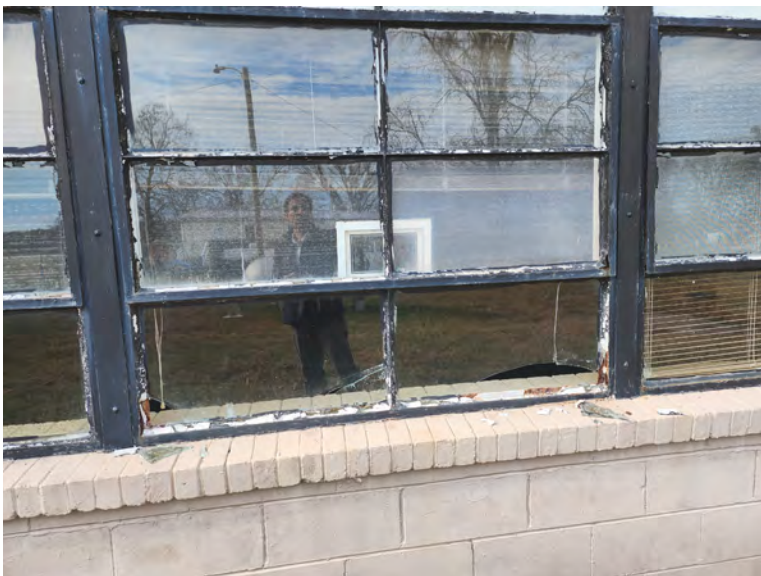
Broken window glass and rotted sashes.

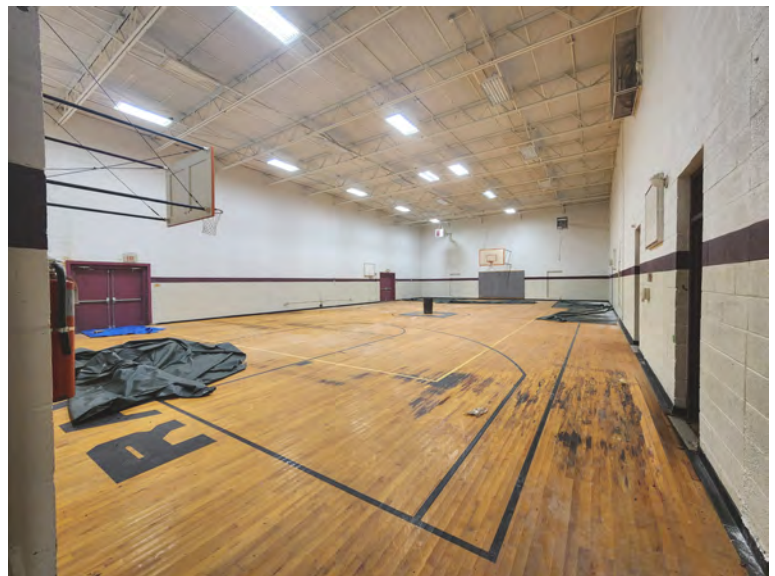
Water damage on wood sport floor.

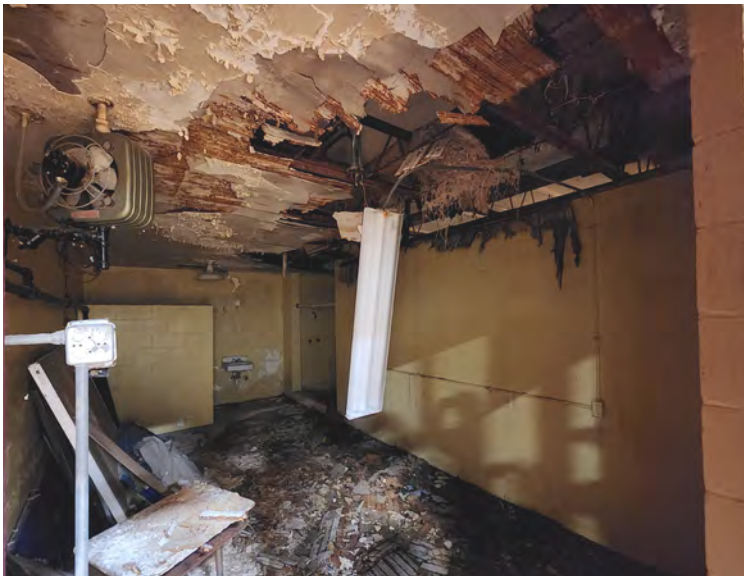
Water damage to locker rooms.

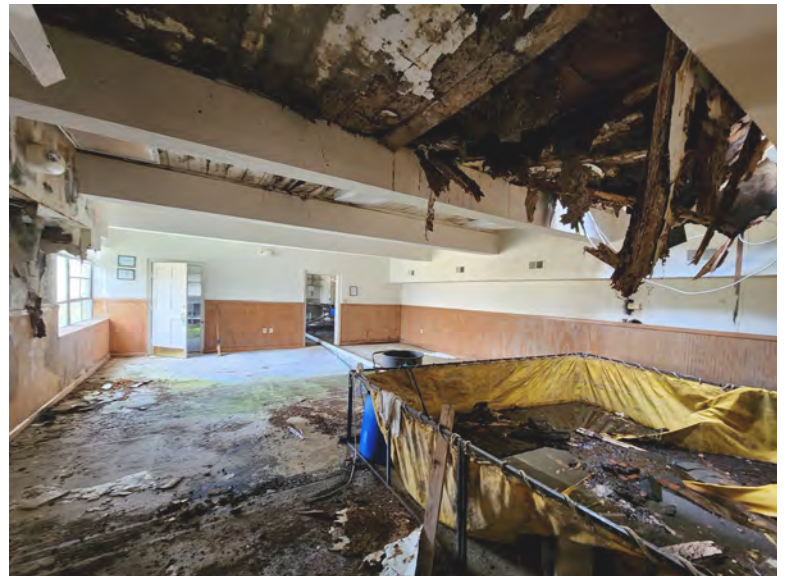
Water damage to dining area. Daylight visible through hole.

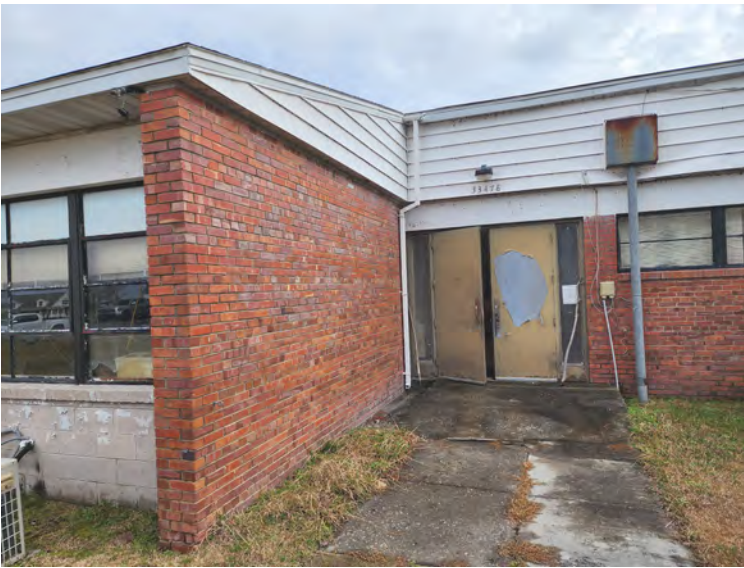
Deteriorating exterior doors.

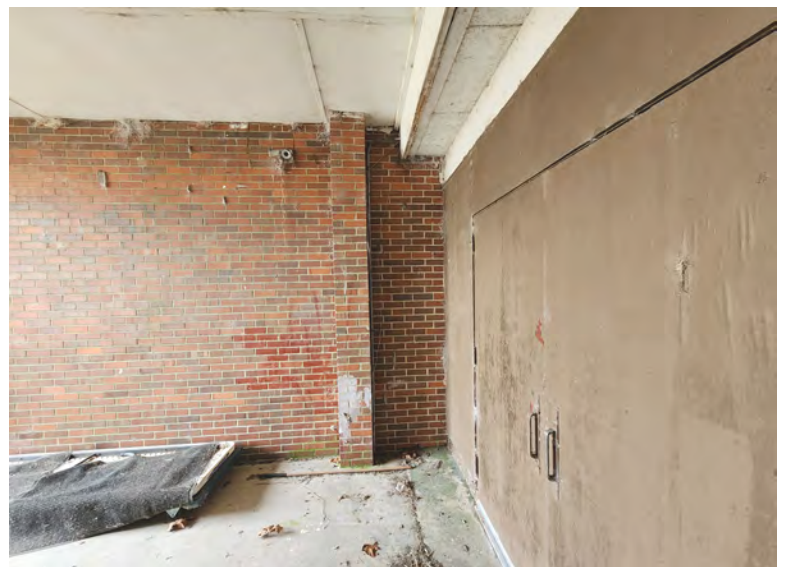
Painted plywood sheathing over masonry veneer.

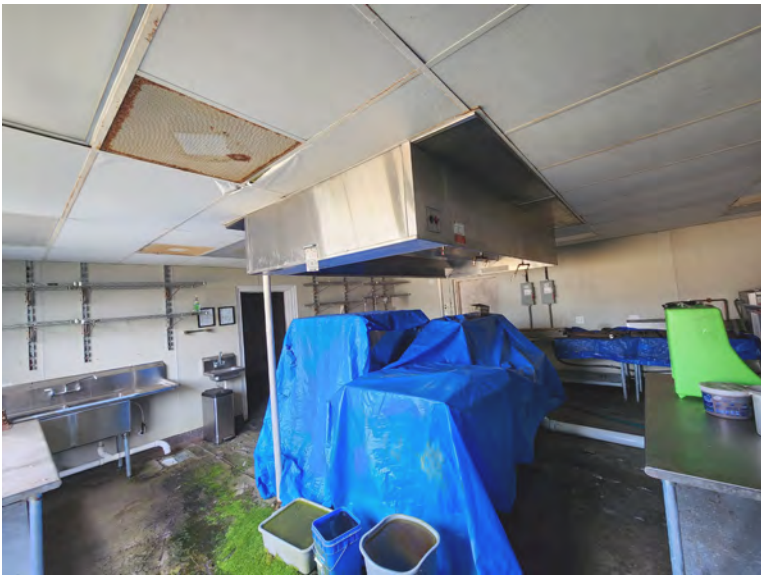
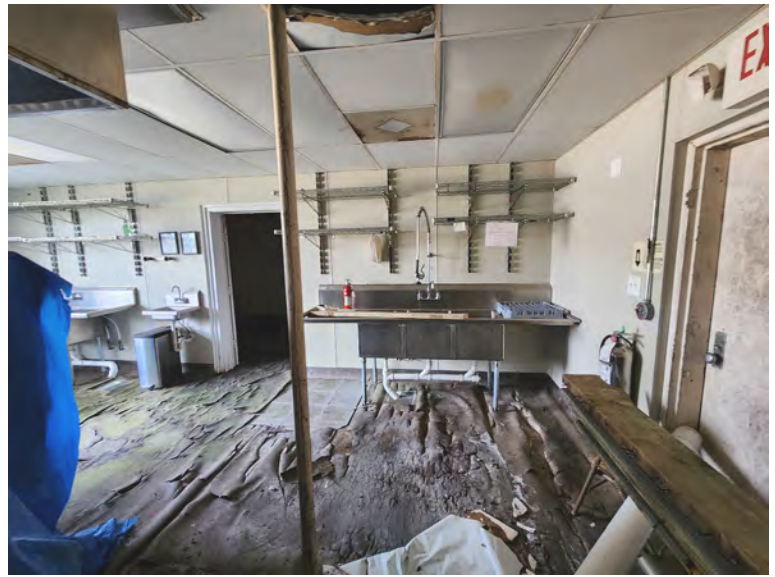
Water damage to commercial kitchen.

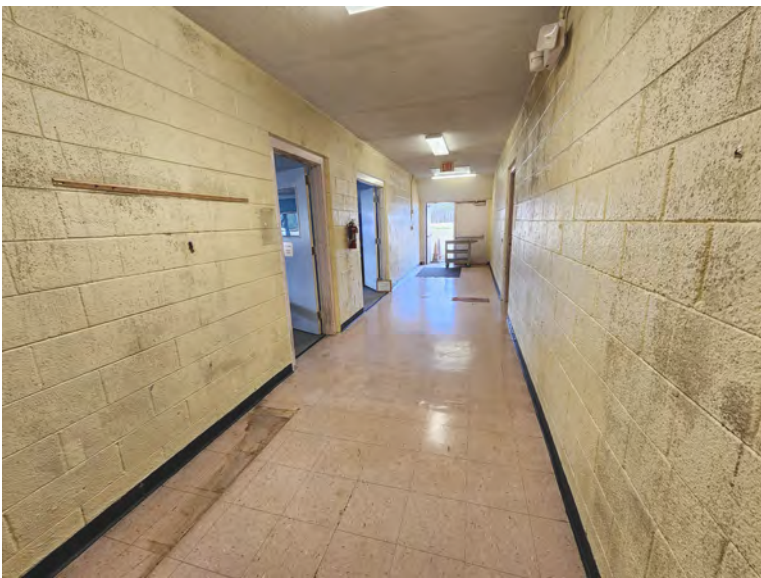
Classroom hallway with visible mold on walls.
