**Environmental Review for Activity/Project that is Categorically
Excluded Subject to Section 58.5
Pursuant to 24 CFR 58.35(a)**

Project Name: Davis Ventures Community Center

Project Location: 33478 U.S. Highway 264, Engelhard, Hyde County, NC 27824

ROOF & BUILDING REPAIRS

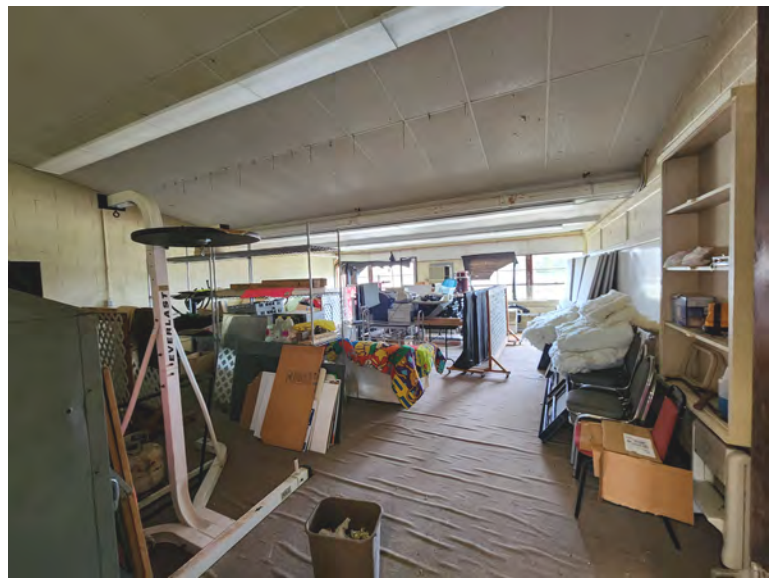
Classroom with evidence of moisture throughout (wrinkled carpet, smell, visible mold, etc.)

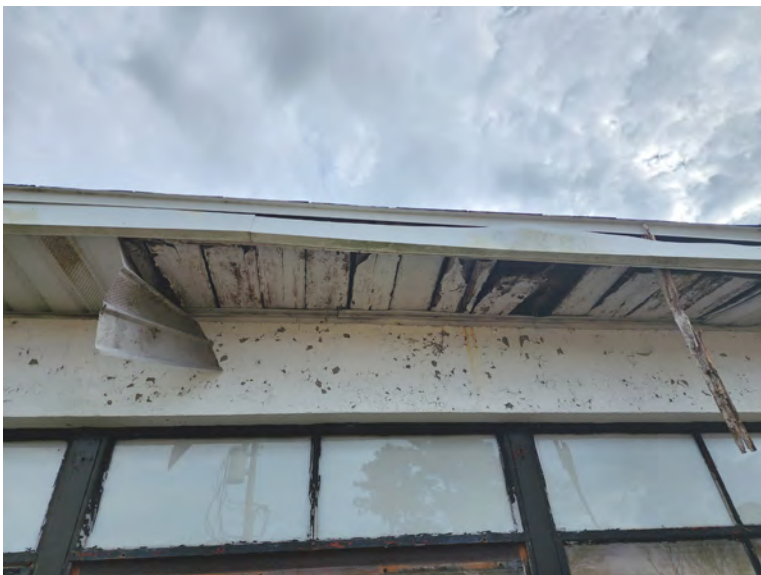
deteriorating soffit condition.

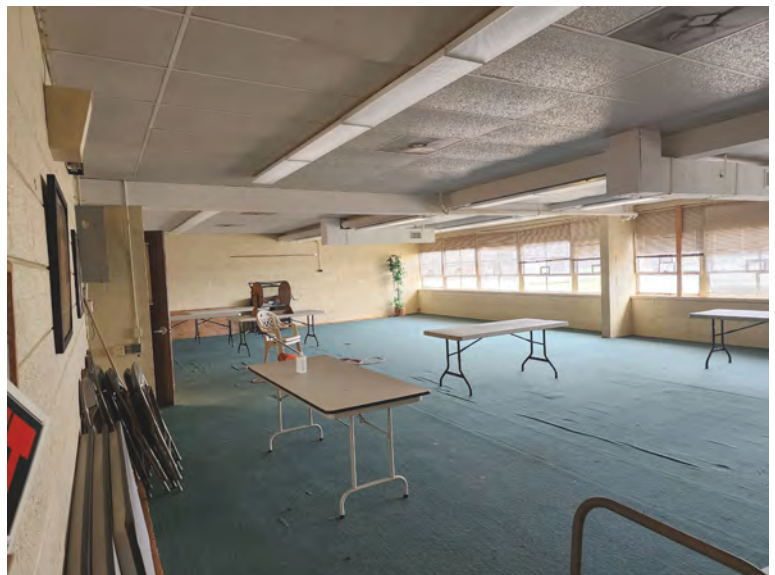
Classroom with evidence of moisture throughout (wrinkled carpet, smell, visible mold, etc.)

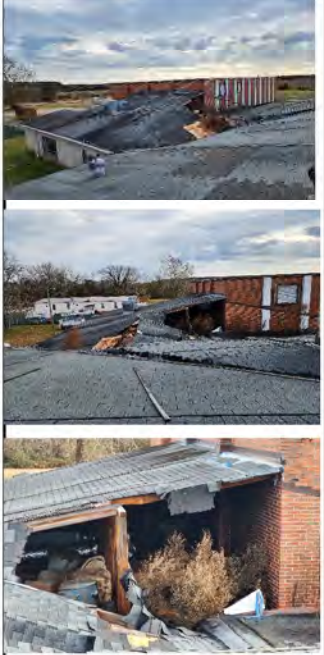
R.02	Roof caved in, severe structural and roof damage.	Remove portions of roof and structure where caved in and damaged. Replace damaged roof trusses, install new sheathing, waterproofing sheet, and shingles.

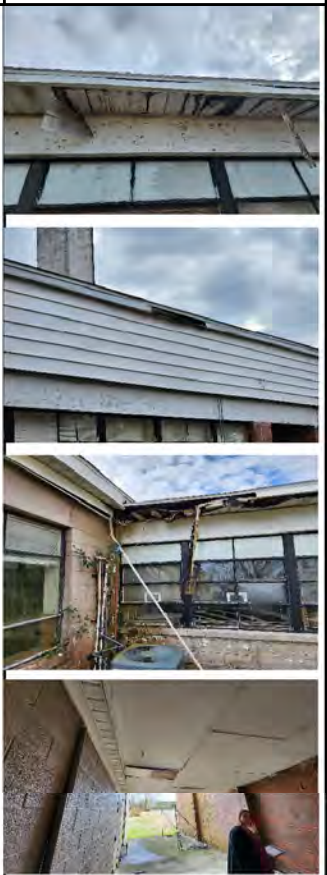
Item	Description	Recommendation	Photos
R.03	Failing/disintegrating aluminum soffit panels and original wood deck above.	remove soffit panels, fascia, drip edge, and rotting/damaged wood deck. Replace wood decking where needed, install new drip edge, fascia, and soffit panels around perimeter of building.

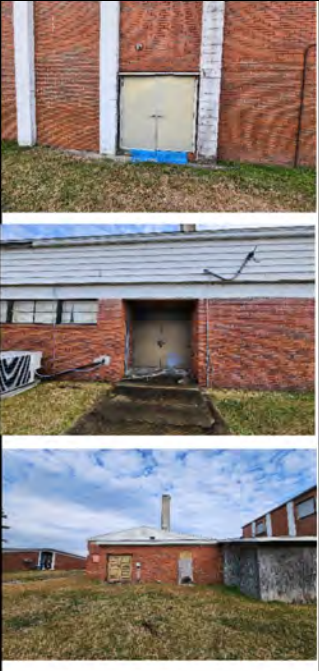
Item	Description	Recommendation	Photos
E.02	<p>Exterior doors are rusting and have improper hardware. Some doors are chained closed, which as an occupied building would be a life safety hazard. Existing thresholds appear to be damaged in many places allowing for water infiltration under the doors into the building.</p>	<p>Remove existing doors, frames, thresholds, hardware, etc. Replace with aluminum frames, FRP or aluminum doors, ADA compliant aluminum thresholds, and ADA compliant and code compliant door hardware.</p>	  <p>The photos show: 1) An exterior view of a rusted metal door set in a brick wall with a damaged threshold. 2) An interior view of a door that is chained closed, leading to a hallway. 3) A close-up of a rusted metal door on a brick wall. 4) An exterior view of a door set within a brick wall with vertical concrete pillars. 5) An interior view of a hallway with a door and a blue tape marking on the floor.</p>

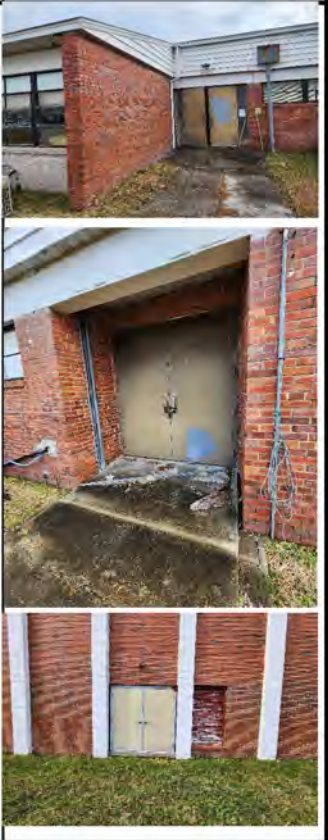
Item	Description	Recommendation	Photos
Grounds			
G.01	Sidewalks at building entries do not appear to be ADA compliant. Not all exit doors have sidewalks leading to the public way.	Sidewalk slopes should be checked for ADA compliance. If slopes exceed minimum allowable by code (max 1:20 parallel to path of travel, max 1:48 cross slope, and max. 1:48 in any direction within 5' of an entry). Add sidewalks as required at exit doors that lead to the public way.

<p>The photos for G.01 show three different building entrances. The top photo shows a brick building with a concrete path leading to a door. The middle photo shows a close-up of a door with a concrete step. The bottom photo shows a door set within a brick wall with a concrete path leading to it.</p>
G.02	Storm inlet has significant erosion and is a safety concern if children/public are on the site.	Regrade around inlet to eliminate the large ditches at the inlet, and secure cap as needed to prevent moving.

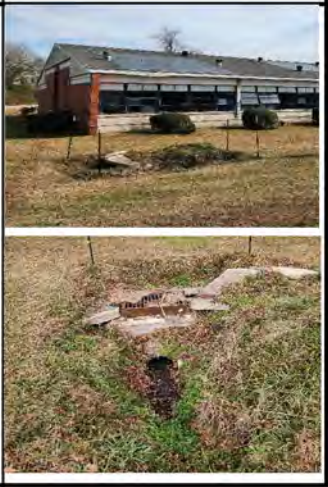
<p>The photos for G.02 show a storm inlet. The top photo shows a wide view of the inlet area with a large, deep ditch on either side. The bottom photo shows a close-up of the inlet opening, which is surrounded by a concrete curb and a large ditch.</p>

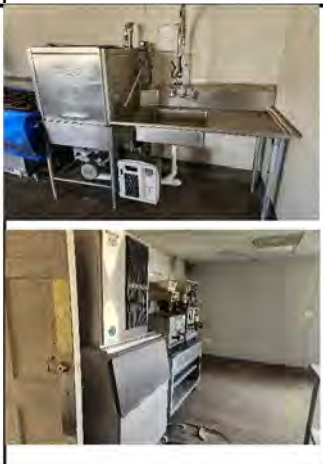
F.05	Flooring in commercial kitchen has been wet and moldy and caused cracks and damage in the floor finish.	Remove existing flooring down to existing concrete slab on grade. Seal existing concrete slab and install new flooring. Epoxy with turned up base or quarry tile floor and base are recommended for kitchen spaces.

<p>The photos show two different views of a commercial kitchen. The top photo shows a room with blue walls, a pool table, and a tiled floor. The bottom photo shows a room with blue walls, a pool table, and a tiled floor.</p>

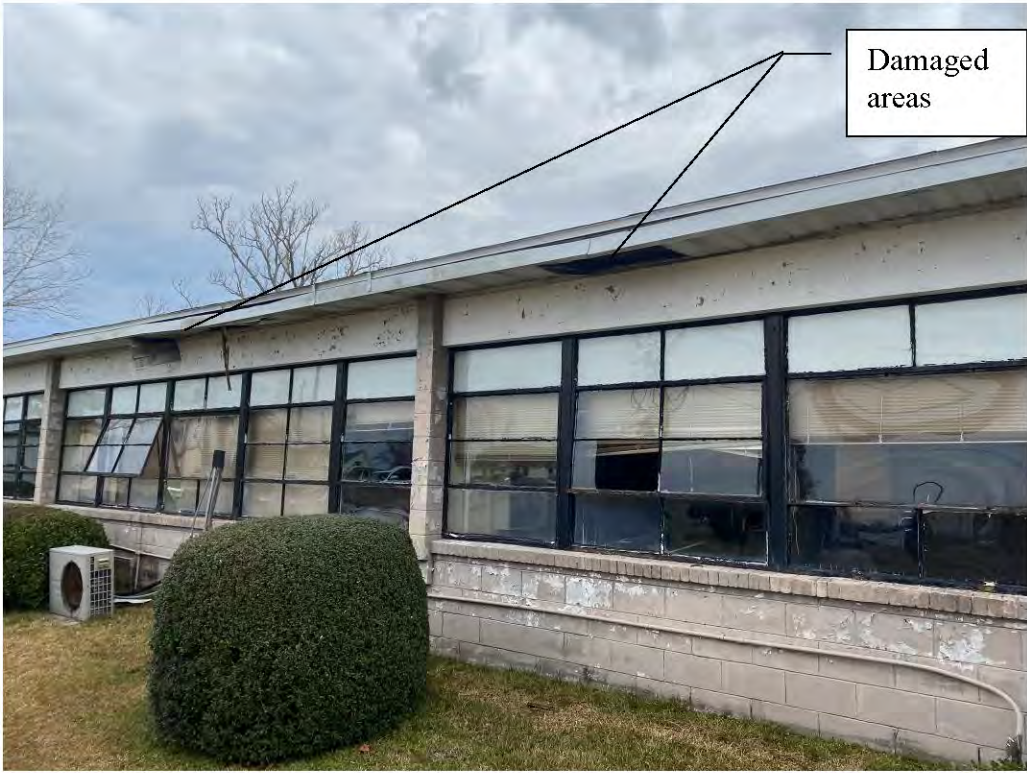
Photograph 8 – Damaged Soffit Areas – Front of Classroom Building

1. There are some damaged soffit areas at the front side of the classroom building (see photograph 8). The roof trusses bear at the exterior masonry wall on a double wood plate

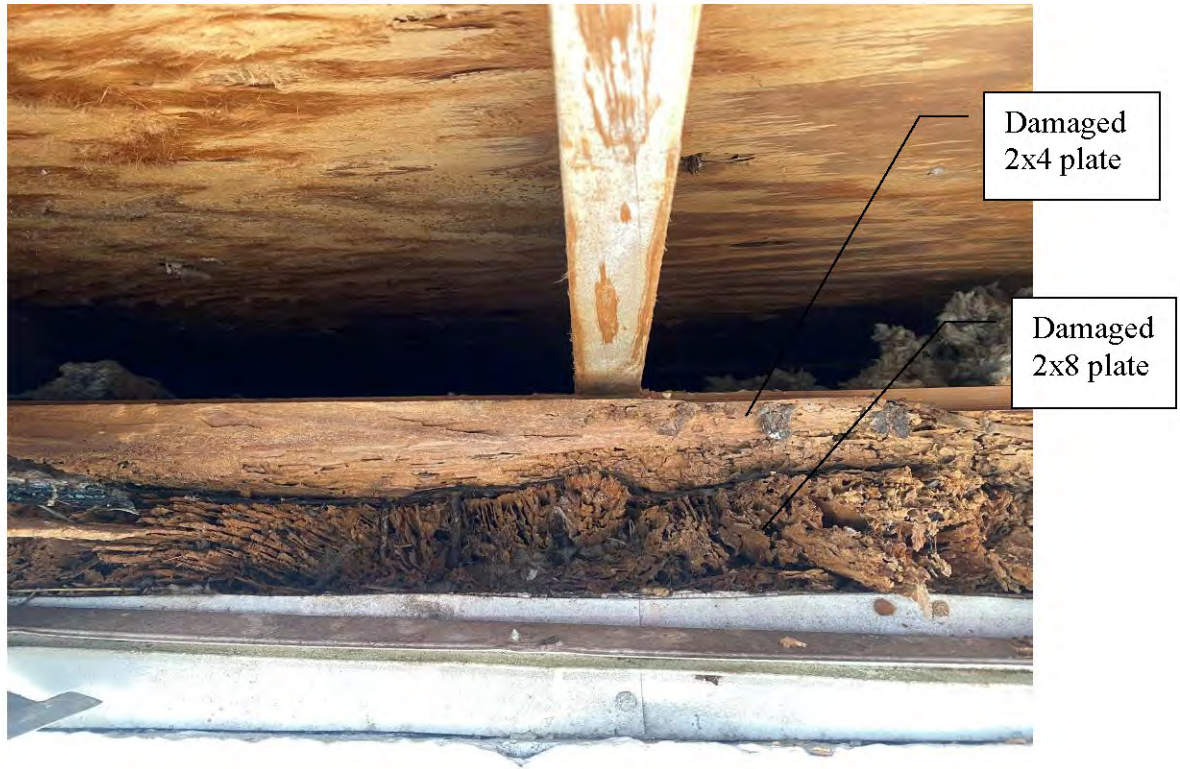
Photograph 9 – Damaged Wood Plating Under Roof Trusses – Classroom Building

(2x4 top, 2x8 bottom). The 2x4 has some partial damage at these areas and the 2x8 has been almost completely destroyed (see photograph 9). Both will need to be replaced where they are rotten. The soffit will need to be opened up further to see if there are other rotten areas. Also, the roof trusses are not connected to the plates at these areas, and probably not at any other areas. Installation of hurricane ties is recommended.

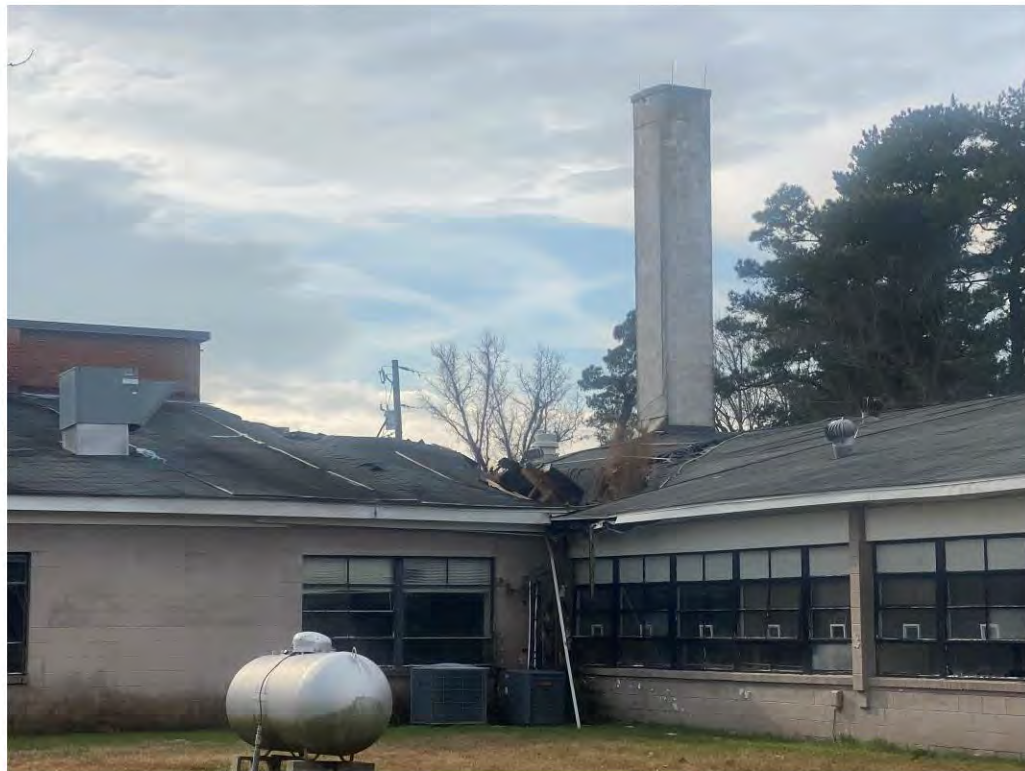
Photograph 10 – Collapsed Roof Area at Right End of Classroom Building

2. The right end of the classroom building connects to the gym building, which has a much higher roof. The roof truss overframing has collapsed at part of this area (see photographs 10 and 11). Also, the original flat roof sheathing boards are badly damaged in some areas and there are holes in the roof (see photograph 15). The original concrete beams that support the sheathing boards appear to be undamaged. The wood roof framing in most of this area will need to be removed and replaced.

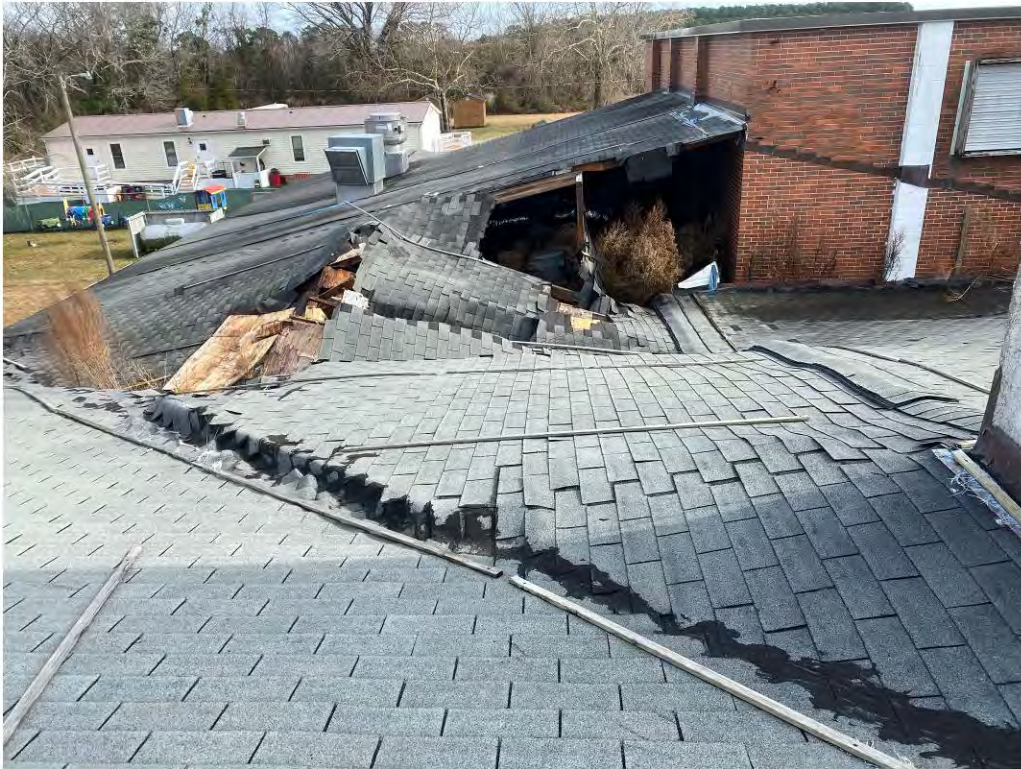
Photograph 11 – Collapsed Roof Area at Right End of Classroom Building

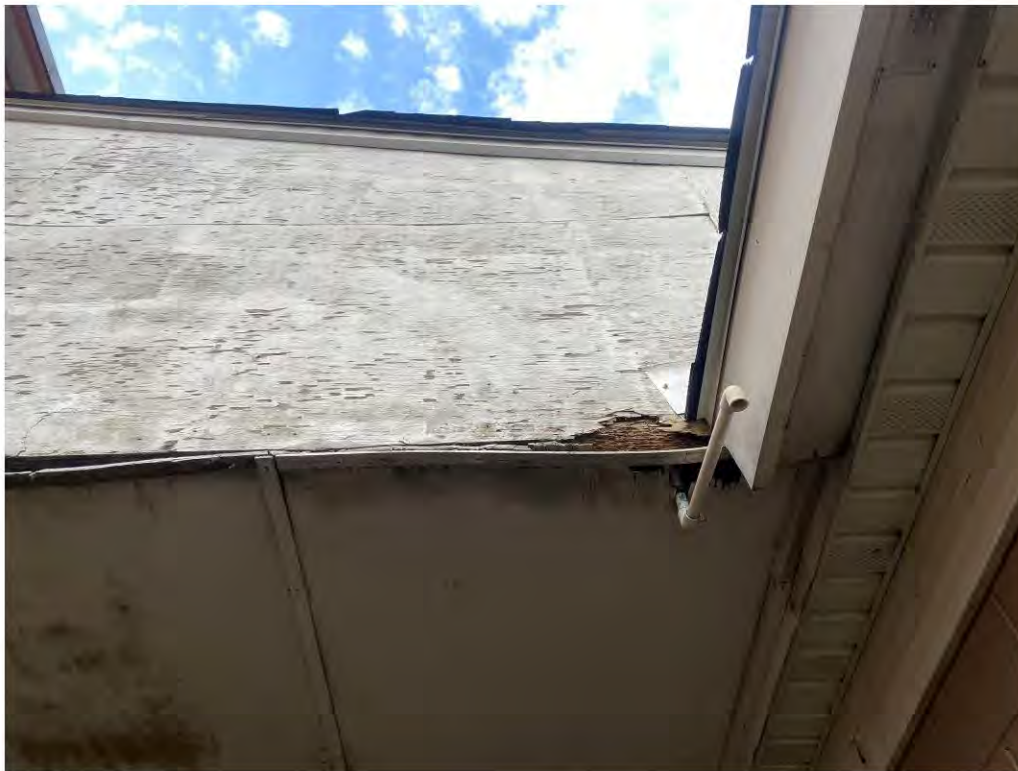
Photograph 12 – Damaged Soffit/Fascia Area at Rear of Gym/Classroom Connector

4. Part of the soffit/fascia at the rear of the gym/connector is damaged (see photograph 12). It is not clear if the damage is just to the soffit/fascia panels or also to the roof framing. Further investigation is required.

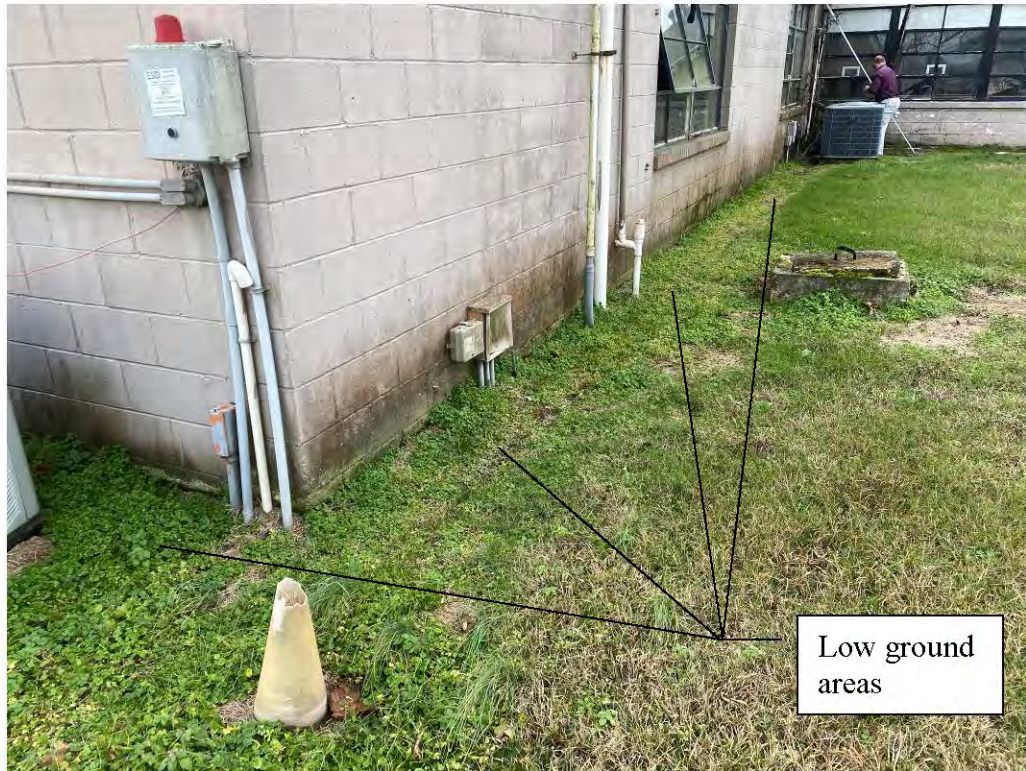
Photograph 13 – Low Ground Areas at Left Side of Gym Connector

5. There are low ground areas along the left side and rear of the gym/classroom connector (see photograph 13). This appears to be due to erosion of the ground along the wall due to water flowing off of the roof (there are no gutters). This can saturate the soil around the footings, which can result in settlement problems. I did not observe any brick cracks or other signs of settlement but recommend that this be corrected to prevent possible future problems. The low ground areas should be filled and sloped away from the building. Installation of gutters/downspouts is also recommended to help direct water away from the building.

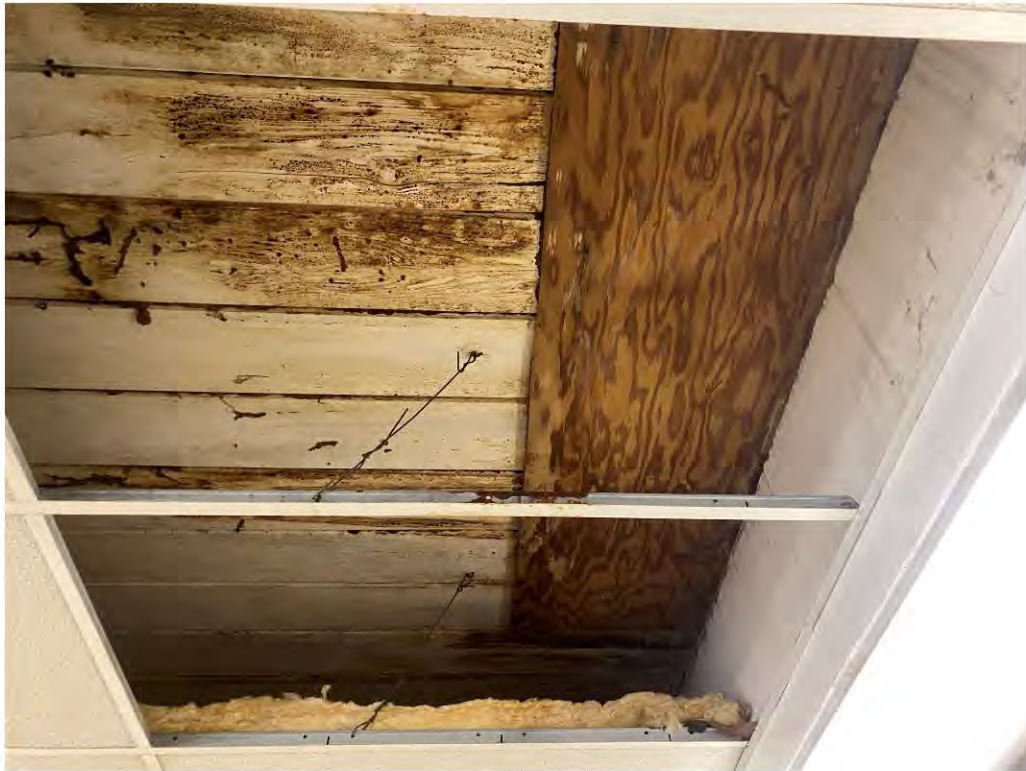
Photograph 14 – Roof Sheathing Damage/Patch Near Front/Center of Classroom Bldg

3. There is an area in the classroom building, near the front/center of the building, where the roof sheathing boards are stained and a plywood patch has been installed (see photograph 14). Additional repairs may be needed but some demolition of the ceiling and further investigation is needed to determine what may be required.

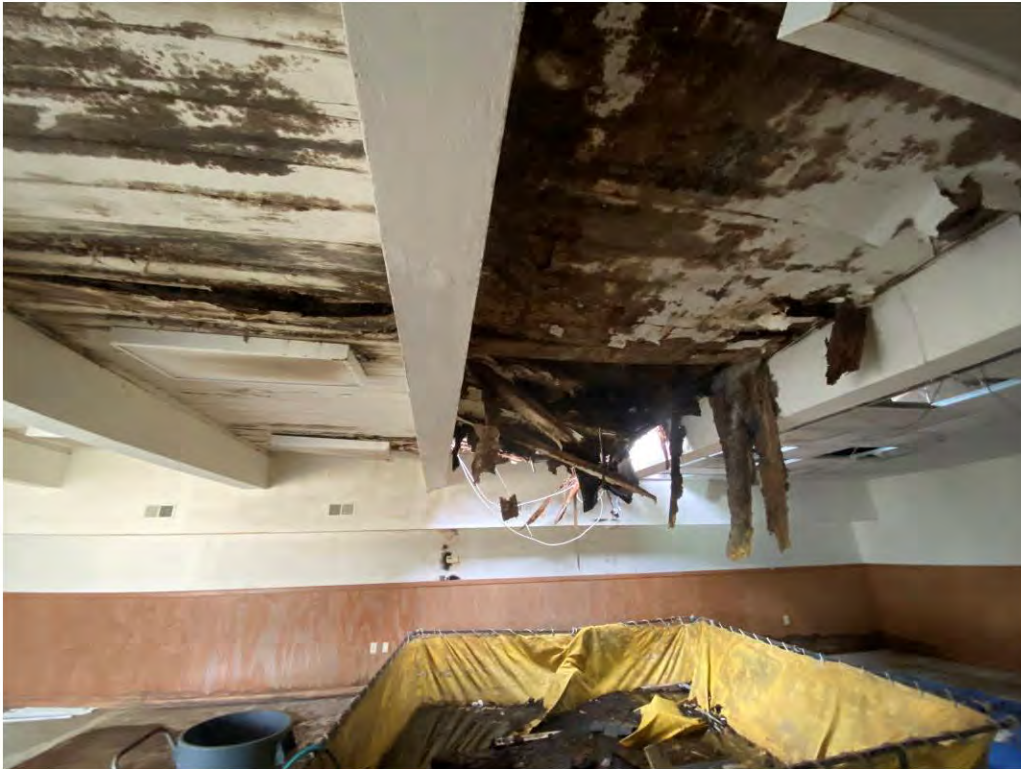
Photograph 15 – Damaged Original Roof Sheathing at Right End of Classroom Building

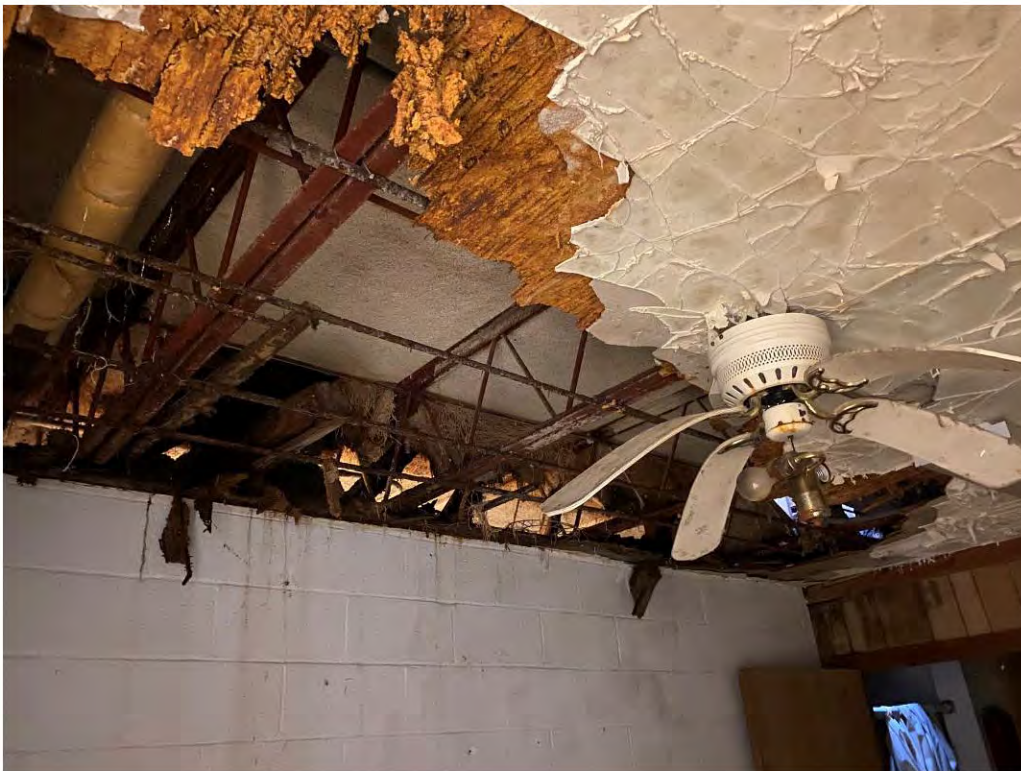
Photograph 16 – Damaged Ceiling and Rusted Bar Joists at Gym Locker Room Area

6. Portions of the ceiling in the locker room area is damaged where the steel bar joists above are rusted in some locations (see photograph 16). The joists do not appear to be damaged but the rest of the ceiling needs to be removed to allow examination of all of the joists.

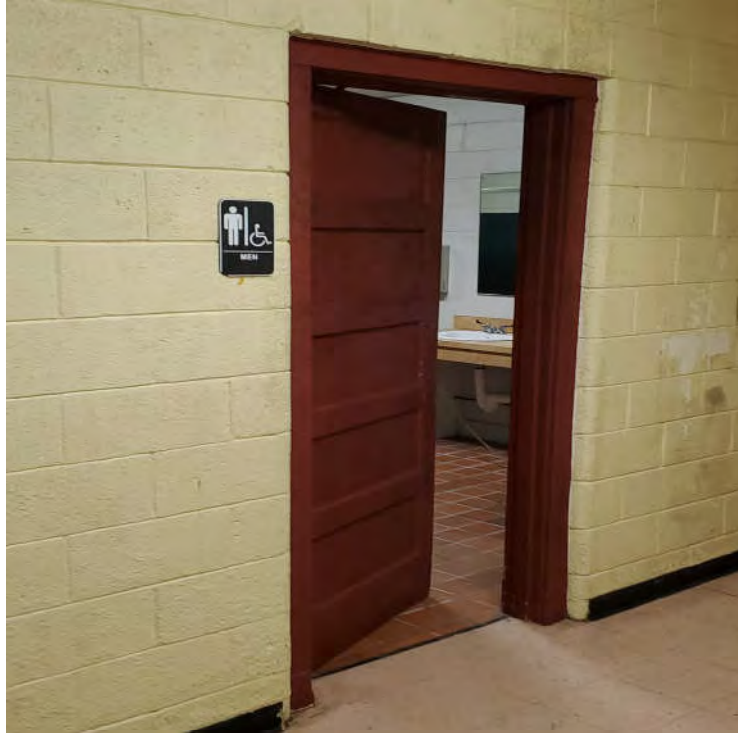
Photograph 7 - Typical Lead-Based Paint on Red Doors and Dooring Casings in Restrooms of Main Building.

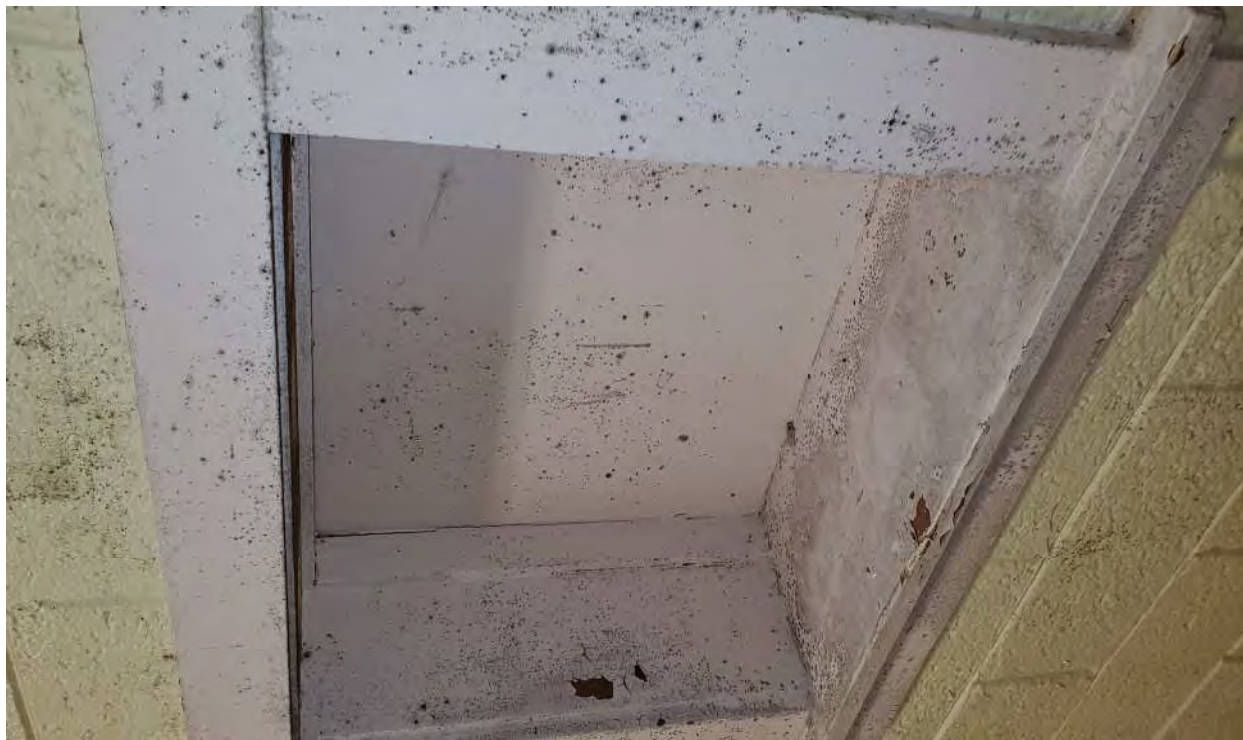
Photograph 11 - Typical Mold Growth on Walls, Door Components, & Other Surfaces Located Throughout the Main Building.

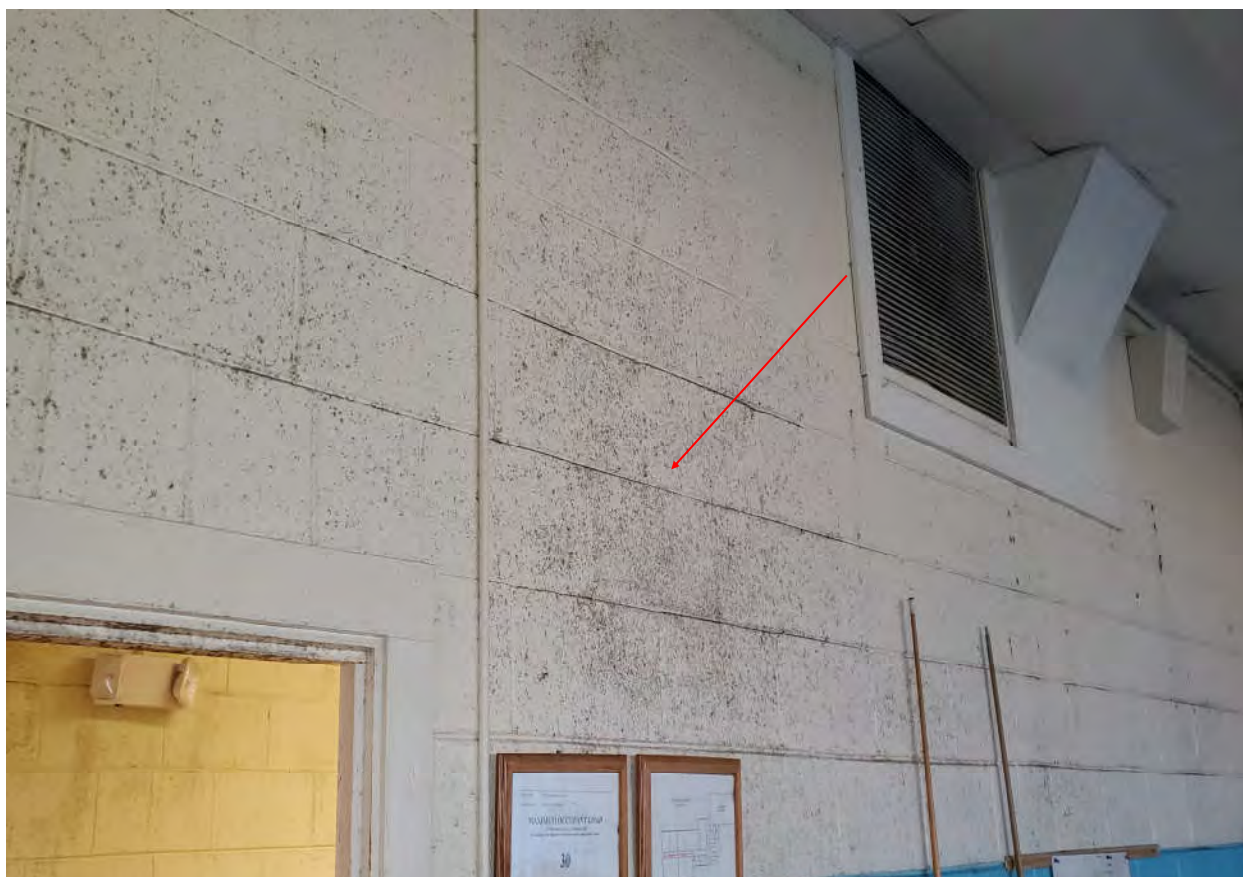
Photograph 12 - Typical Mold Growth on Walls, Door Components, & Other Surfaces Located Throughout the Main Building.

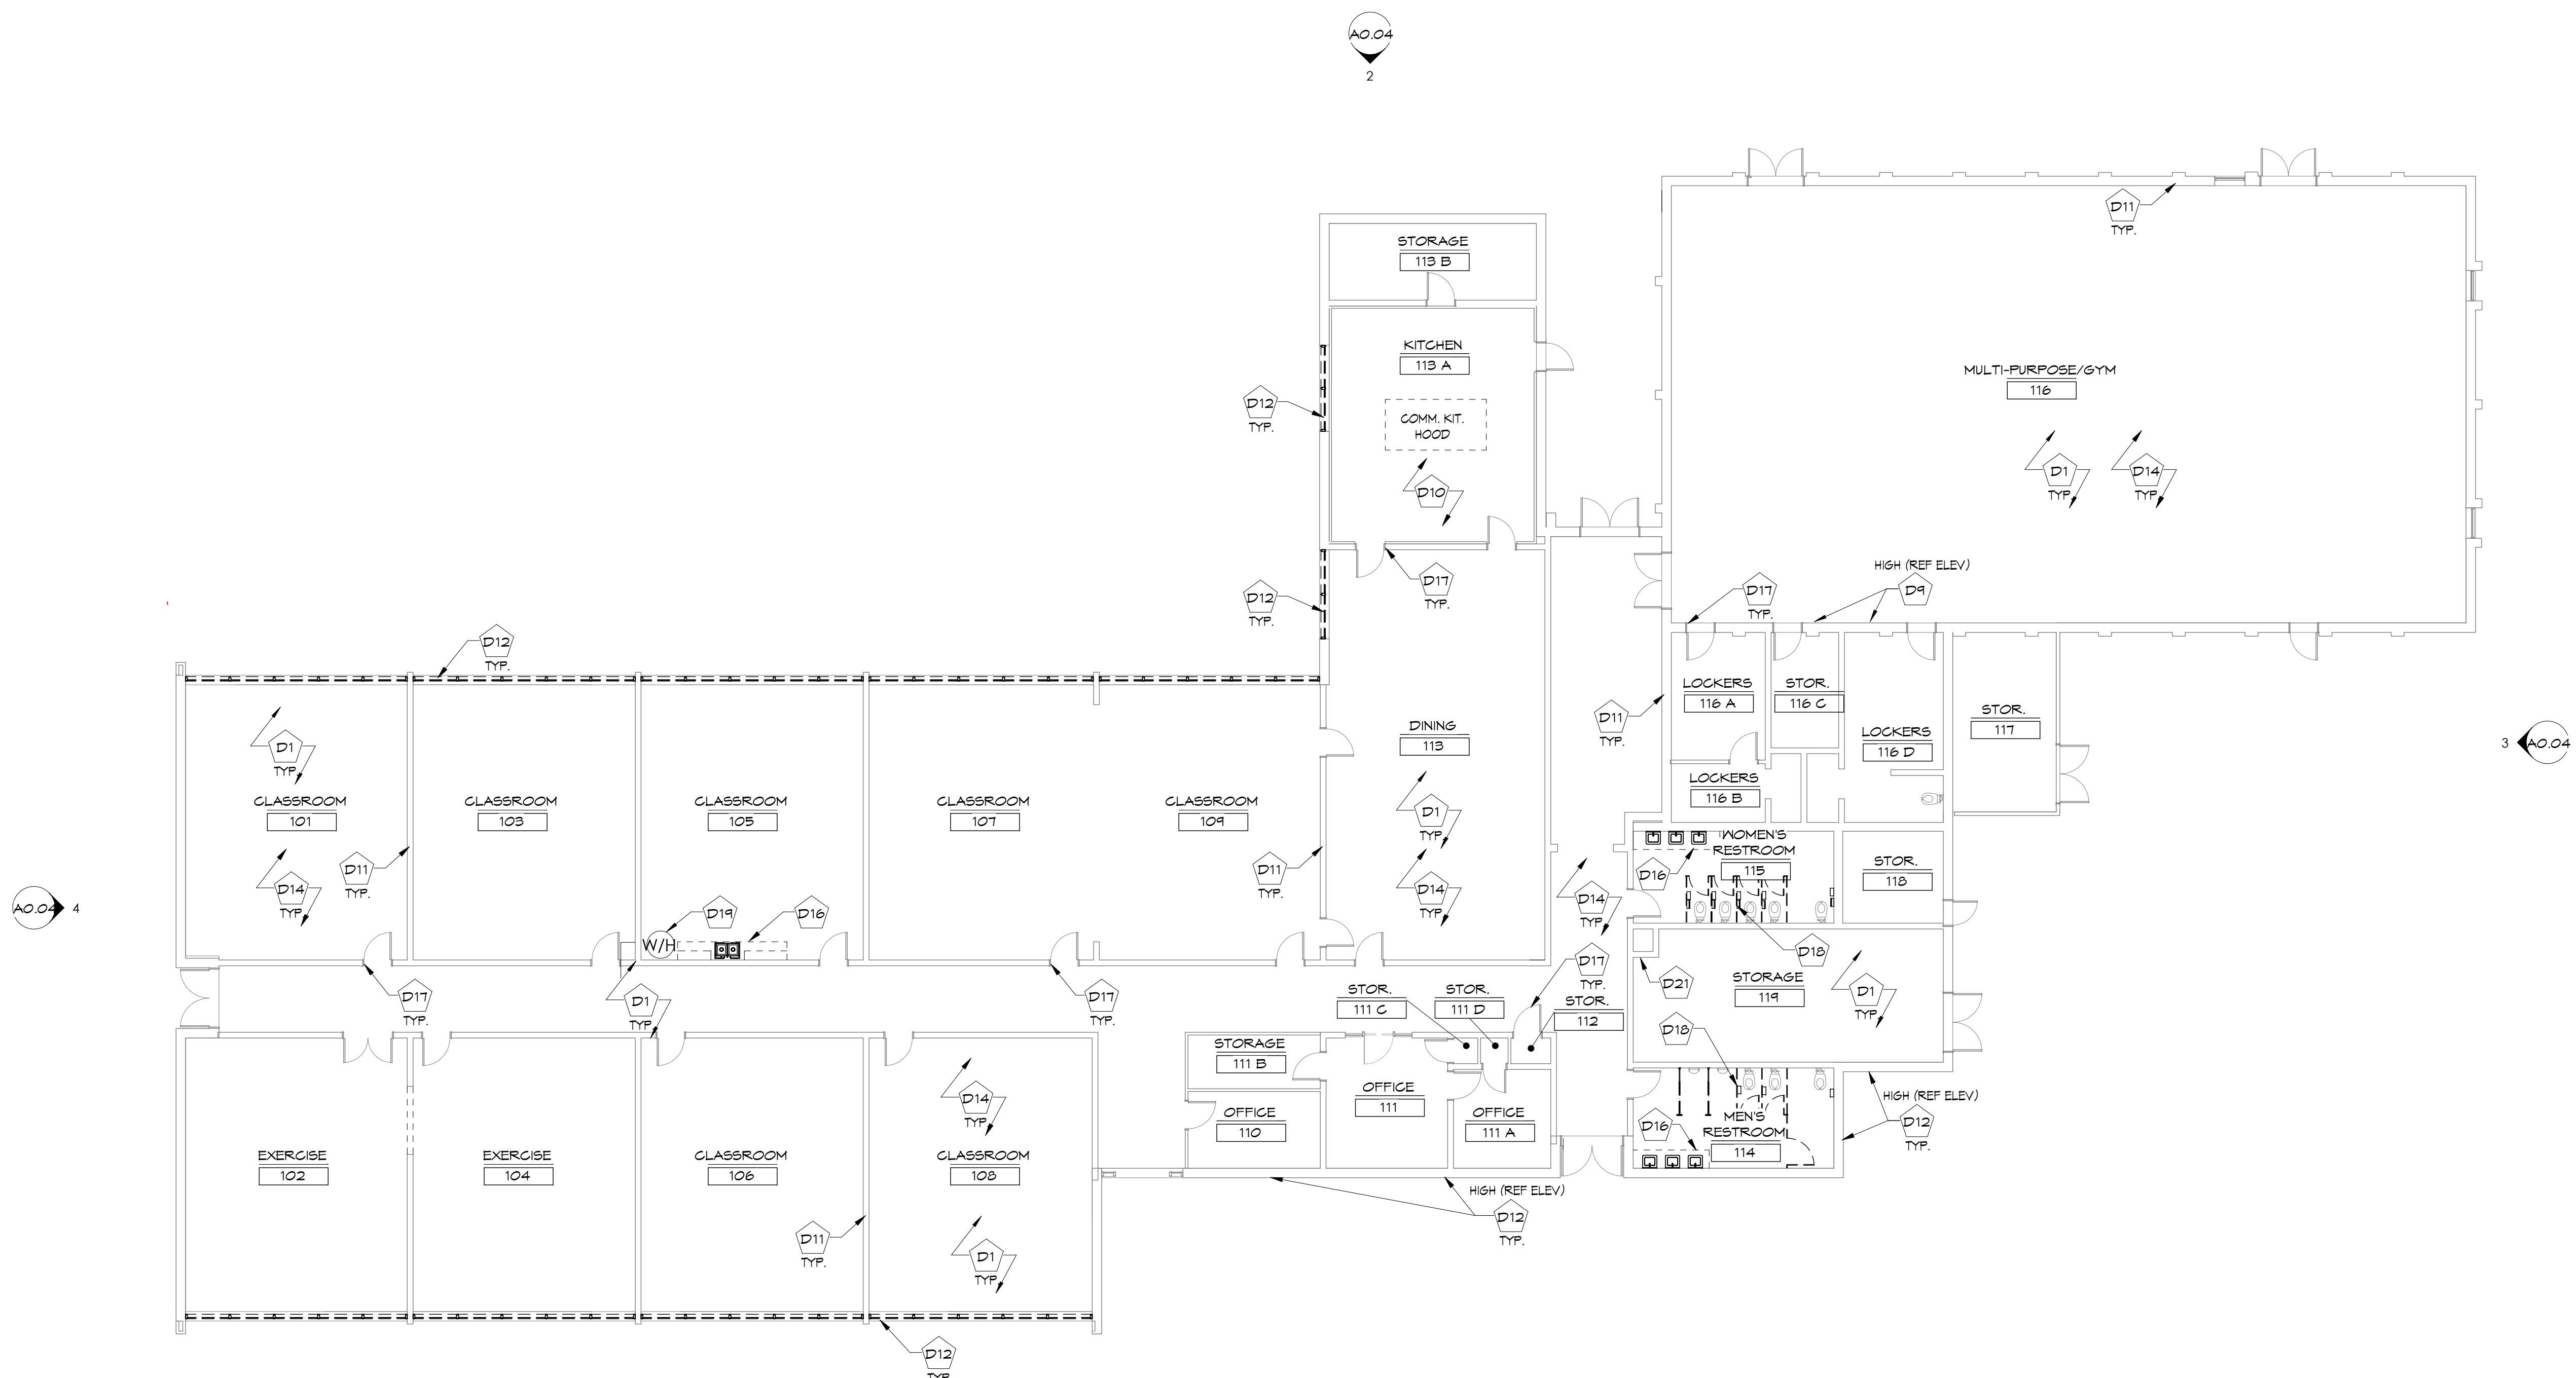
DEMO FLOOR PLAN 1
3/32" = 1'-0"

- D21** – EXIST CHIMNEY TO REMAIN, NO WORK.
 - D22** – REMOVE PORTION OF EXISTING ROOF SEATHING FOR VENTED RIDGE PER MANUF. REQUIREMENTS FOR FREE AREA.

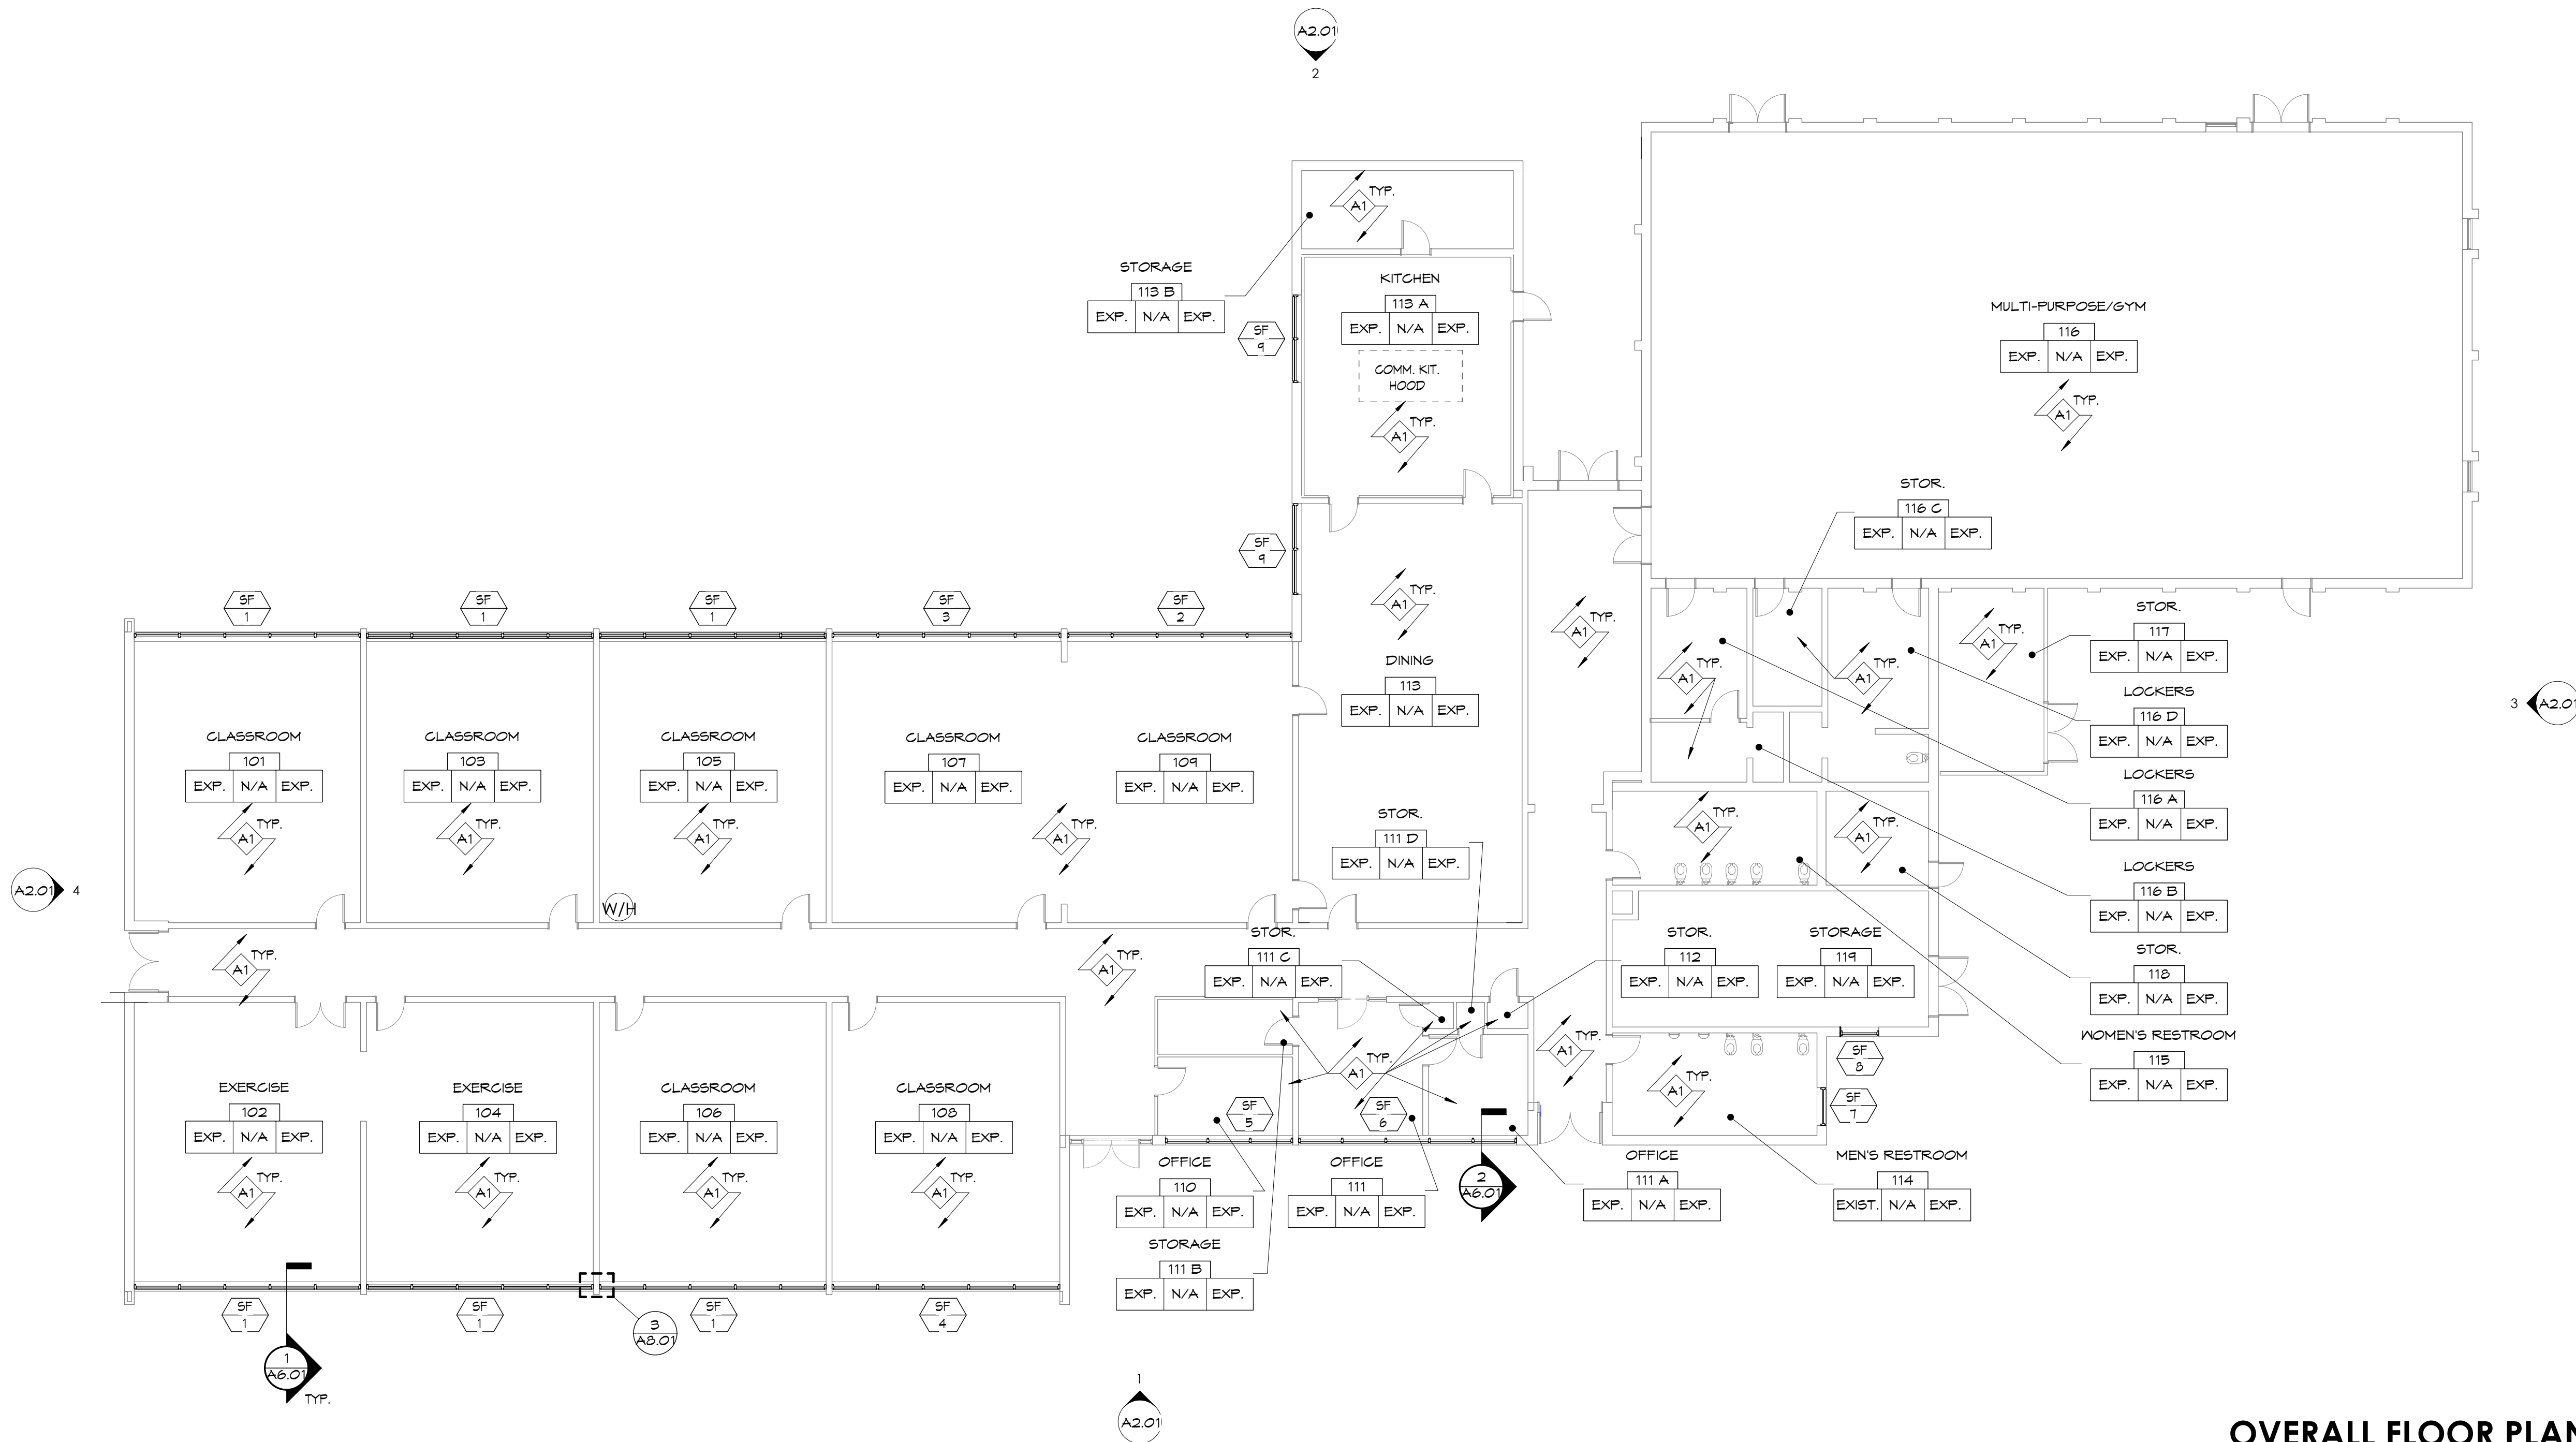
OVERALL FLOOR PLAN ①
3/32" = 1'-0"

EXP. - EXISTING FINISH WAS BEEN REMOVED IF APPLICABLE, ABATED, MOLD REMEDIATED, AND CLEANED.

EXIST. - EXISTING FINISH TO REMAIN, REMEDIATE MOLD AND CLEAN AS REQ'D.
