**Environmental Review for Activity/Project that is Categorically
Excluded Subject to Section 58.5
Pursuant to 24 CFR 58.35(a)**

Project Name: Davis Ventures Community Center

Project Location: 33478 U.S. Highway 264, Engelhard, Hyde County, NC 27824

ROOF & BUILDING REPAIRS

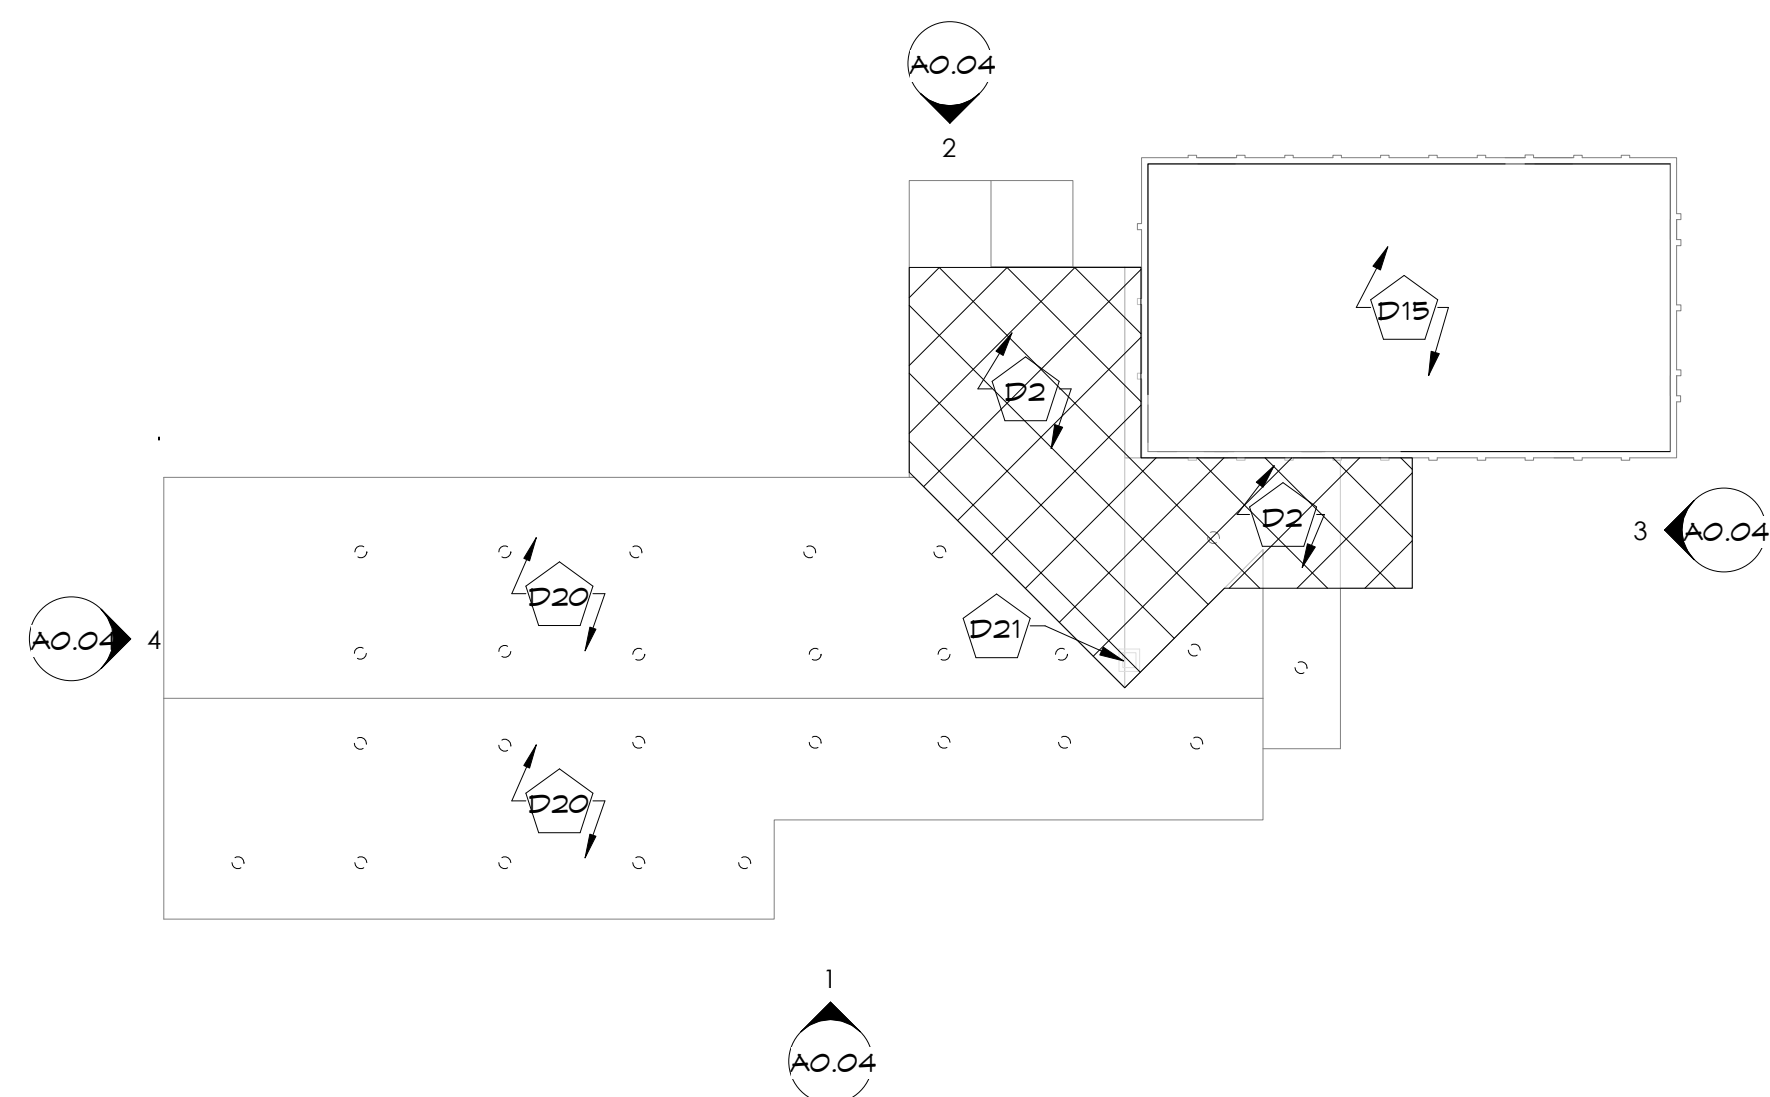
DEMO ROOF PLAN - HIGH ROOF FRAMING
1/32" = 1'-0" **3**

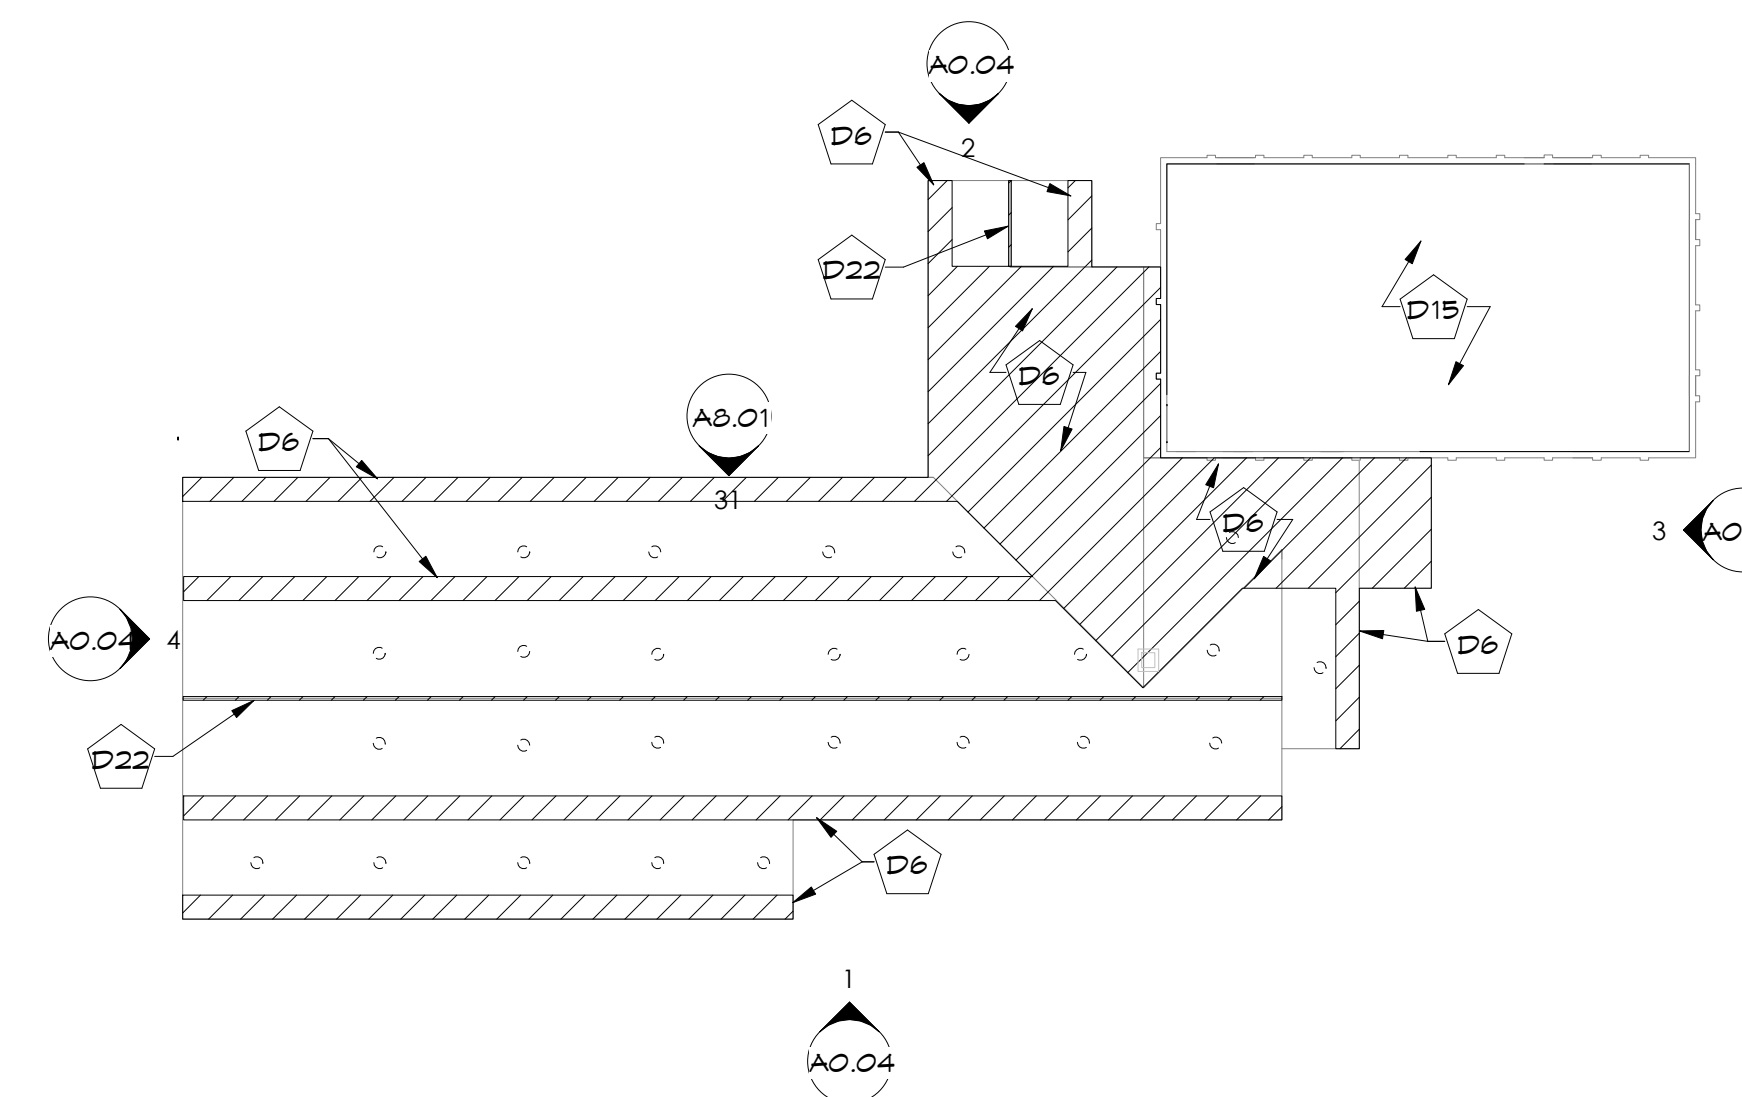
DEMO ROOF PLAN - ROOF SHEATHING
1/32" = 1'-0" **1**

D22 – REMOVE PORTION OF EXISTING ROOF SEATHING FOR VENTED RIDGE PER MANUF. REQUIREMENTS FOR FREE AREA.

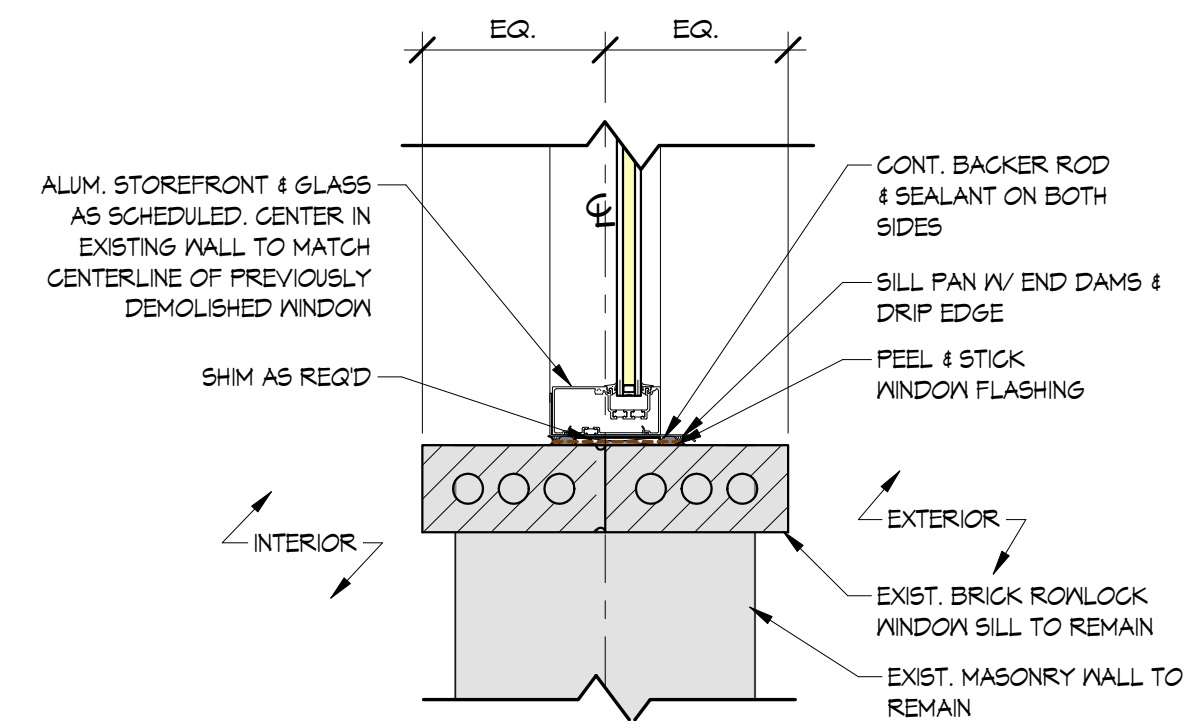
TYP. SILL DETAIL 2
1 1/2" = 1'-0"

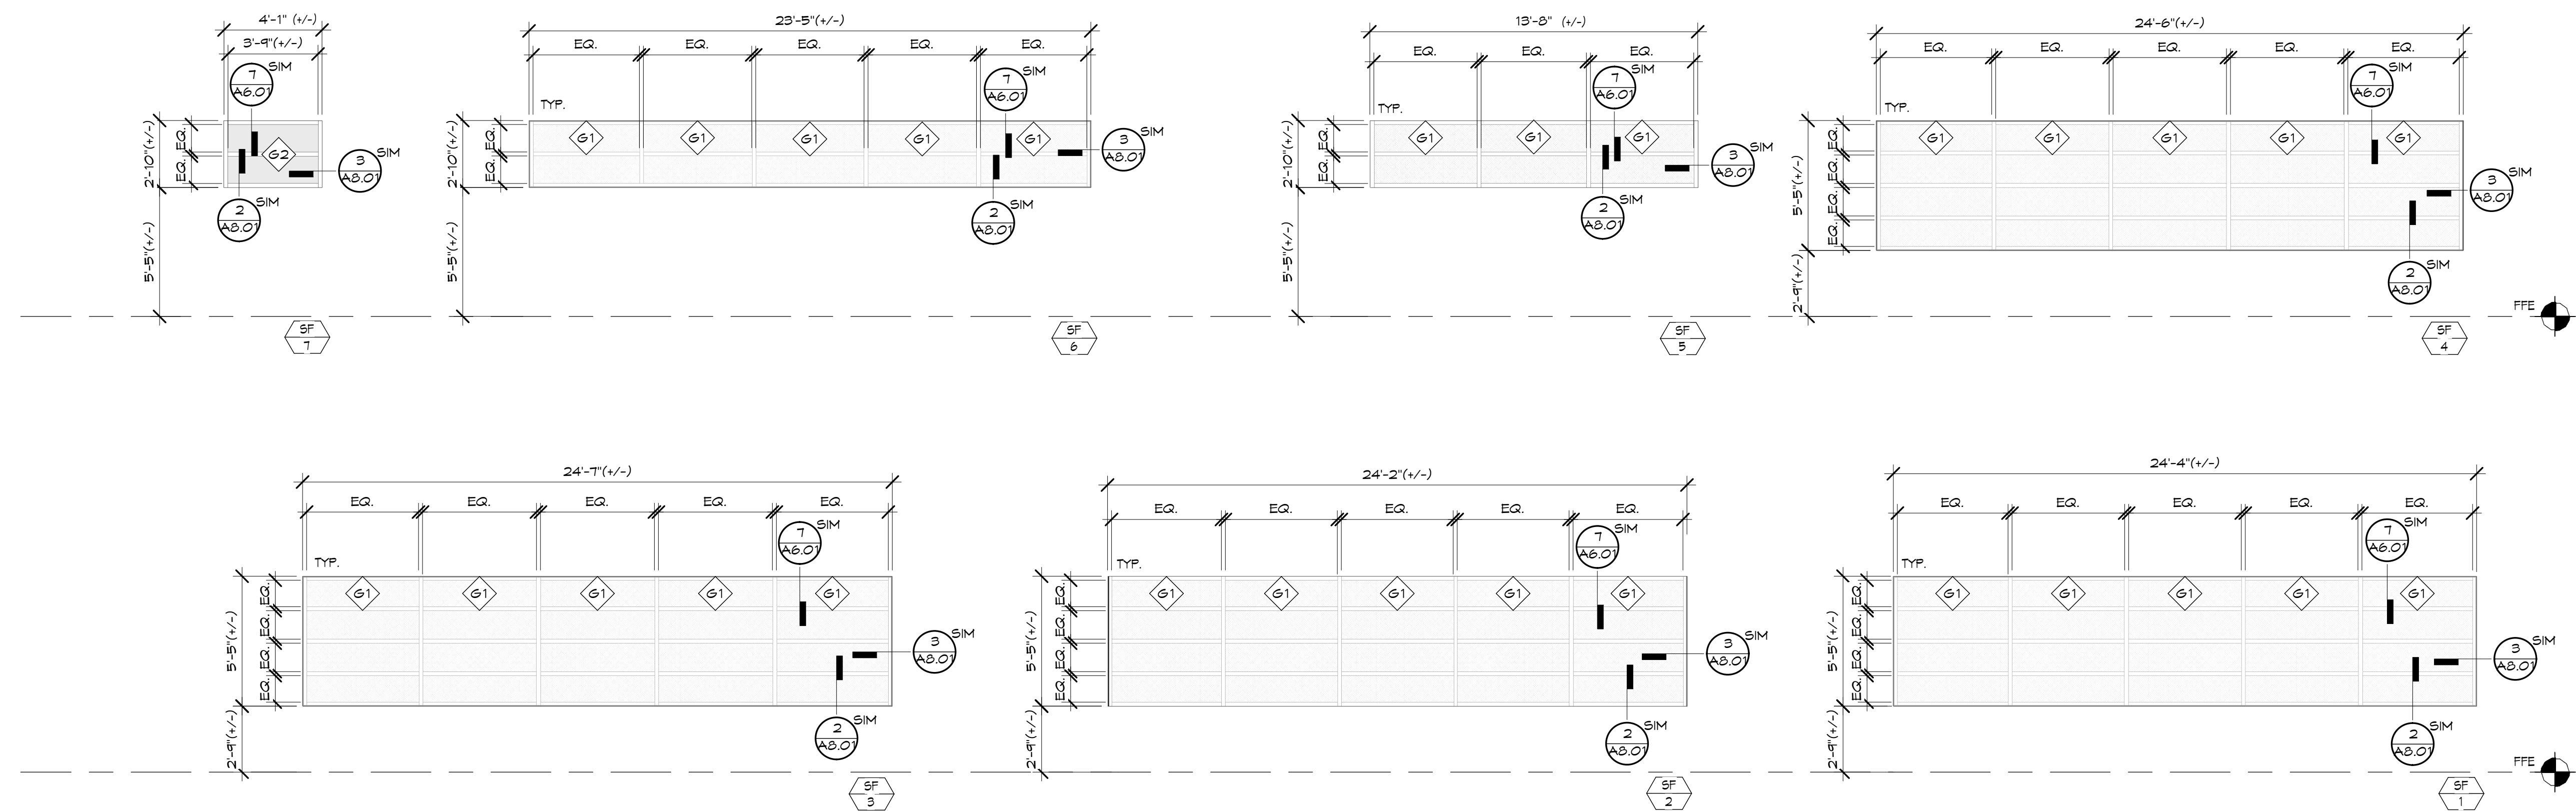
FRAME ELEVATIONS 1
1/4" = 1'-0"

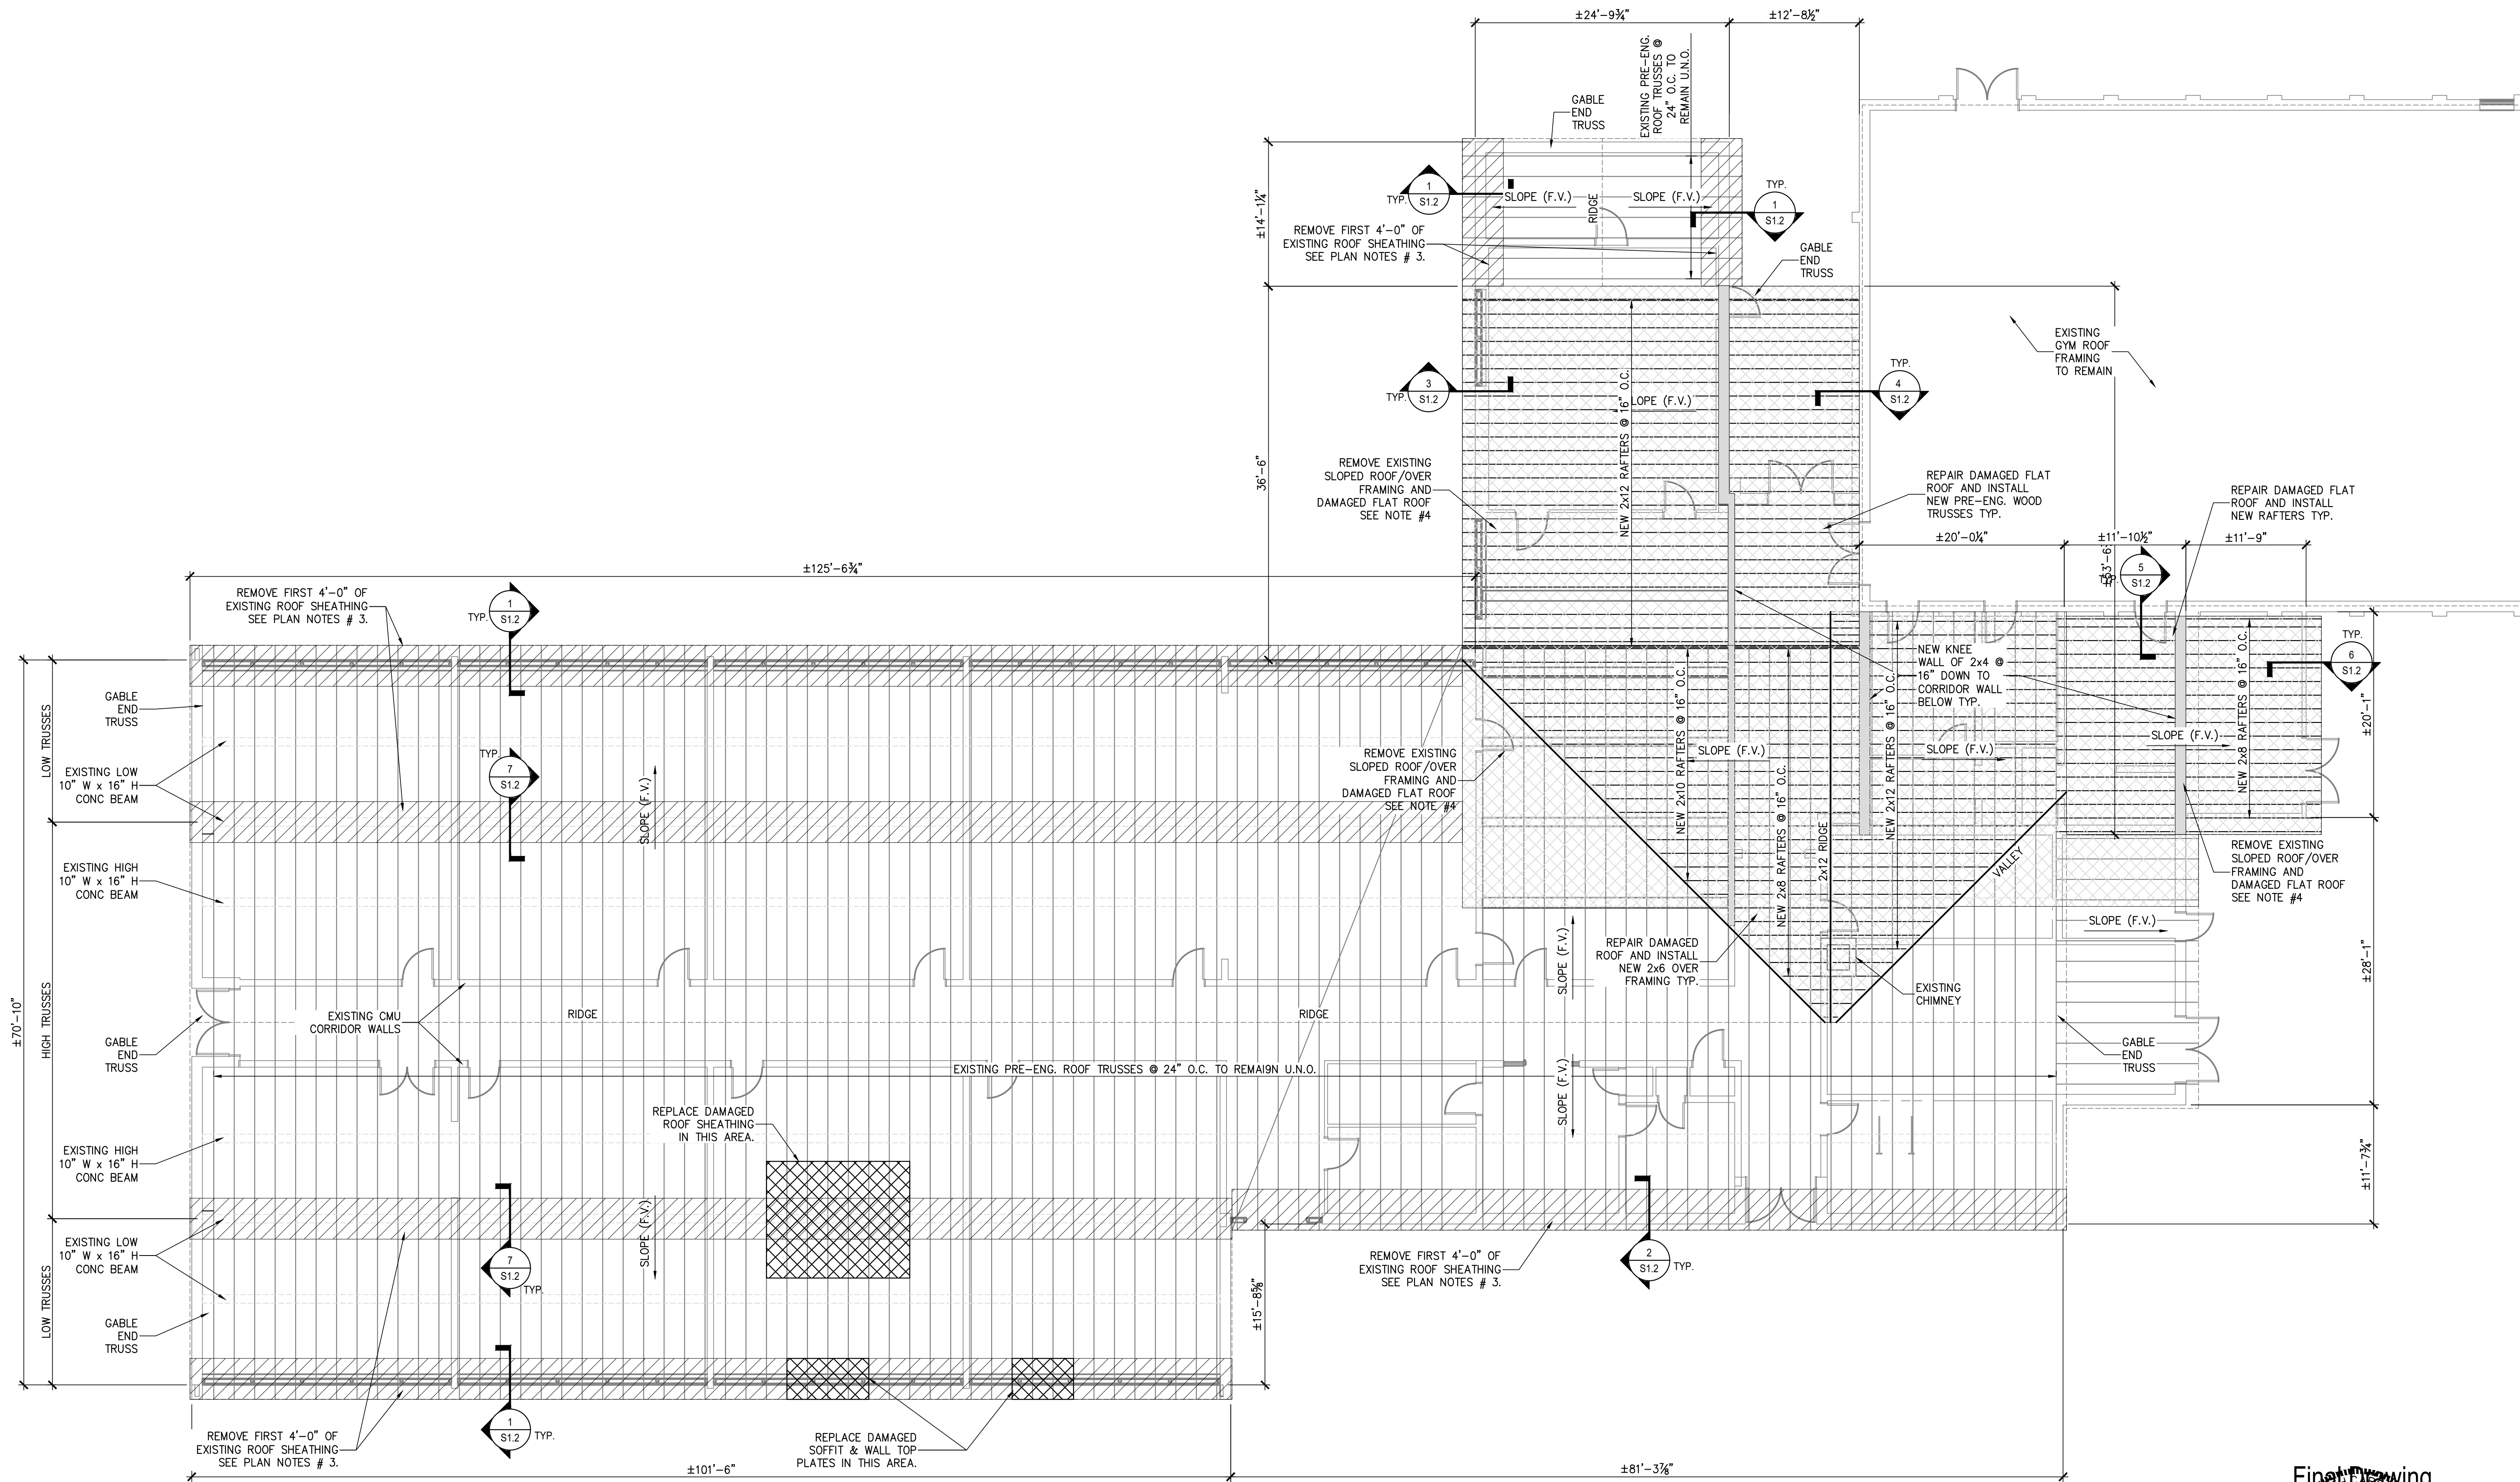
PARTIAL ROOF FRAMING PLAN
1/8" = 1'-0"

- ROOF FRAMING PLAN NOTES:**
- SEE SHEET S1.2 FOR DESIGN CRITERIA, GENERAL STRUCTURAL NOTES AND SCHEDULES.
 - ALL BUILDING DIMENSIONS ARE FROM FACE TO FACE OF STUD WALLS, U.N.O.
 - REMOVE FIRST 4'-0" OF ROOF SHEATHING TO EXPOSE TRUSS ENDS FOR INSTALLATION OF NEW HURRICANE TIES AT EA. TRUSS, U.N.O. AND REINSTALL ROOF SHEATHING TO MATCH EXISTING.
 - REMOVE EXISTING SLOPED ROOF OVER FRAMING AND DAMAGED FLAT ROOF (ORIGINAL ROOF) WOOD FRAMING IN THESE AREAS. REPAIR ORIGINAL ROOF, AND INSTALL NEW FRAMING AS SHOWN ON PLAN, TO MATCH EXISTING.
 - ± DENOTES FIELD VERIFY ALL DIMENSIONS WITH ARCHITECTURAL DRAWINGS.
 - U.N.O. DENOTES UNLESS NOTED OTHERWISE.

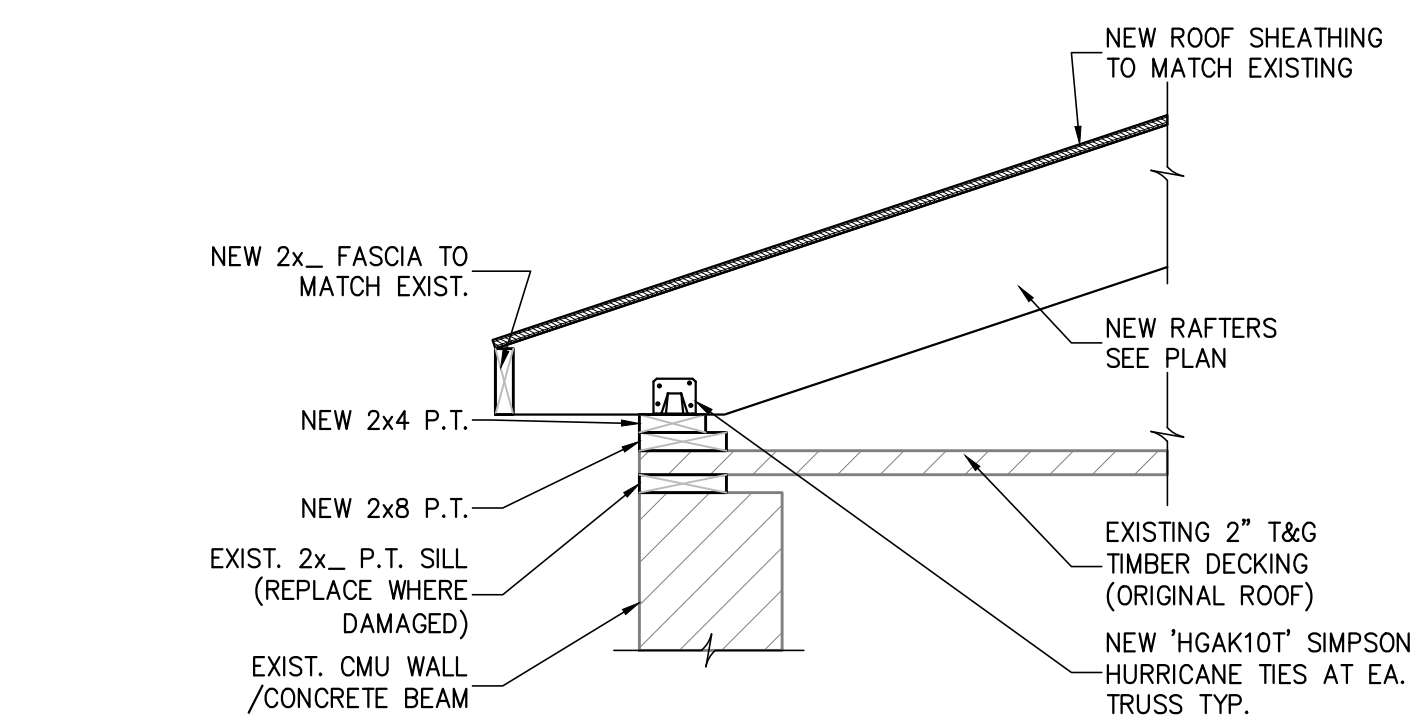
3 SECTION AT TRUSS BEARING
S1.2 3/4" = 1'-0" (ROOF REPLACEMENT)

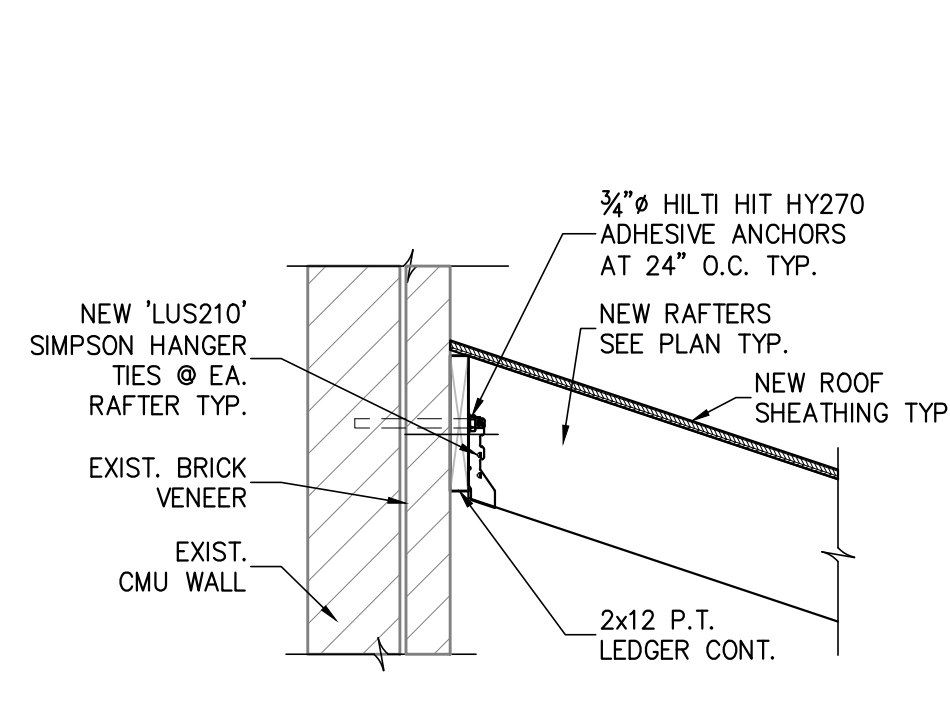
4 LEDGER CONN. TO EXIST. WALL
S1.2 3/4" = 1'-0"

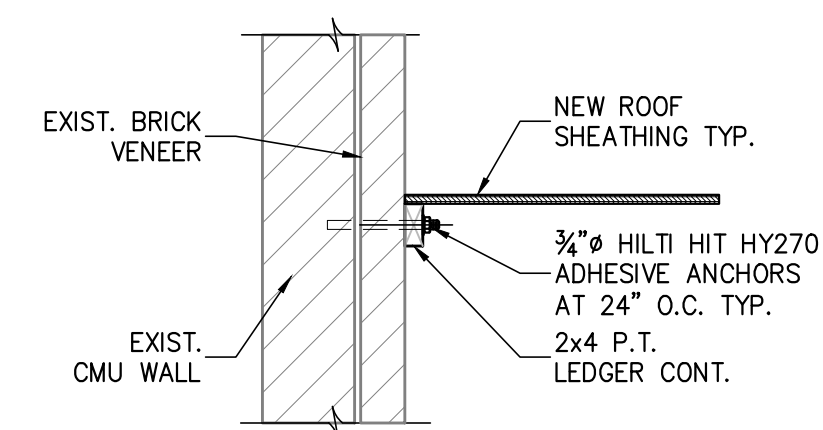
5 LEDGER CONN. TO EXIST. WALL
S1.2 3/4" = 1'-0"

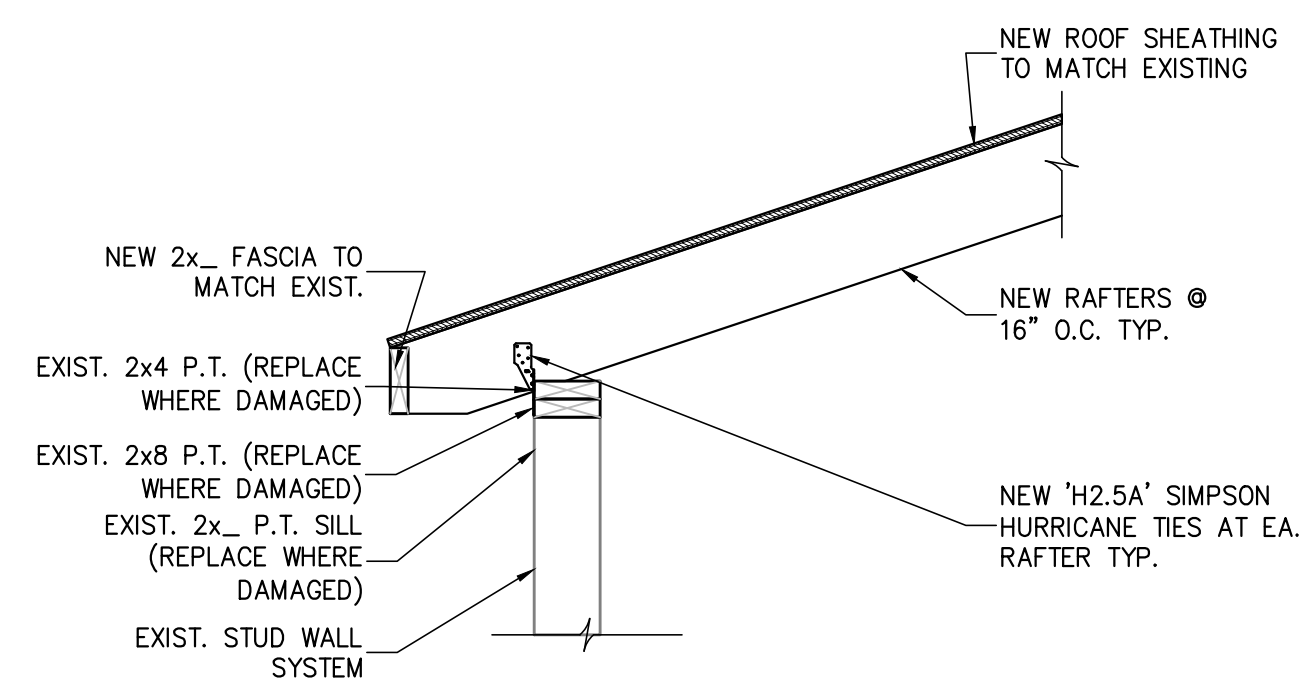
6 SECTION AT RAFTER BEARING
S1.2 3/4" = 1'-0" (LOW ROOF)

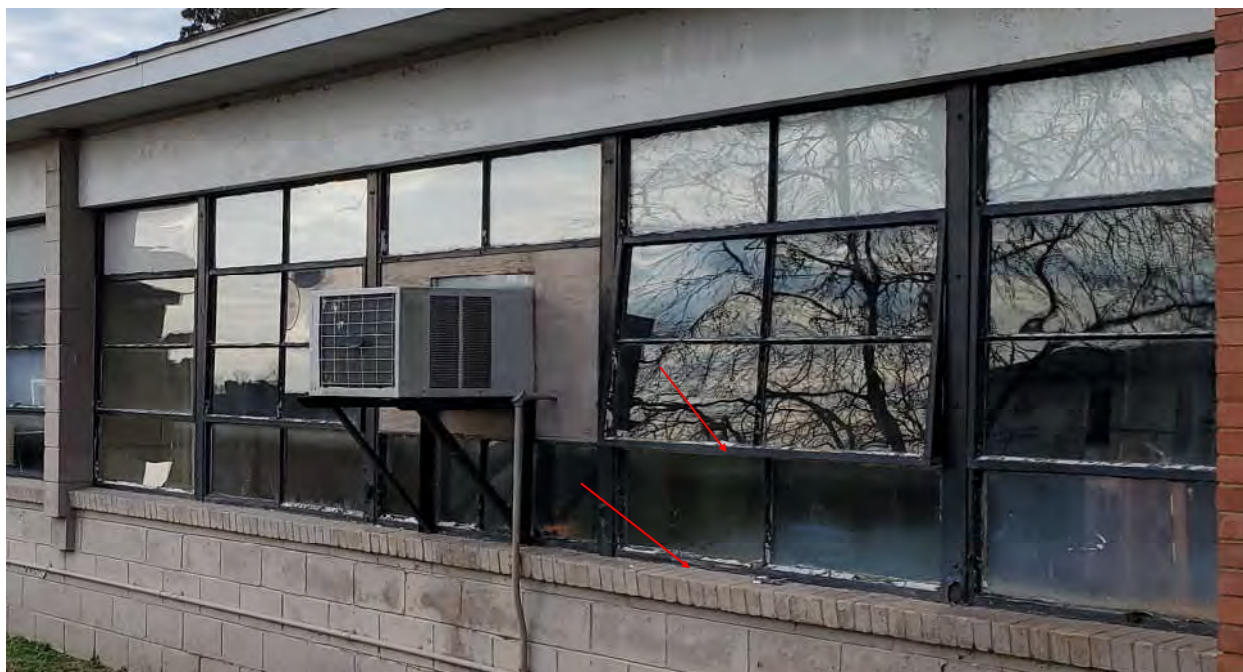
Photograph 1 - Homogeneous Areas A-01 & A-22—Typical Asbestos-Containing Exterior Window Glazing and Window Frame Caulking Located Throughout Main Building Window Units. (57 Window Units)

Photograph 1 - Homogeneous Areas A-01 & A-22—Typical Asbestos-Containing Exterior Window Glazing and Window Frame Caulking Located Throughout Main Building Window Units. (57 Window Units)

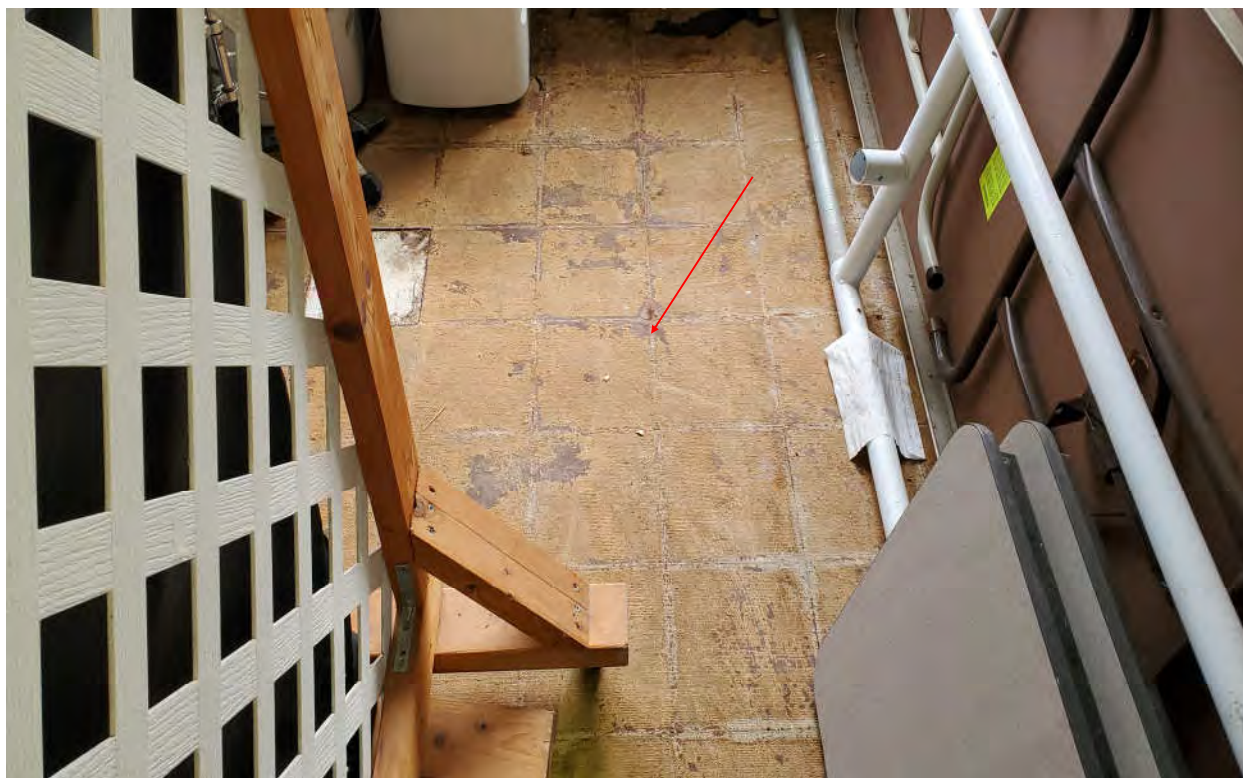
Photograph 2 - Homogeneous Area A-06—Typical Asbestos-Containing 9" x 9" Floor Tile & Black Mastic (Green & Brown Colors) Located as Underlayer Throughout Main Building Classrooms, Corridors, & Office Area Under Carpet or Non-ACM Floor Tile or Linoleum (9,700 SF)

Photograph 2 - Homogeneous Area A-06—Typical Asbestos-Containing 9" x 9" Floor Tile & Black Mastic (Green & Brown Colors) Located as Underlayer Throughout Main Building Classrooms, Corridors, & Office Area Under Carpet or Non-ACM Floor Tile or Linoleum (9,700 SF)

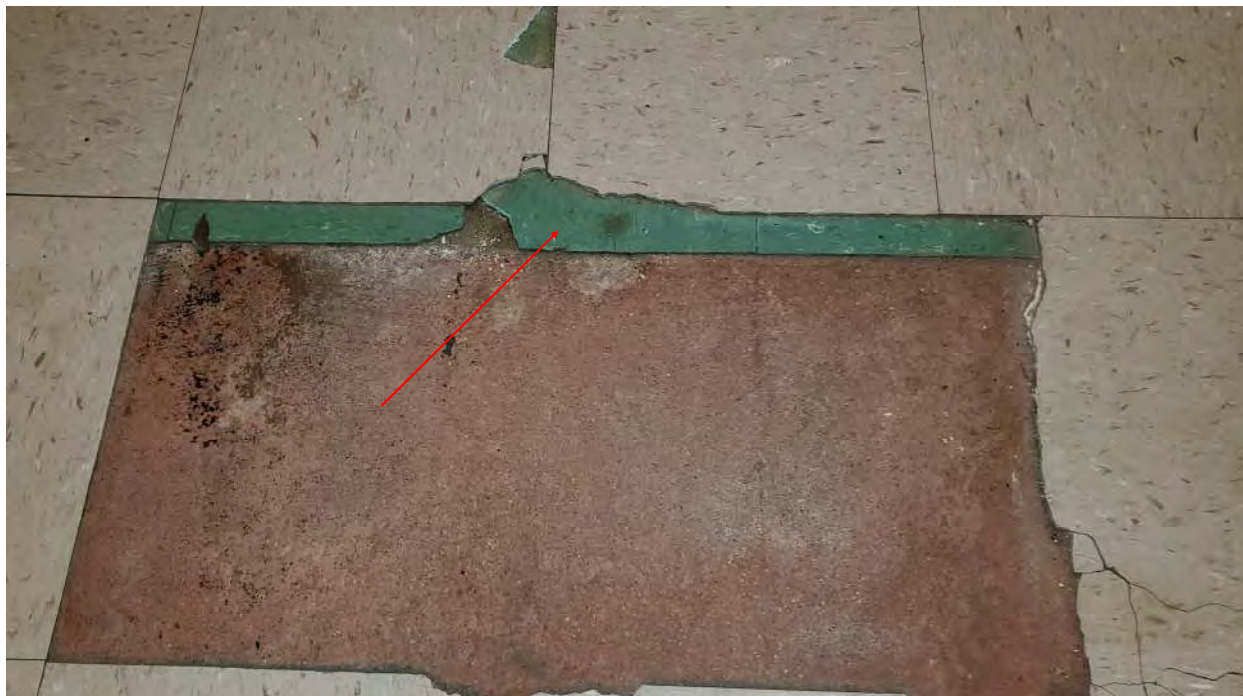
Photograph 3 - Homogeneous Area A-06 - Typical Asbestos-Containing 9" x 9" Floor Tile & Black Mastic (Green & Brown Colors) Located as Underlayer Throughout Main Building Classrooms, Corridors, & Office Area Under Carpet or Non-ACM Floor Tile or Linoleum

Photograph 3 - Homogeneous Area A-06 - Typical Asbestos-Containing 9" x 9" Floor Tile & Black Mastic (Green & Brown Colors) Located as Underlayer Throughout Main Building Classrooms, Corridors, & Office Area Under Carpet or Non-ACM Floor Tile or Linoleum

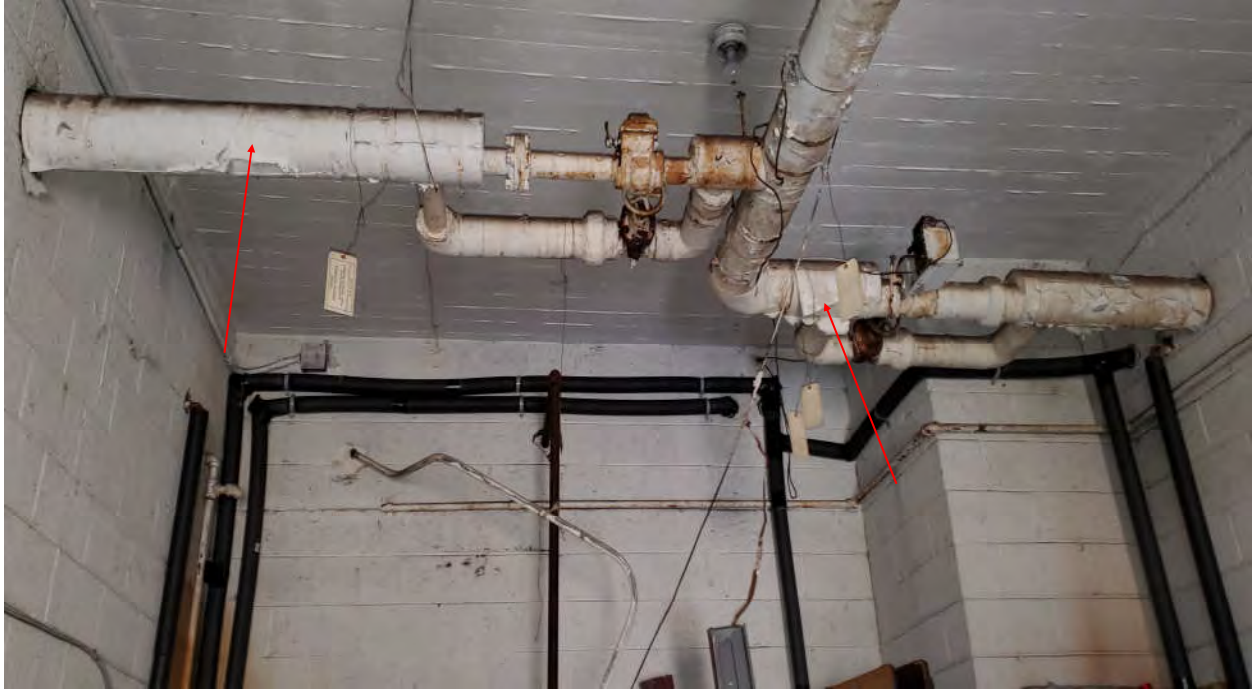
Photograph 5 - Homogeneous Area A-23 - Asbestos-Containing “Air-Cell” Straight Run Pipe Insulation Located Overhead in the Mechanical Room. (10 LF)

Photograph 5 - Homogeneous Area A-23 - Asbestos-Containing “Air-Cell” Straight Run Pipe Insulation Located Overhead in the Mechanical Room. (10 LF)

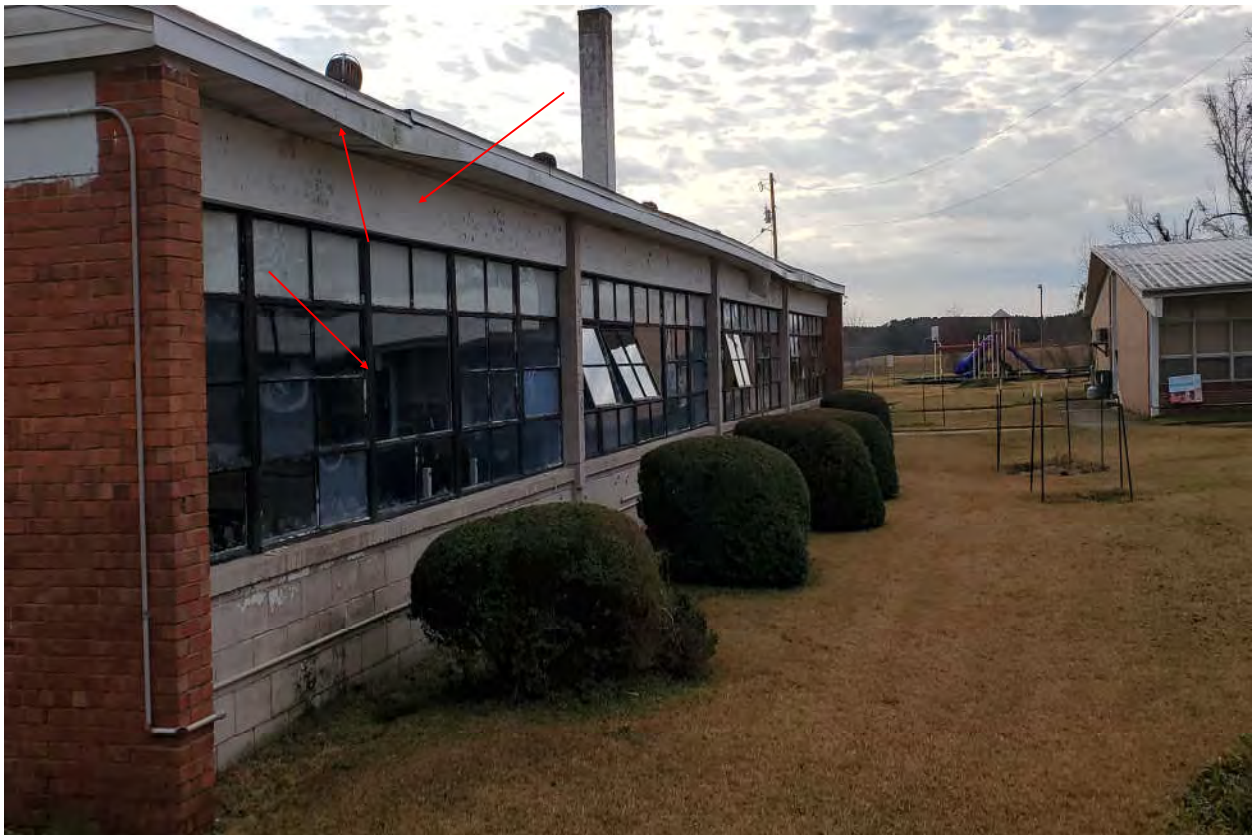
Photograph 6 - Typical Lead-Based Paint Throughout Interior and Exterior Metal Window Components (Sashes & Casings), Concrete Window Headers, & Wooden Eaves of Main Building.

Photograph 6 - Typical Lead-Based Paint Throughout Interior and Exterior Metal Window Components (Sashes & Casings), Concrete Window Headers, & Wooden Eaves of Main Building.

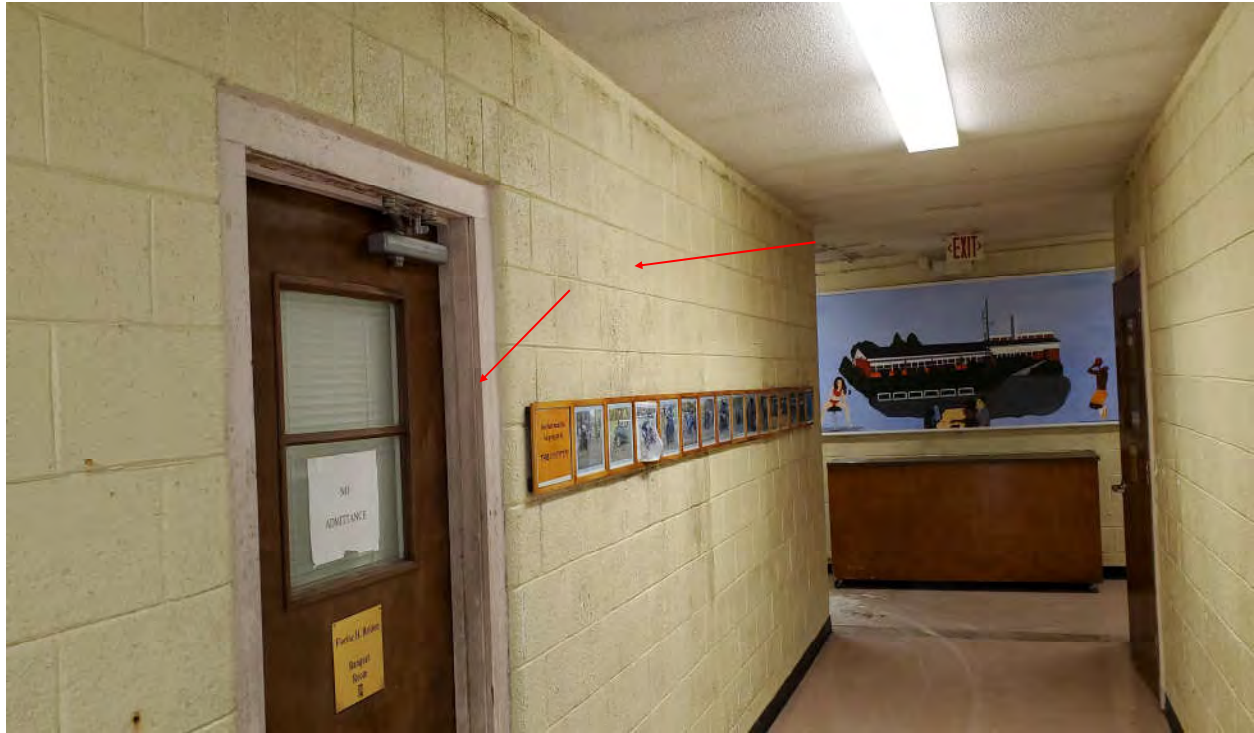
Photograph 9 - Typical Mold Growth on Walls, Door Components, & Other Surfaces Located Throughout the Main Building.

Photograph 9 - Typical Mold Growth on Walls, Door Components, & Other Surfaces Located Throughout the Main Building.

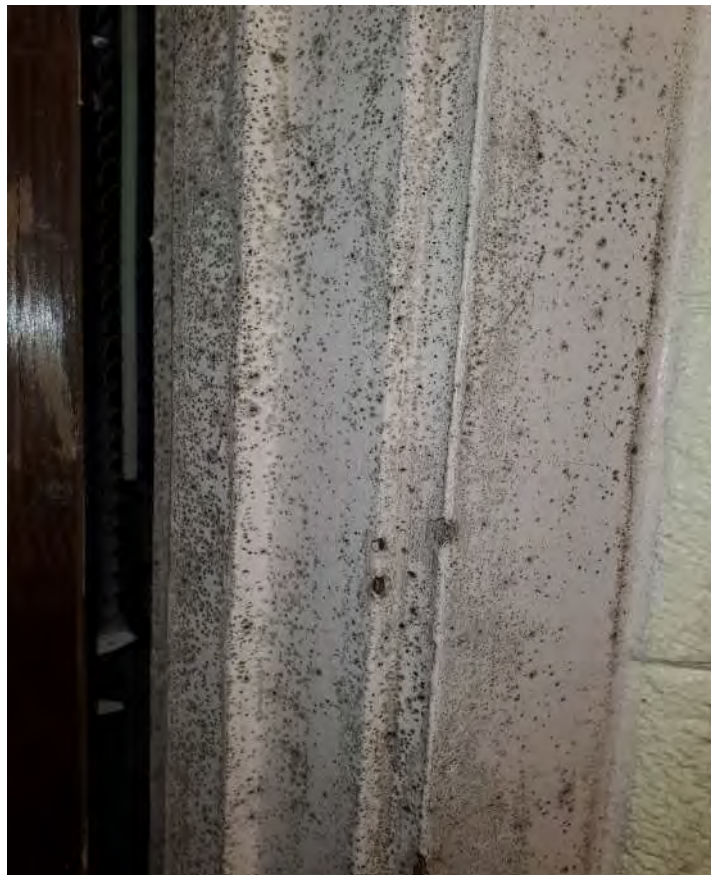
Photograph 10 - Typical Mold Growth on Walls, Door Components, & Other Surfaces Located Throughout the Main Building.

Photograph 10 - Typical Mold Growth on Walls, Door Components, & Other Surfaces Located Throughout the Main Building.

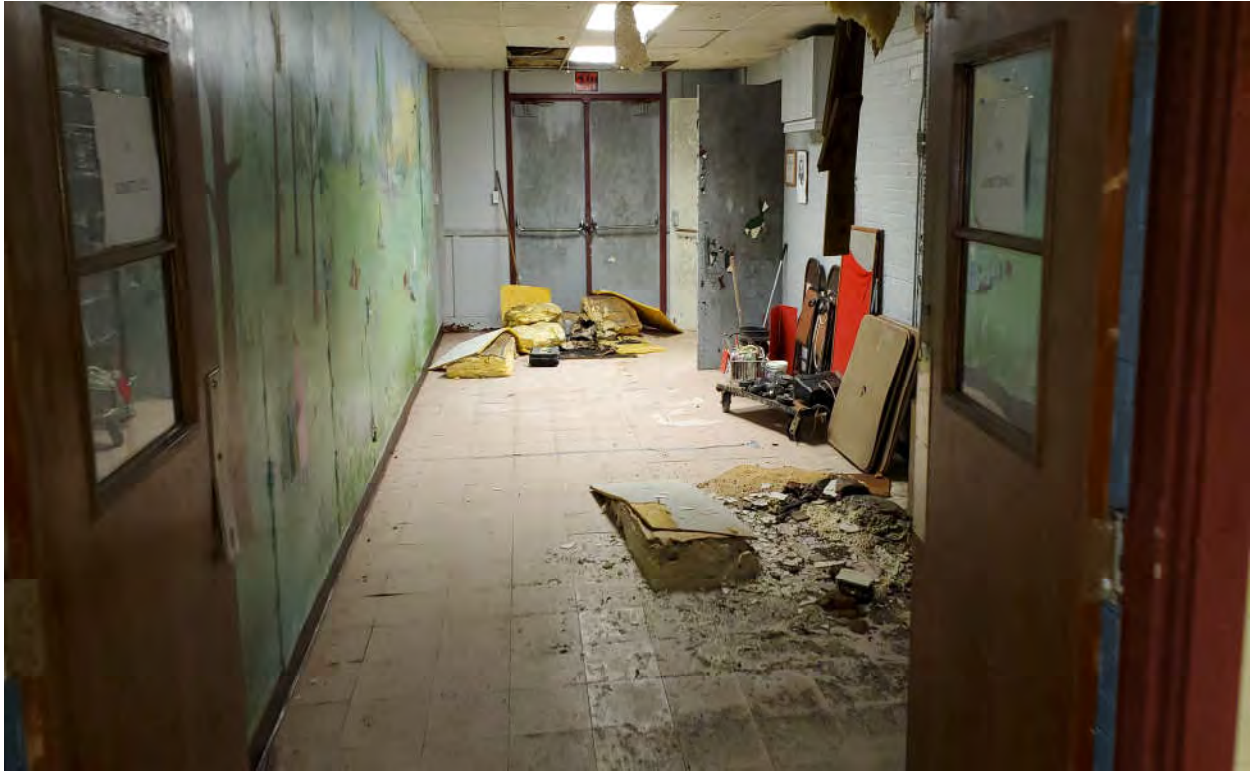
Photograph 15 - Typical Water Damage & Mold Growth in Gym Corridor from Damaged Roof.

Photograph 15 - Typical Water Damage & Mold Growth in Gym Corridor from Damaged Roof.

1. The roof was observed to be in poor condition throughout. There are numerous tarps on section of the roof. The roof is caved in over the cafeteria dining room and adjacent gym corridor. There are various water damaged ceiling tiles located throughout the building.
2. Visible mold growth was observed on surfaces throughout the building. **(Photos #9, 10, 11, 12, 13, & 14).**
3. The ceilings are badly damaged in the cafeteria, gym corridor, and gym locker rooms from water damage. **(Photos #13, 14, 15, & 16).**

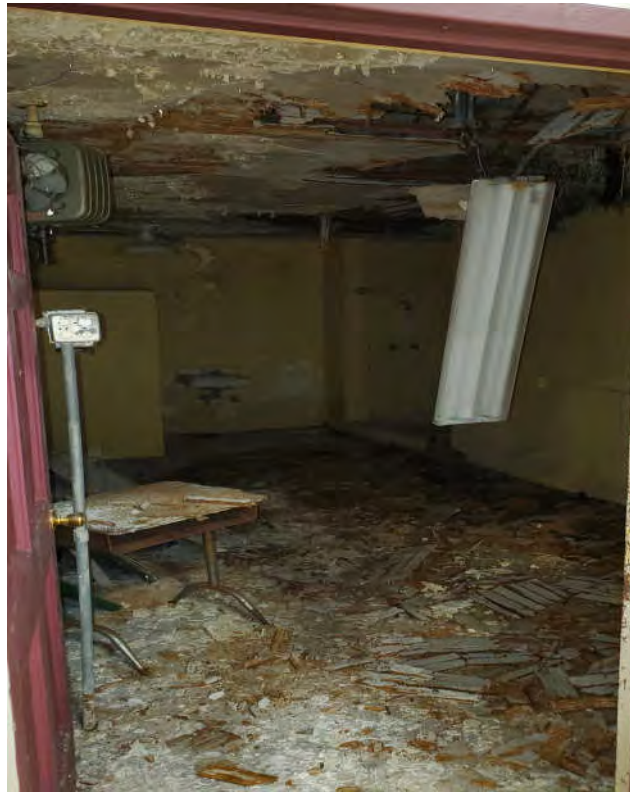
Photograph 16 - Typical Moisture Damage & Mold Growth on Walls, Door Components, & Other Surfaces in the Gym Locker Rooms from Damaged Roof.

Photograph 16 - Typical Moisture Damage & Mold Growth on Walls, Door Components, & Other Surfaces in the Gym Locker Rooms from Damaged Roof.
