**Environmental Review for Activity/Project that is Categorically
Excluded Subject to Section 58.5
Pursuant to 24 CFR 58.35(a)**

Project Name: Davis Ventures Community Center

Project Location: 33478 U.S. Highway 264, Engelhard, Hyde County, NC 27824

ROOF & BUILDING REPAIRS

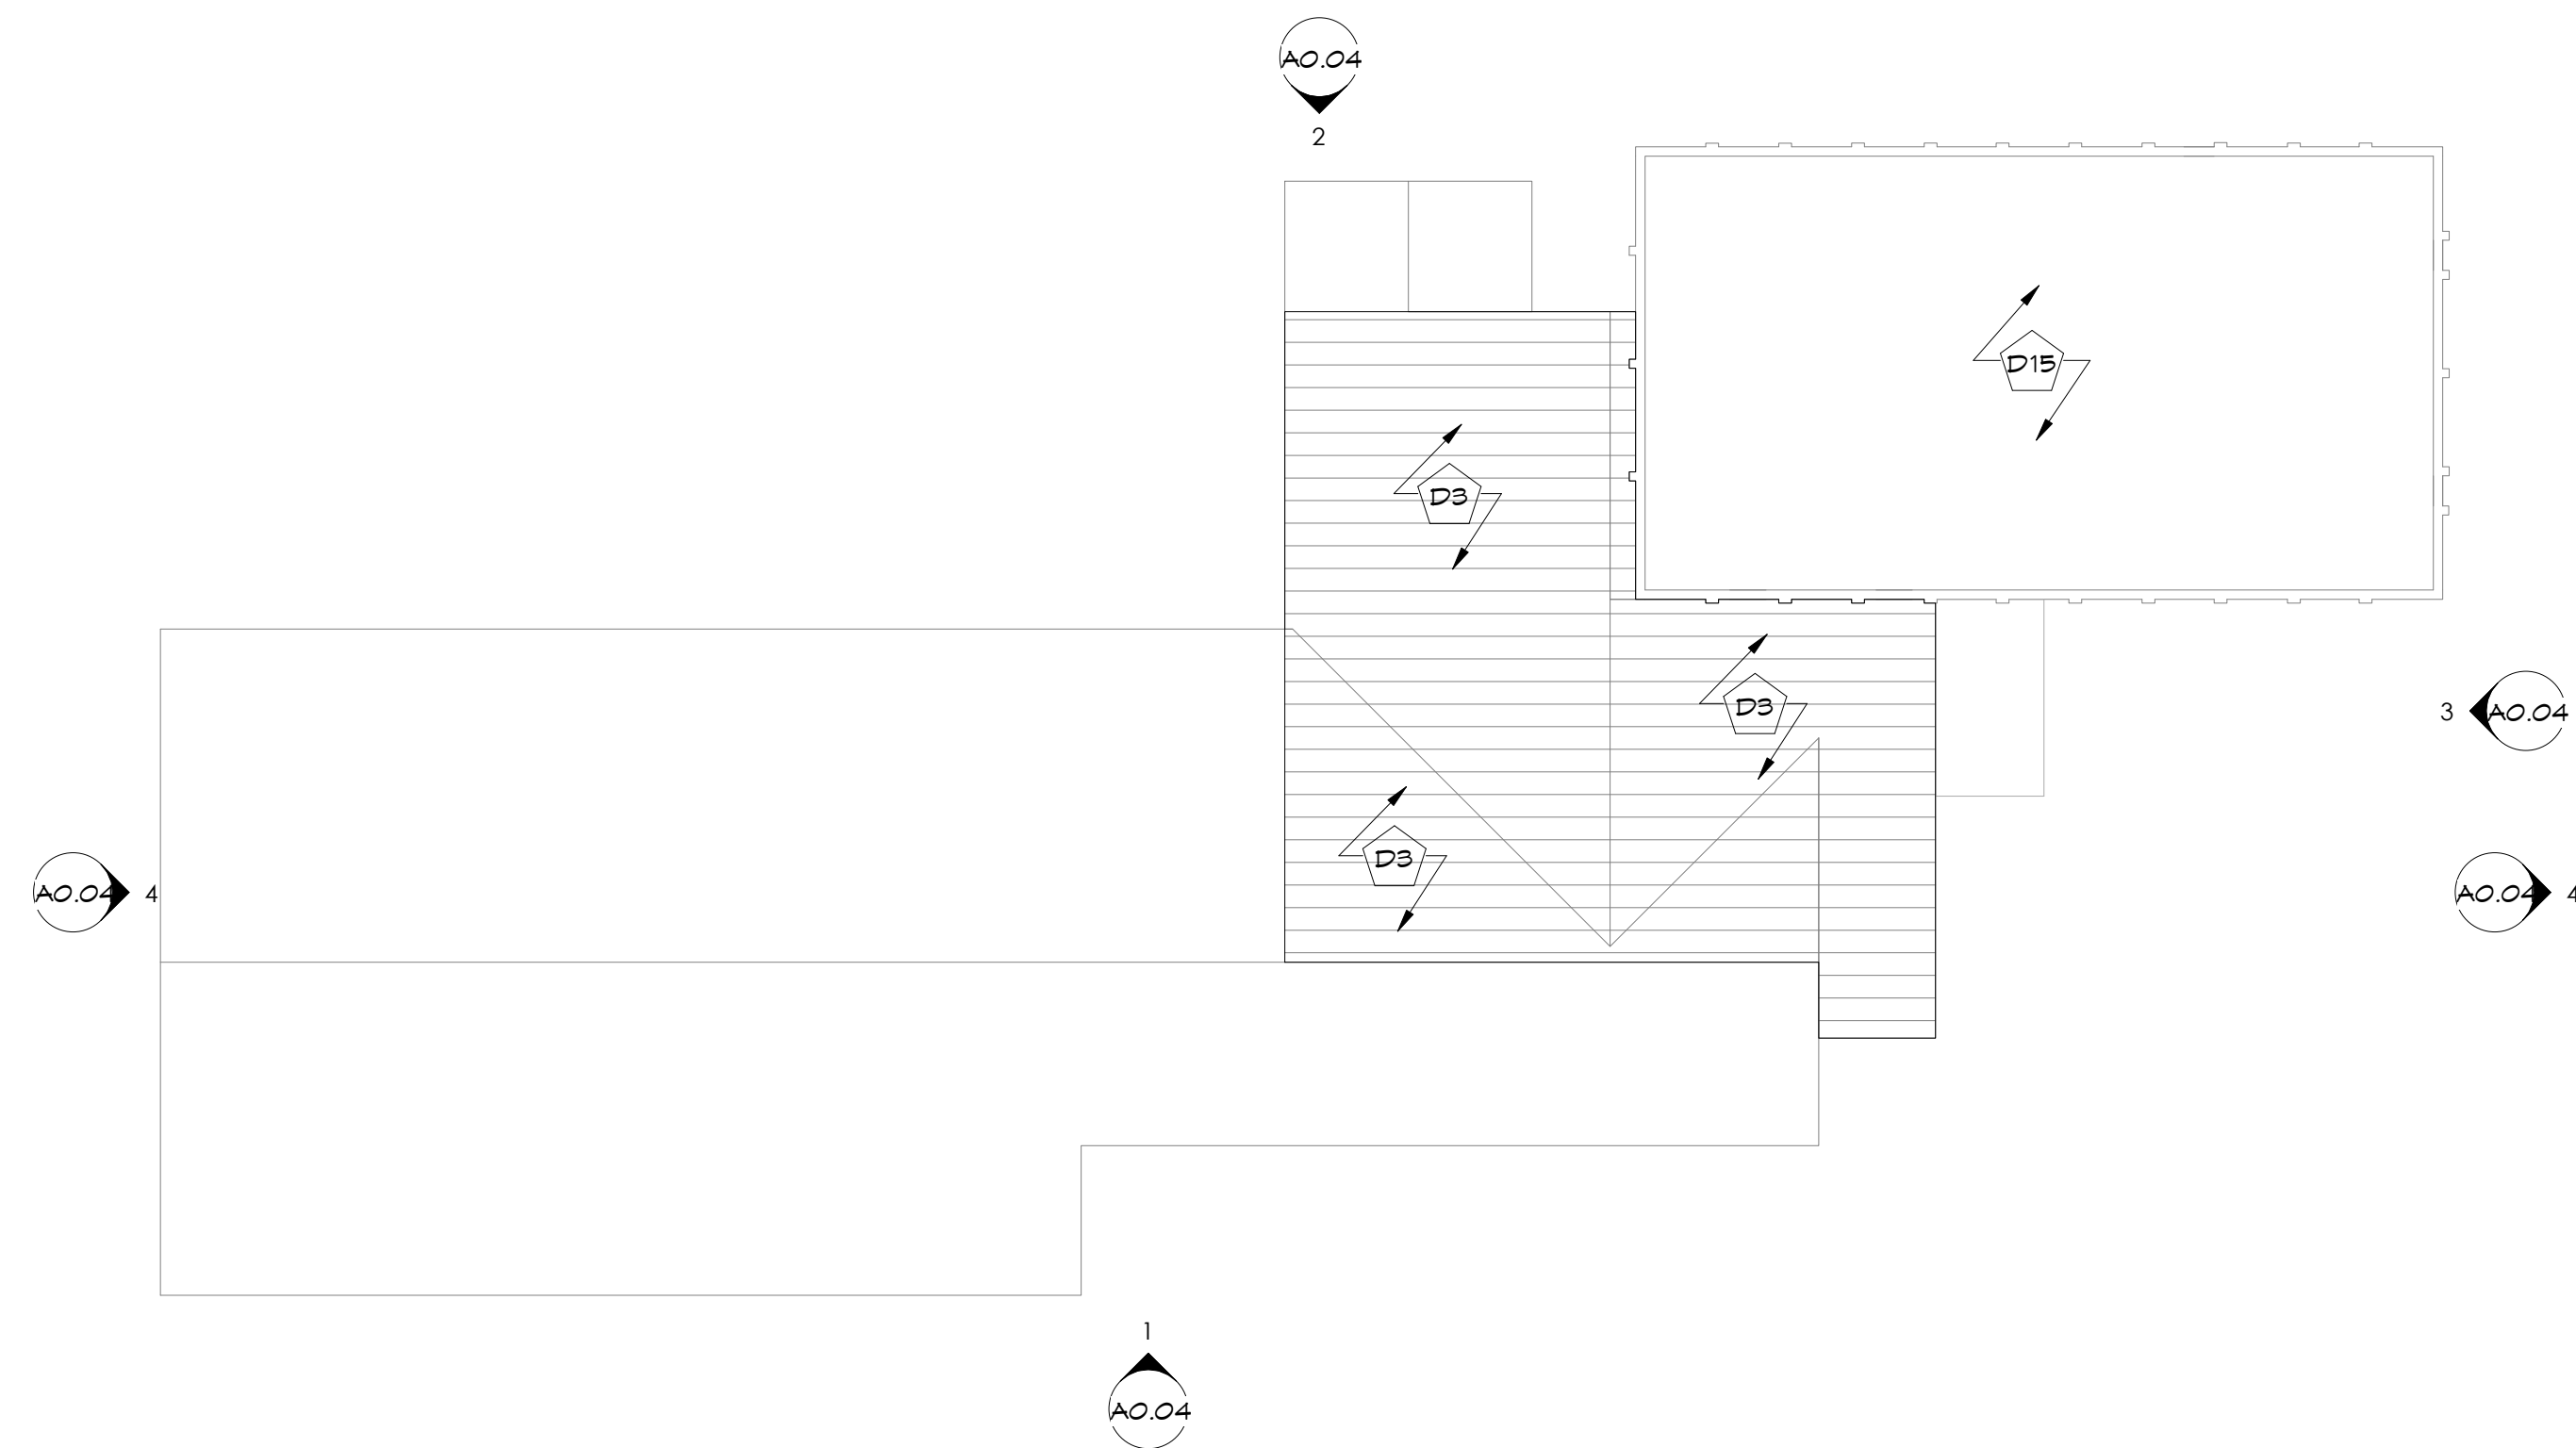
DEMO ROOF PLAN ④
1" = 20'-0"

- D1 – REMEDIATE MOLD AND ABATE ALL HAZARDOUS MATERIALS THROUGHOUT THE BUILDING INCLUDING EXISTING INTERIOR AND EXTERIOR WALLS, FLOOR FINISHES, COMMERCIAL KITCHEN EQUIPMENT, CEILING TILES, DUCT WORK, INTERIOR DOORS, DOOR FRAMES ETC.

- D2 – DEMOLISH AND ABATE ROTTEN, DAMAGED AND COLLAPSED AREAS OF THE GABLED ROOF SYSTEM. PREP FOR INSTALLATION OF NEW ROOF FRAMING IN SOME LOCATIONS AS SHOWN, AND NEW ASPHALT SHINGLE ROOFING SYSTEM THROUGHOUT AS SHOWN IN PROPOSED ROOF PLAN. SEE STRUCTURAL DRAWINGS FOR ADDITIONAL DEMOLITION INSTRUCTIONS AND PROVISIONS.

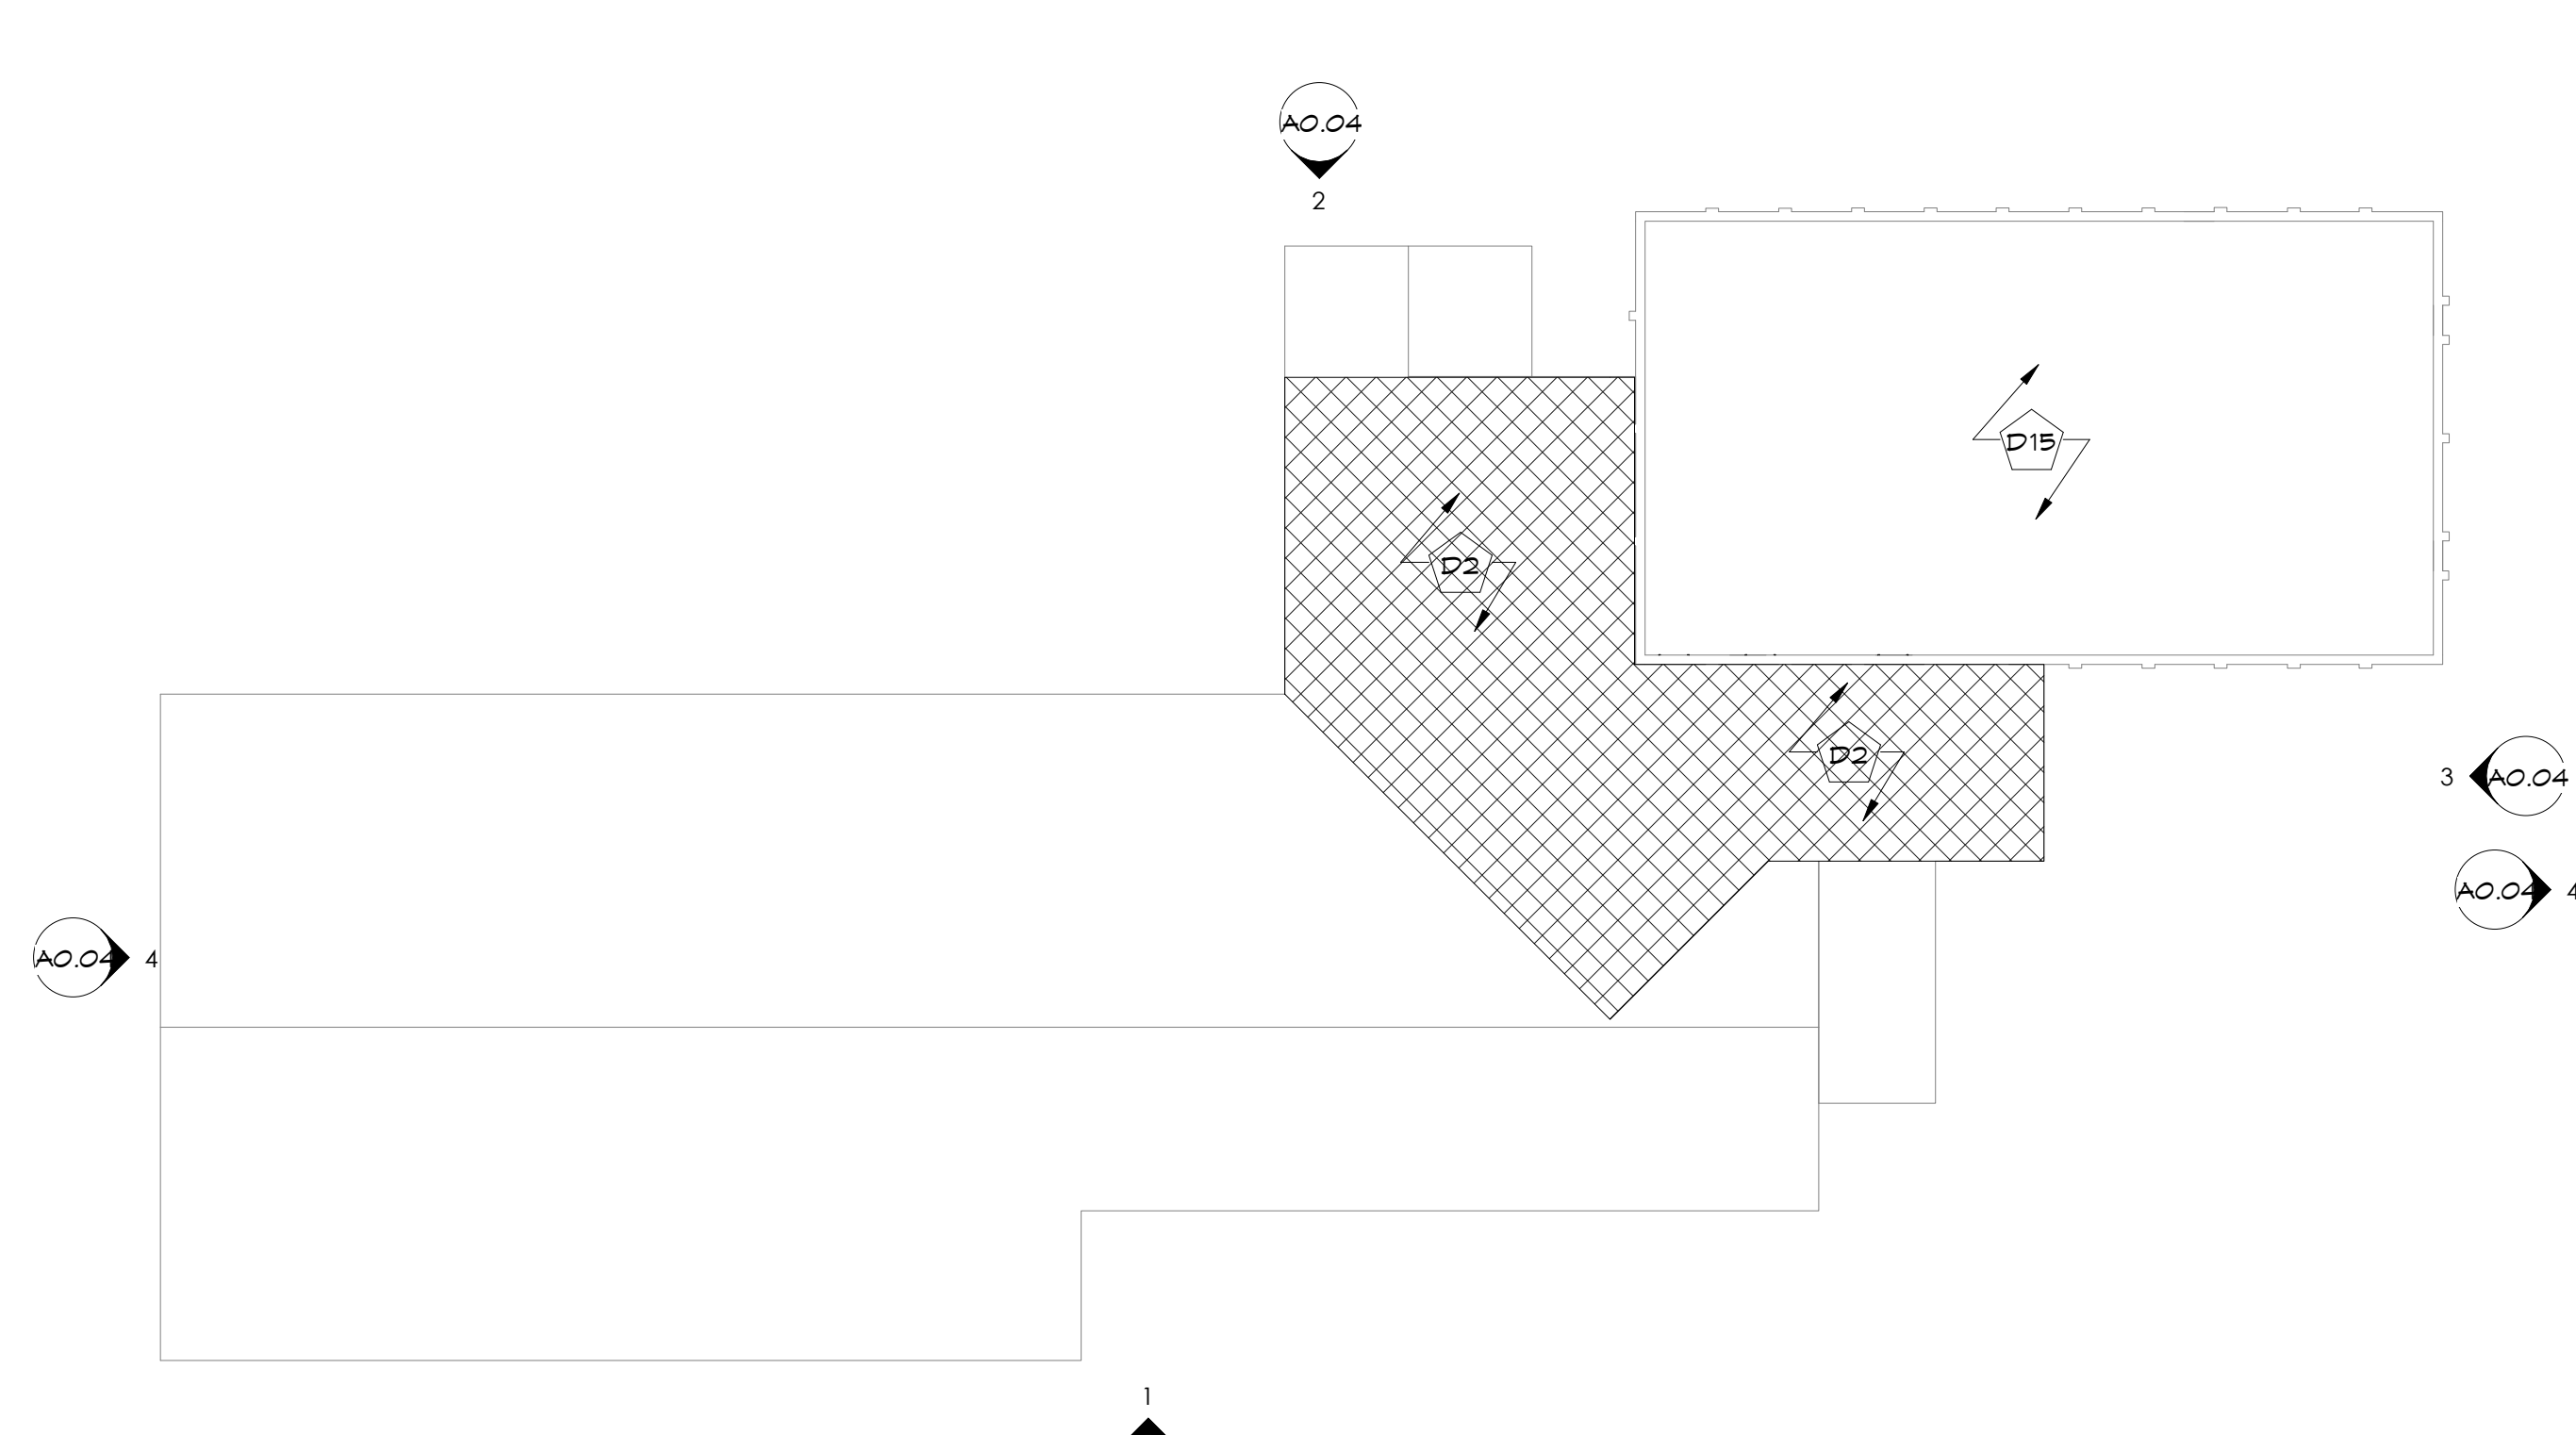
DEMO ROOF PLAN - ROOF FRAMING ③
1" = 20'-0"

- D3 – DEMOLISH AND ABATE ROTTEN, DAMAGED, AND COLLAPSED AREAS OF ORIGINAL FLAT ROOF WOOD DECKING (BELOW GABLED ROOF). DAMAGE SEE STRUCTURAL DRAWINGS FOR ADDITIONAL INFORMATION AND PROVISIONS. REFER TO THE SPECIFICATIONS SHEET FOR THE UNIT PRICE AND QUANTITY ALLOWANCES.

- D4 – DEMOLISH AND ABATE AS REQUIRED ANY EXISTING ROTTEN AND WATER-DAMAGED WOOD SILL PLATES AND ORIGINAL WOOD DECKING UNDER TRUSSES (SEE STRUCTURAL DRAWINGS FOR ADDITIONAL INFORMATION AND PROVISIONS). REFER TO THE SPECIFICATIONS SHEET FOR THE UNIT PRICE AND QUANTITY ALLOWANCES.

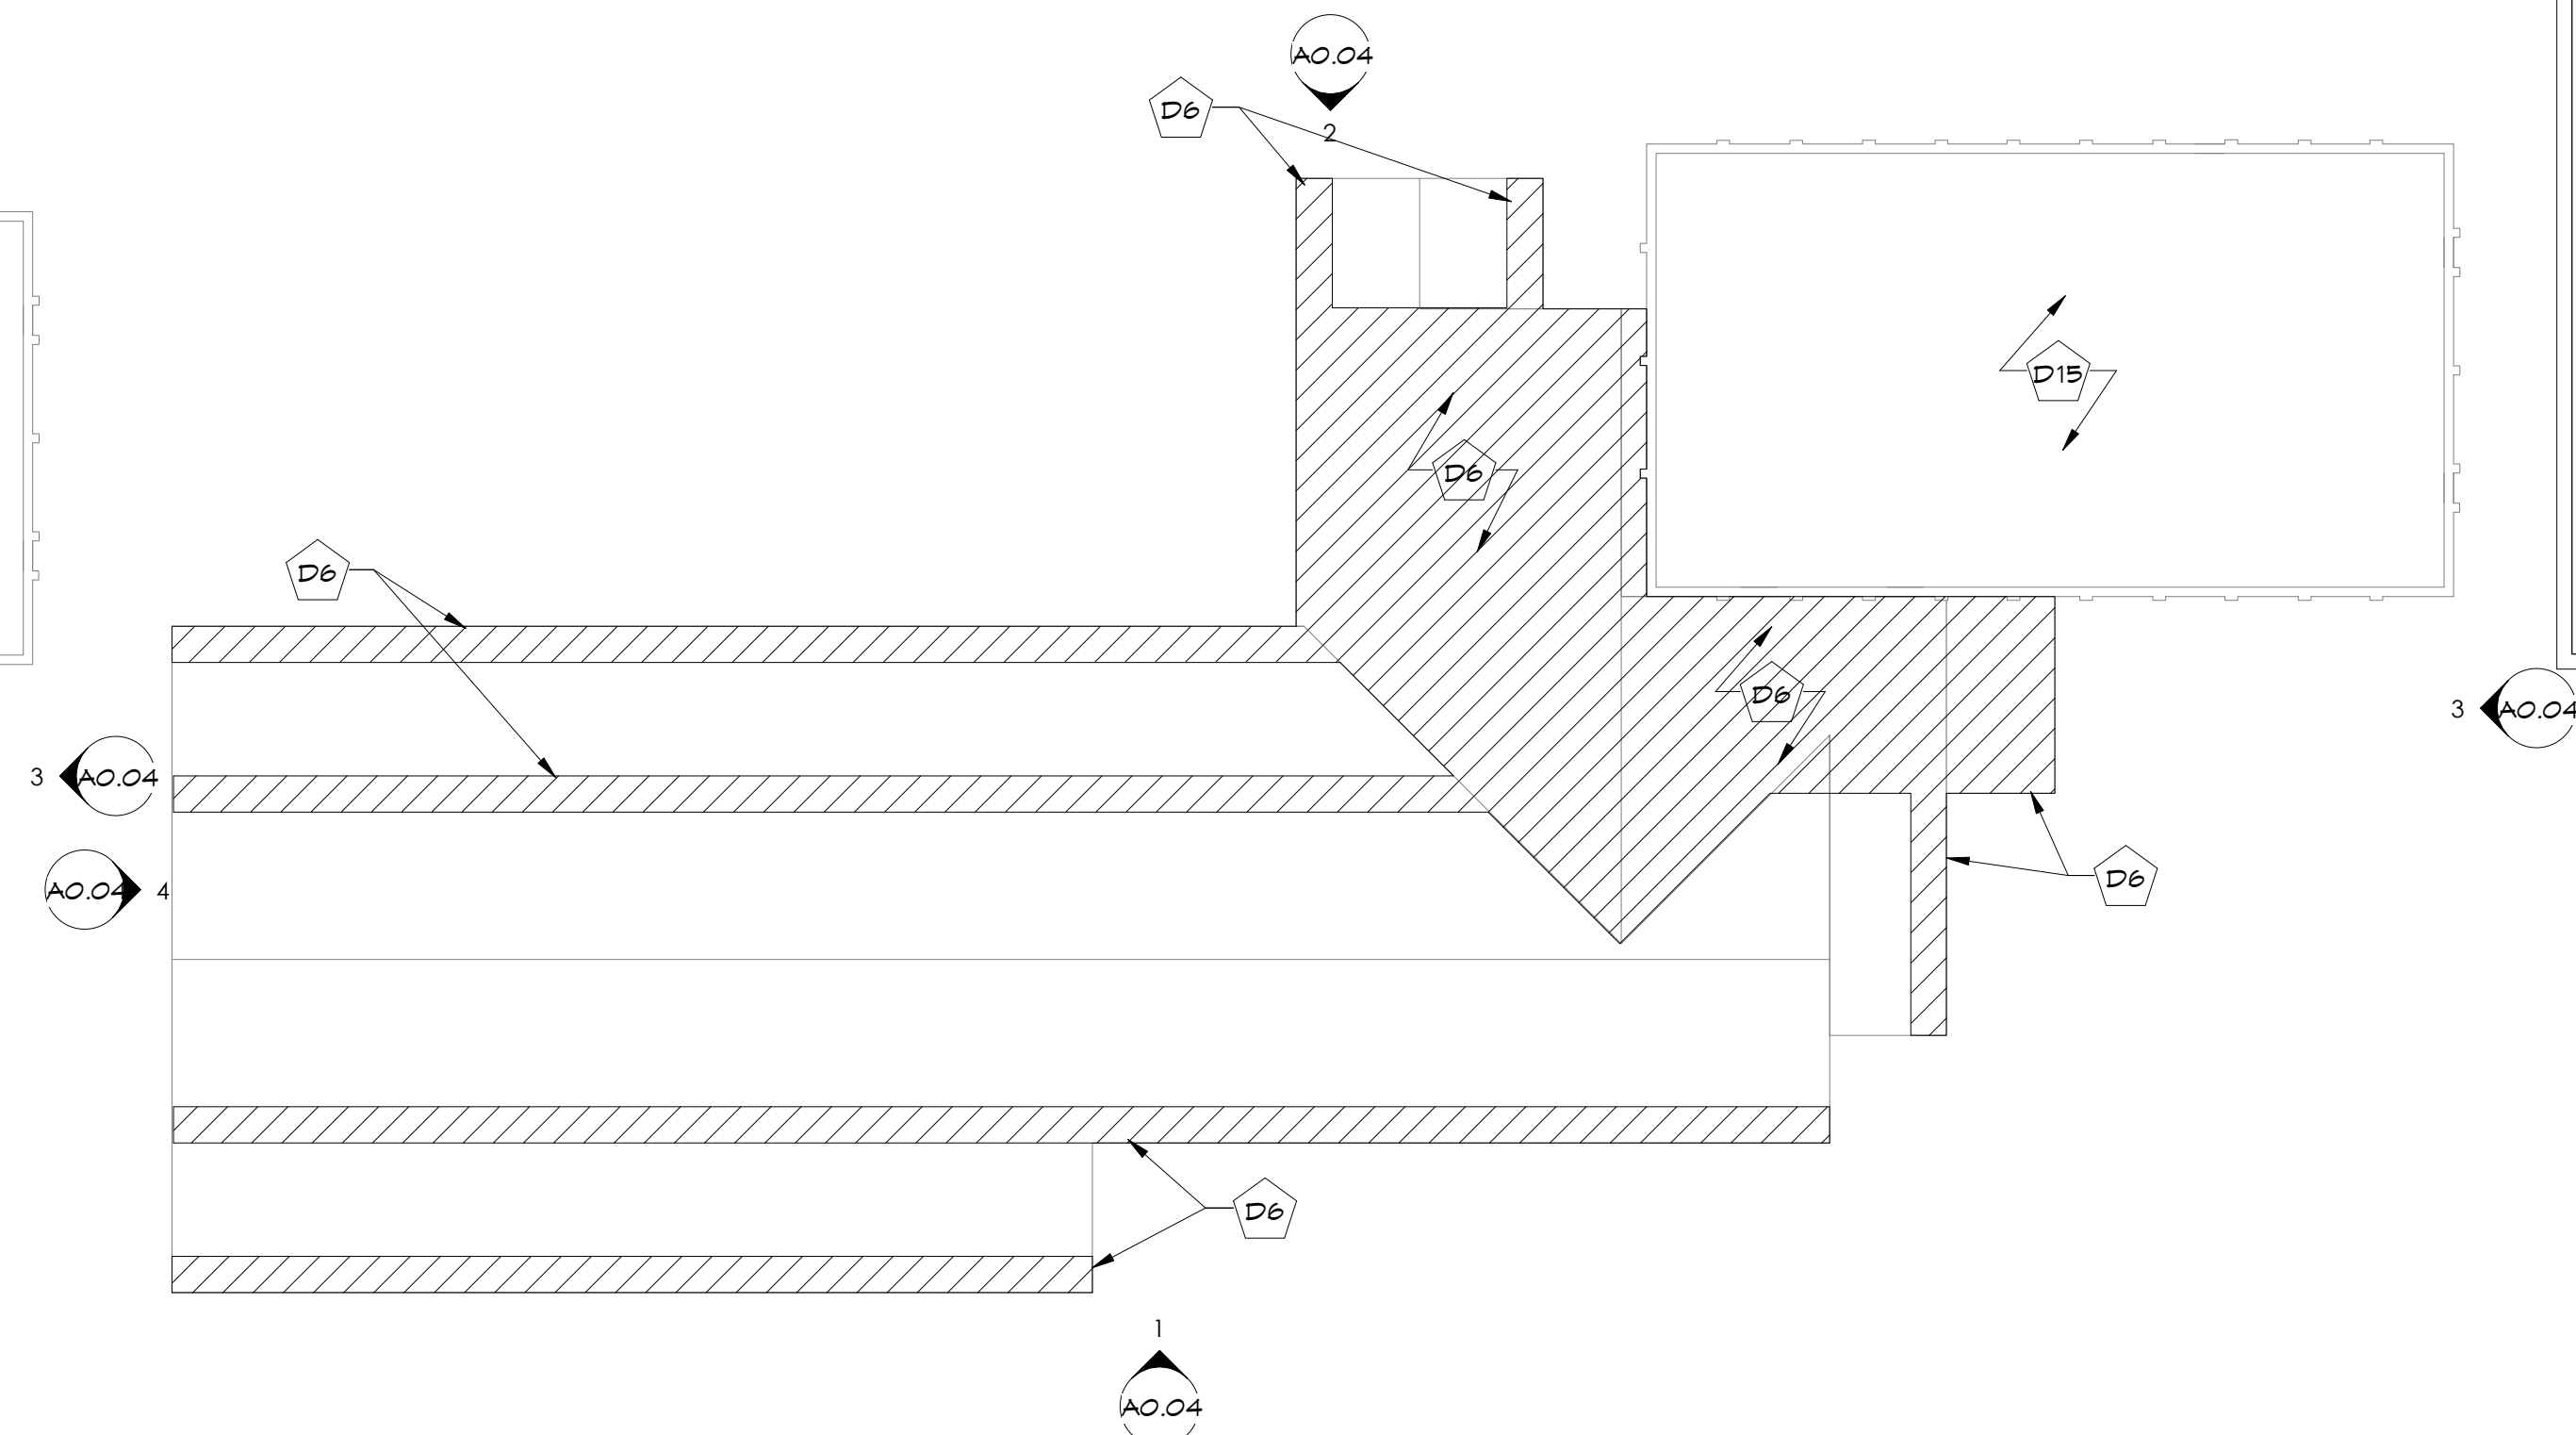
DEMO ROOF PLAN - ROOF SHEATHING ①
1" = 20'-0"

- D6 – REMOVE A PORTION OF THE ROOF SHEATHING AS SHOWN ON DEMOLITION ROOF PLANS TO ACCESS THE CONNECTIONS BETWEEN THE GABLE TRUSSES AND THE WALLS BELOW. REMOVE AND REPLACE ANY DAMAGED/ROTTEN WOOD BELOW (SEE DEMO KEY NOTE D4) AND PREP FOR INSTALLATION OF NEW HURRICANE TIES (SEE STRUCTURAL DRAWINGS). REFER TO SPECIFICATIONS SHEET FOR UNIT PRICES AND ALLOWANCES.

- D7 – REMOVE PORTION OF DAMAGED ROOF SHEATHING AS REQUIRED. PREP FOR INSTALLATION OF NEW SHEATHING TO MATCH EXISTING ADJACENT. REFER TO SPECIFICATION SHEET FOR UNIT PRICE AND ALLOWANCES.

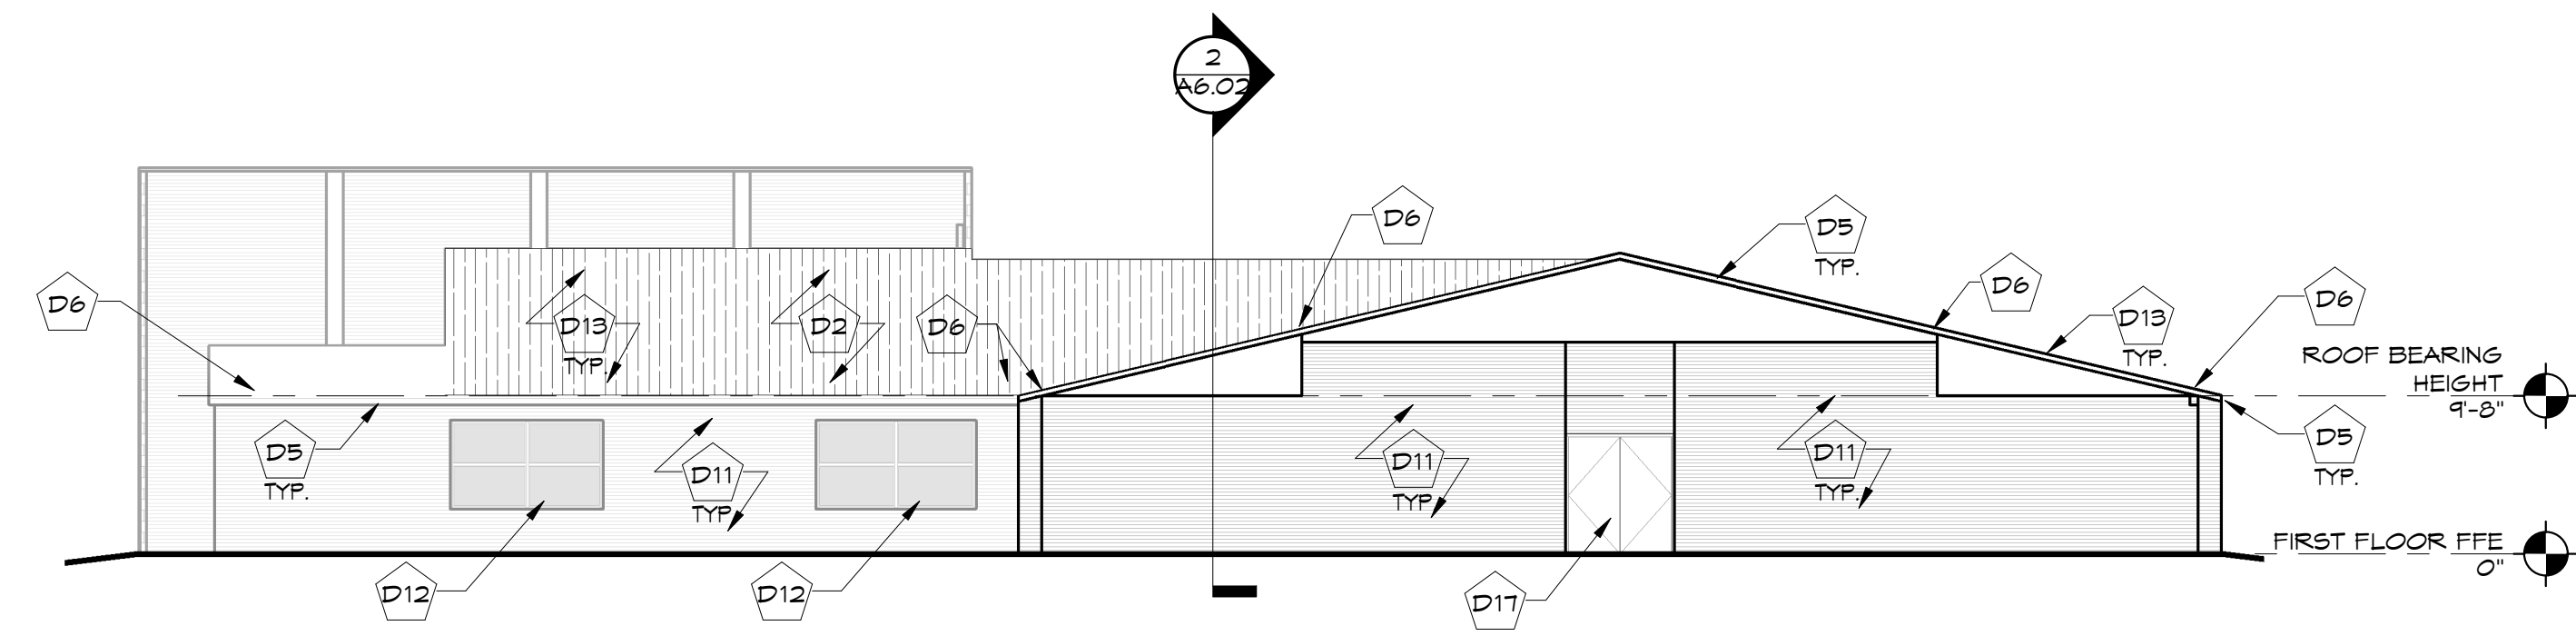
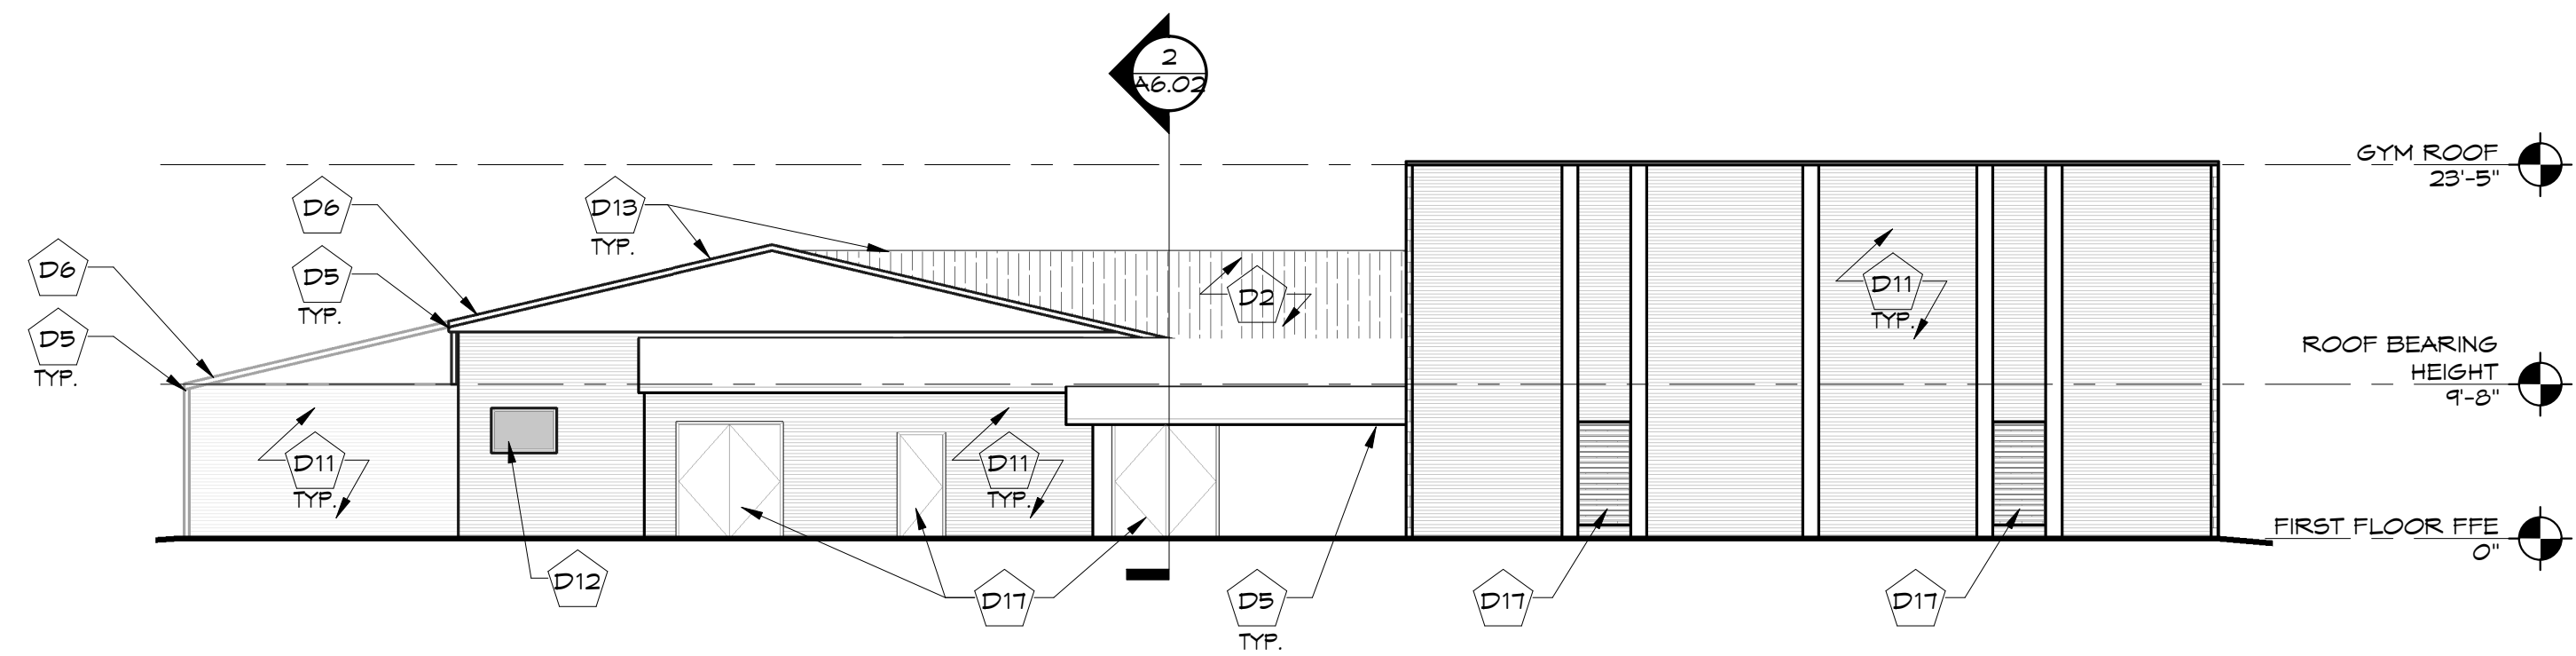
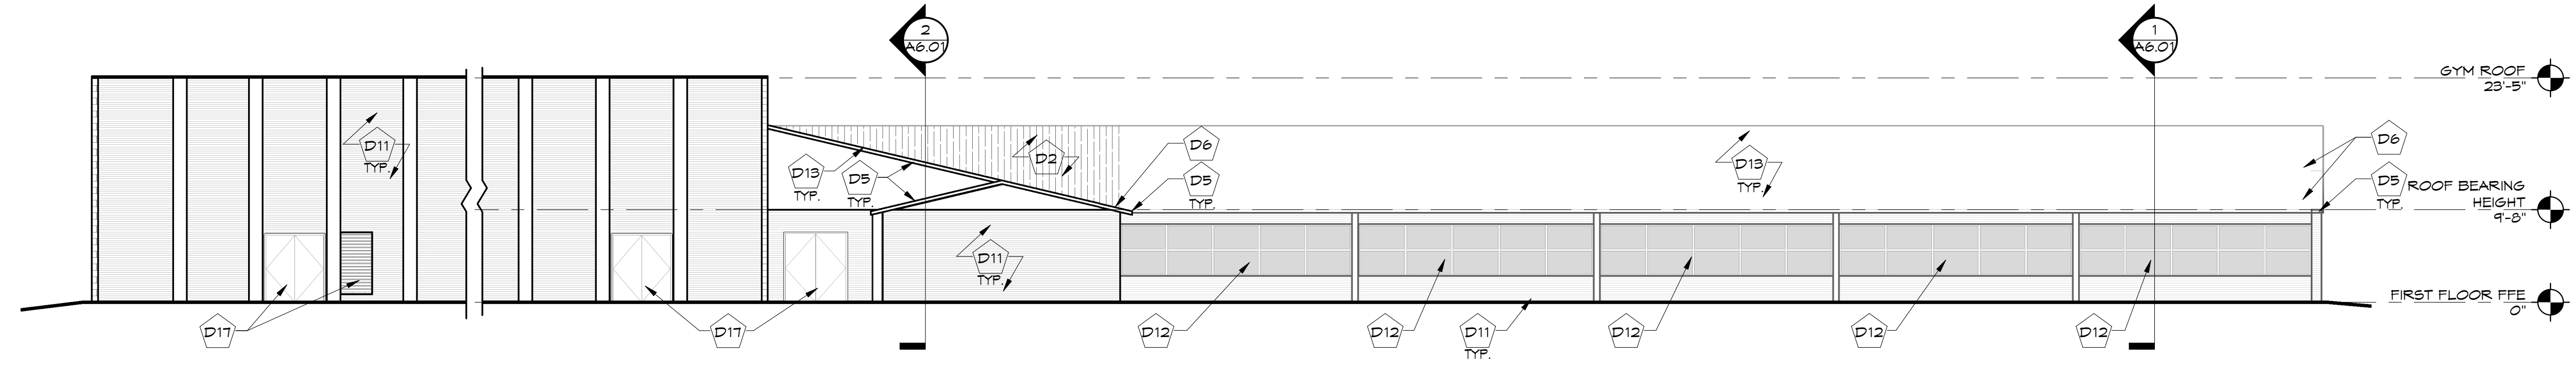
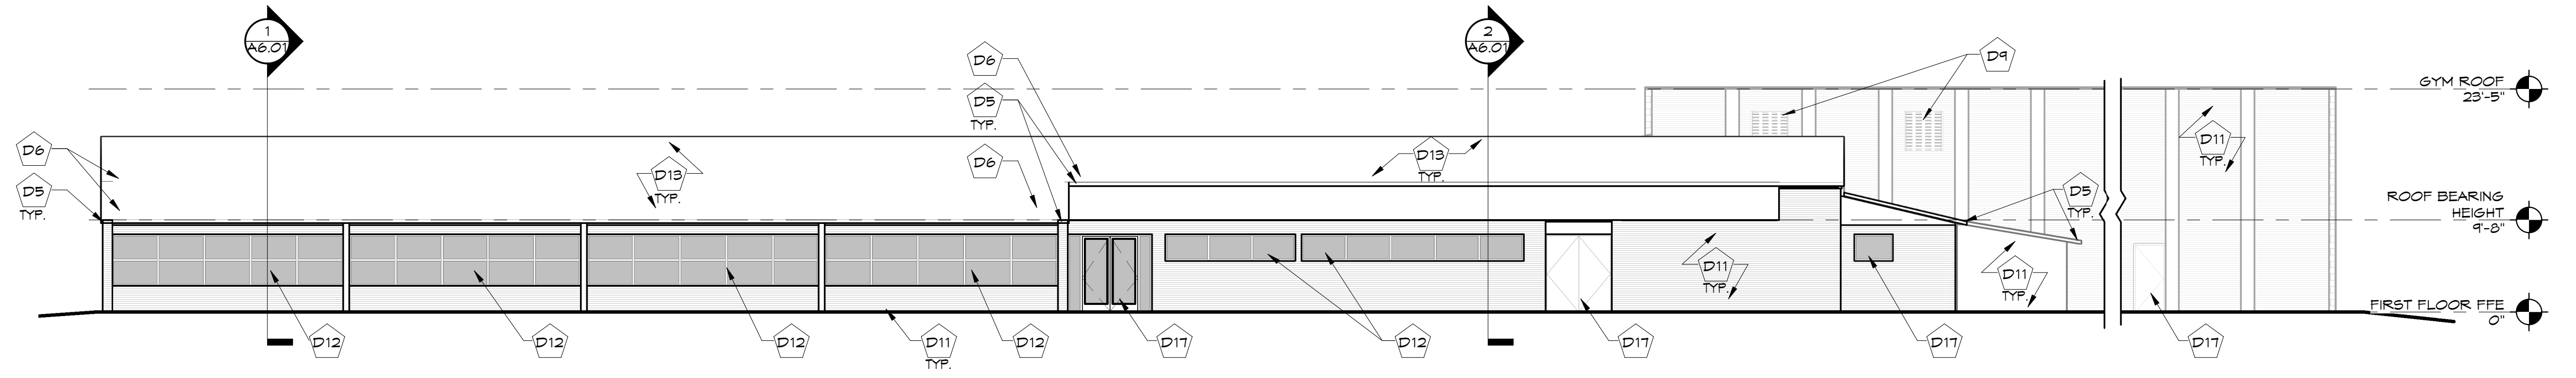
DEMO EXTERIOR ELEVATION 4
3/32" = 1'-0"

DEMO EXTERIOR ELEVATION 3
3/32" = 1'-0"

DEMO EXTERIOR ELEVATION 2
3/32" = 1'-0"

DEMO EXTERIOR ELEVATION 1
3/32" = 1'-0"

- D1 - REMEDIATE MOLD AND ABATE ALL HAZARDOUS MATERIALS THROUGHOUT THE BUILDING INCLUDING EXISTING INTERIOR AND EXTERIOR WALLS, FLOOR FINISHES, COMMERCIAL KITCHEN EQUIPMENT, CEILING TILES, DUCT WORK, INTERIOR DOORS, DOOR FRAMES ETC.

- D2 - DEMOLISH AND ABATE ROTTEN, DAMAGED AND COLLAPSED AREAS OF THE GABLED ROOF SYSTEM. PREP FOR INSTALLATION OF NEW ROOF FRAMING IN SOME LOCATIONS AS SHOWN, AND NEW ASPHALT SHINGLE ROOFING SYSTEM THROUGHOUT AS SHOWN IN PROPOSED ROOF PLAN. SEE STRUCTURAL DRAWINGS FOR ADDITIONAL DEMOLITION INSTRUCTIONS AND PROVISIONS.

- D3 - DEMOLISH AND ABATE ROTTEN, DAMAGED, AND COLLAPSED AREAS OF ORIGINAL FLAT ROOF WOOD DECKING (BELOW GABLED ROOF). DAMAGES SEE STRUCTURAL DRAWINGS FOR ADDITIONAL INFORMATION AND PROVISIONS. REFER TO THE SPECIFICATIONS SHEET FOR THE UNIT PRICE AND QUANTITY ALLOWANCES.

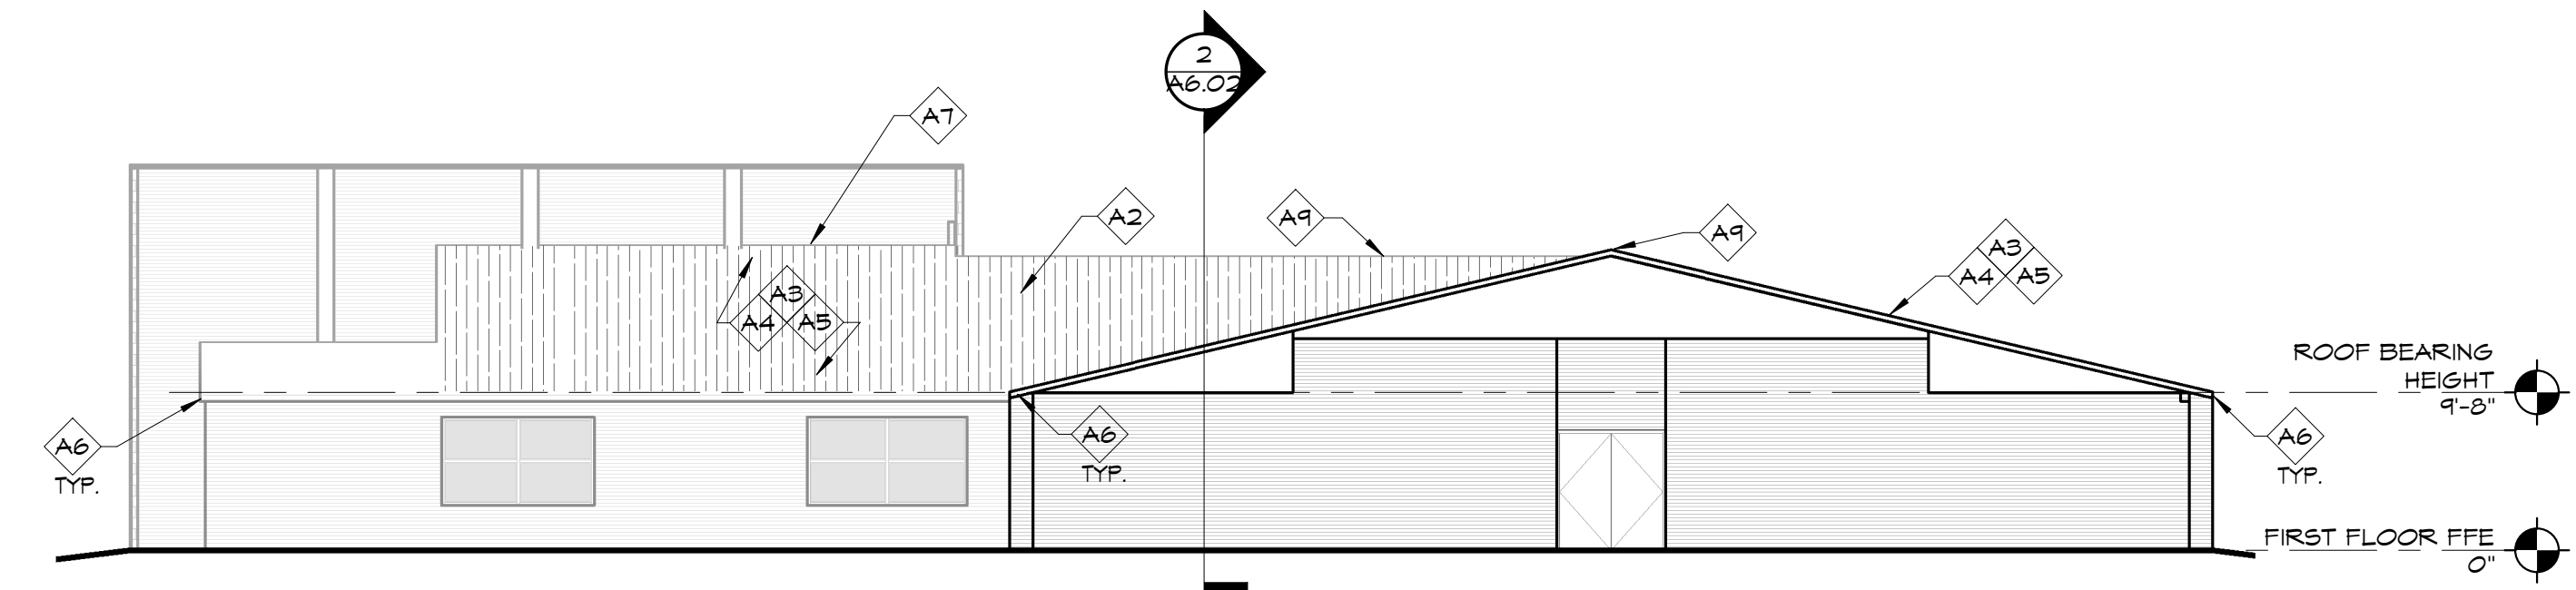
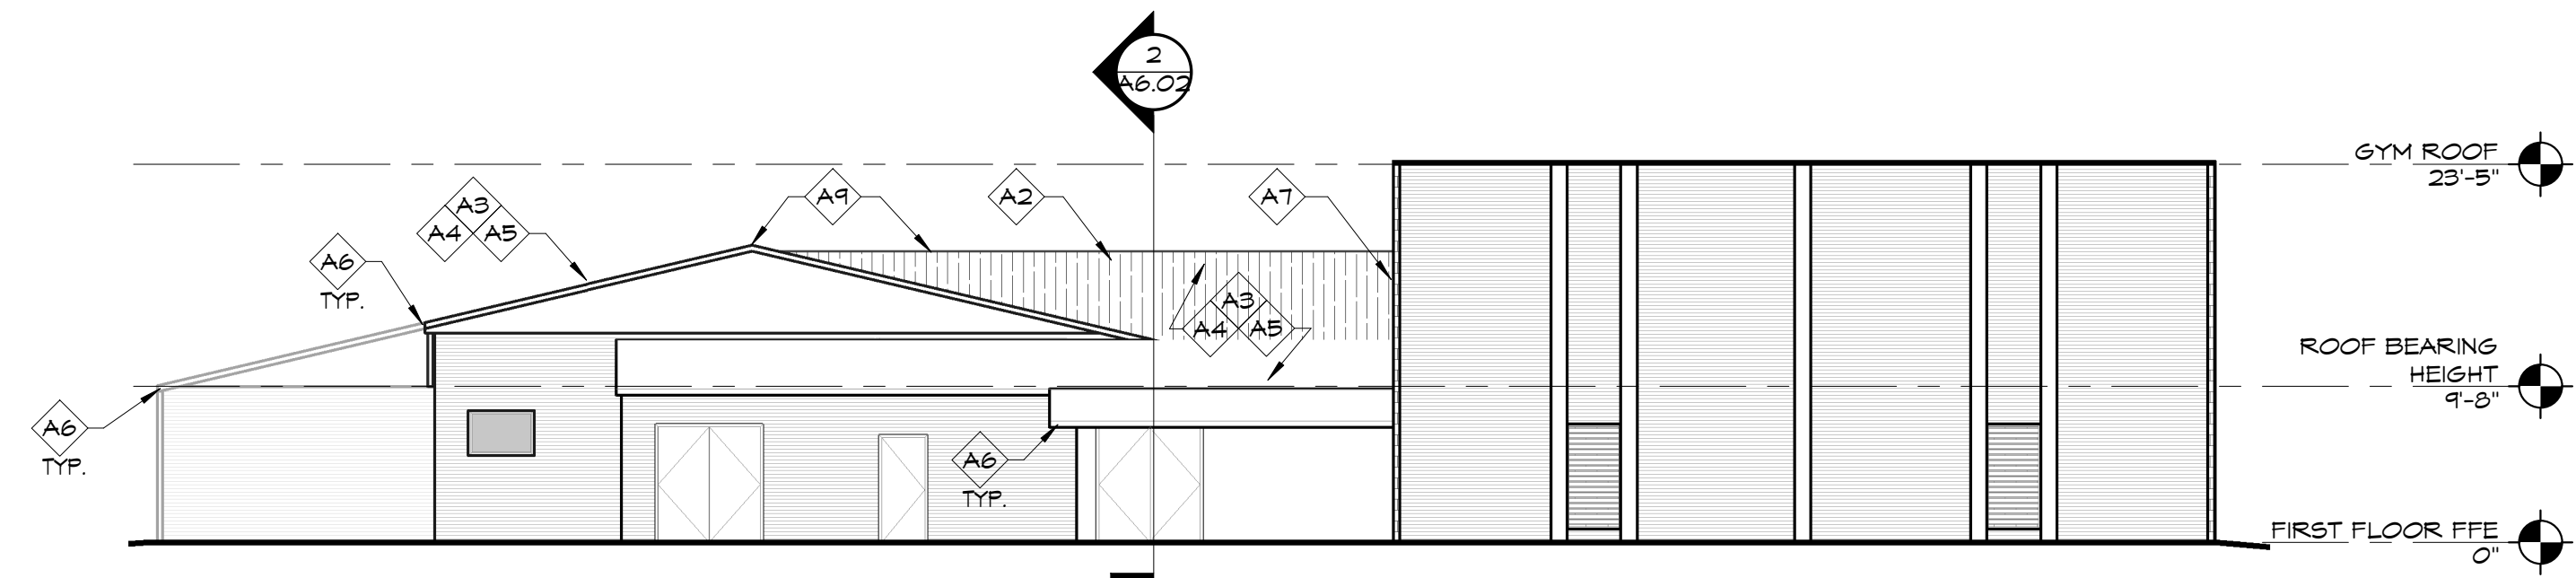
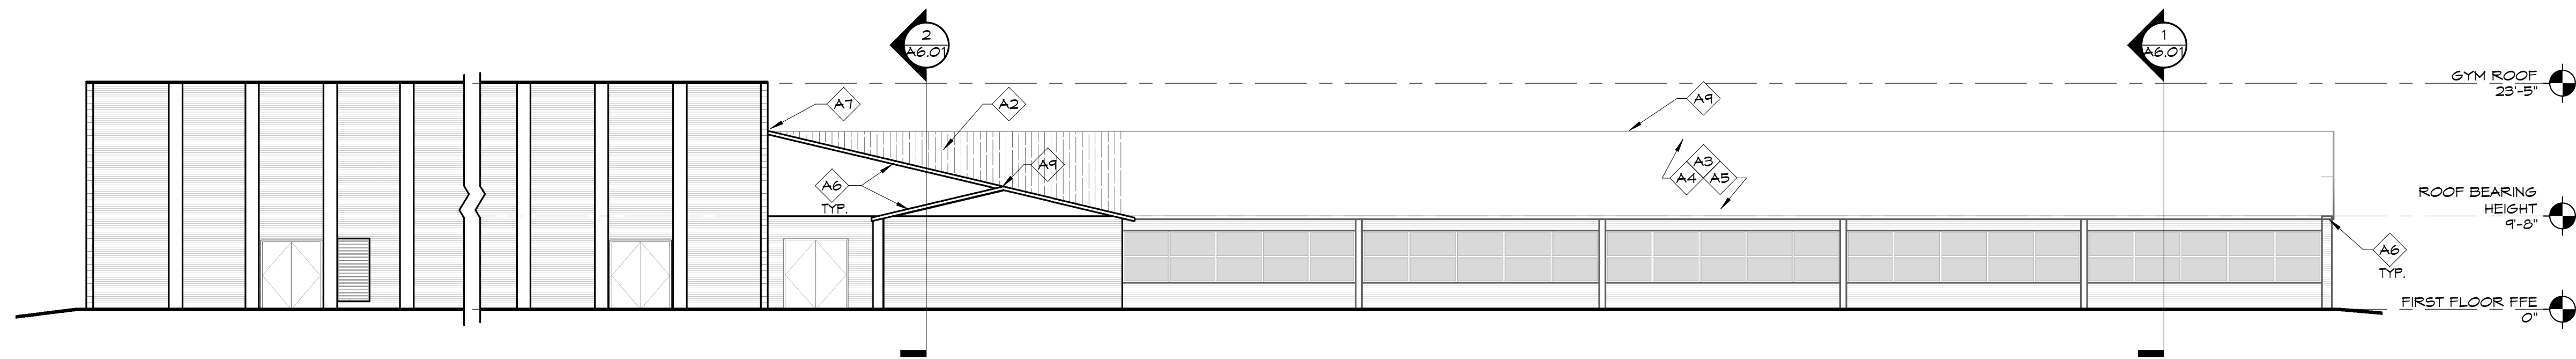
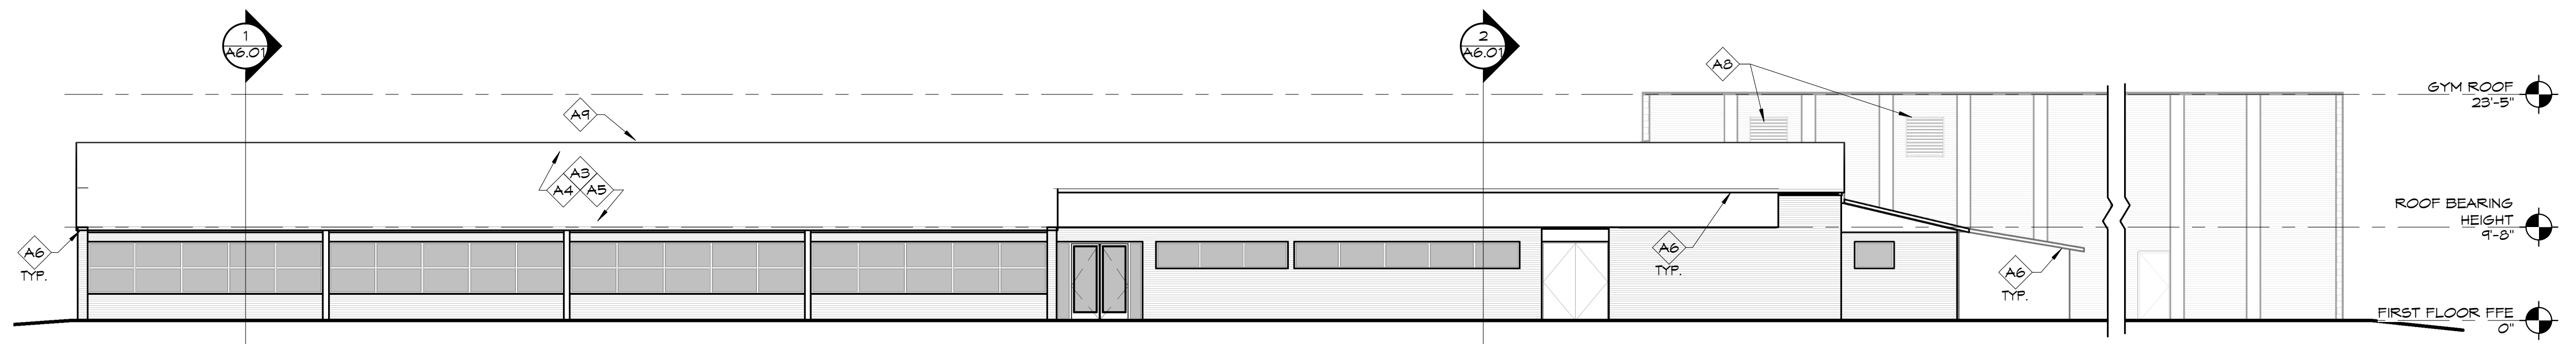
PROPOSED EXTERIOR ELEVATION 4
3/32" = 1'-0"

PROPOSED EXTERIOR ELEVATION 3
3/32" = 1'-0"

PROPOSED EXTERIOR ELEVATION 2
3/32" = 1'-0"

PROPOSED EXTERIOR ELEVATION 1
3/32" = 1'-0"
