**Environmental Review for Activity/Project that is Categorically
Excluded Subject to Section 58.5
Pursuant to 24 CFR 58.35(a)**

Project Name: Davis Ventures Community Center

Project Location: 33478 U.S. Highway 264, Engelhard, Hyde County, NC 27824

ROOF & BUILDING REPAIRS

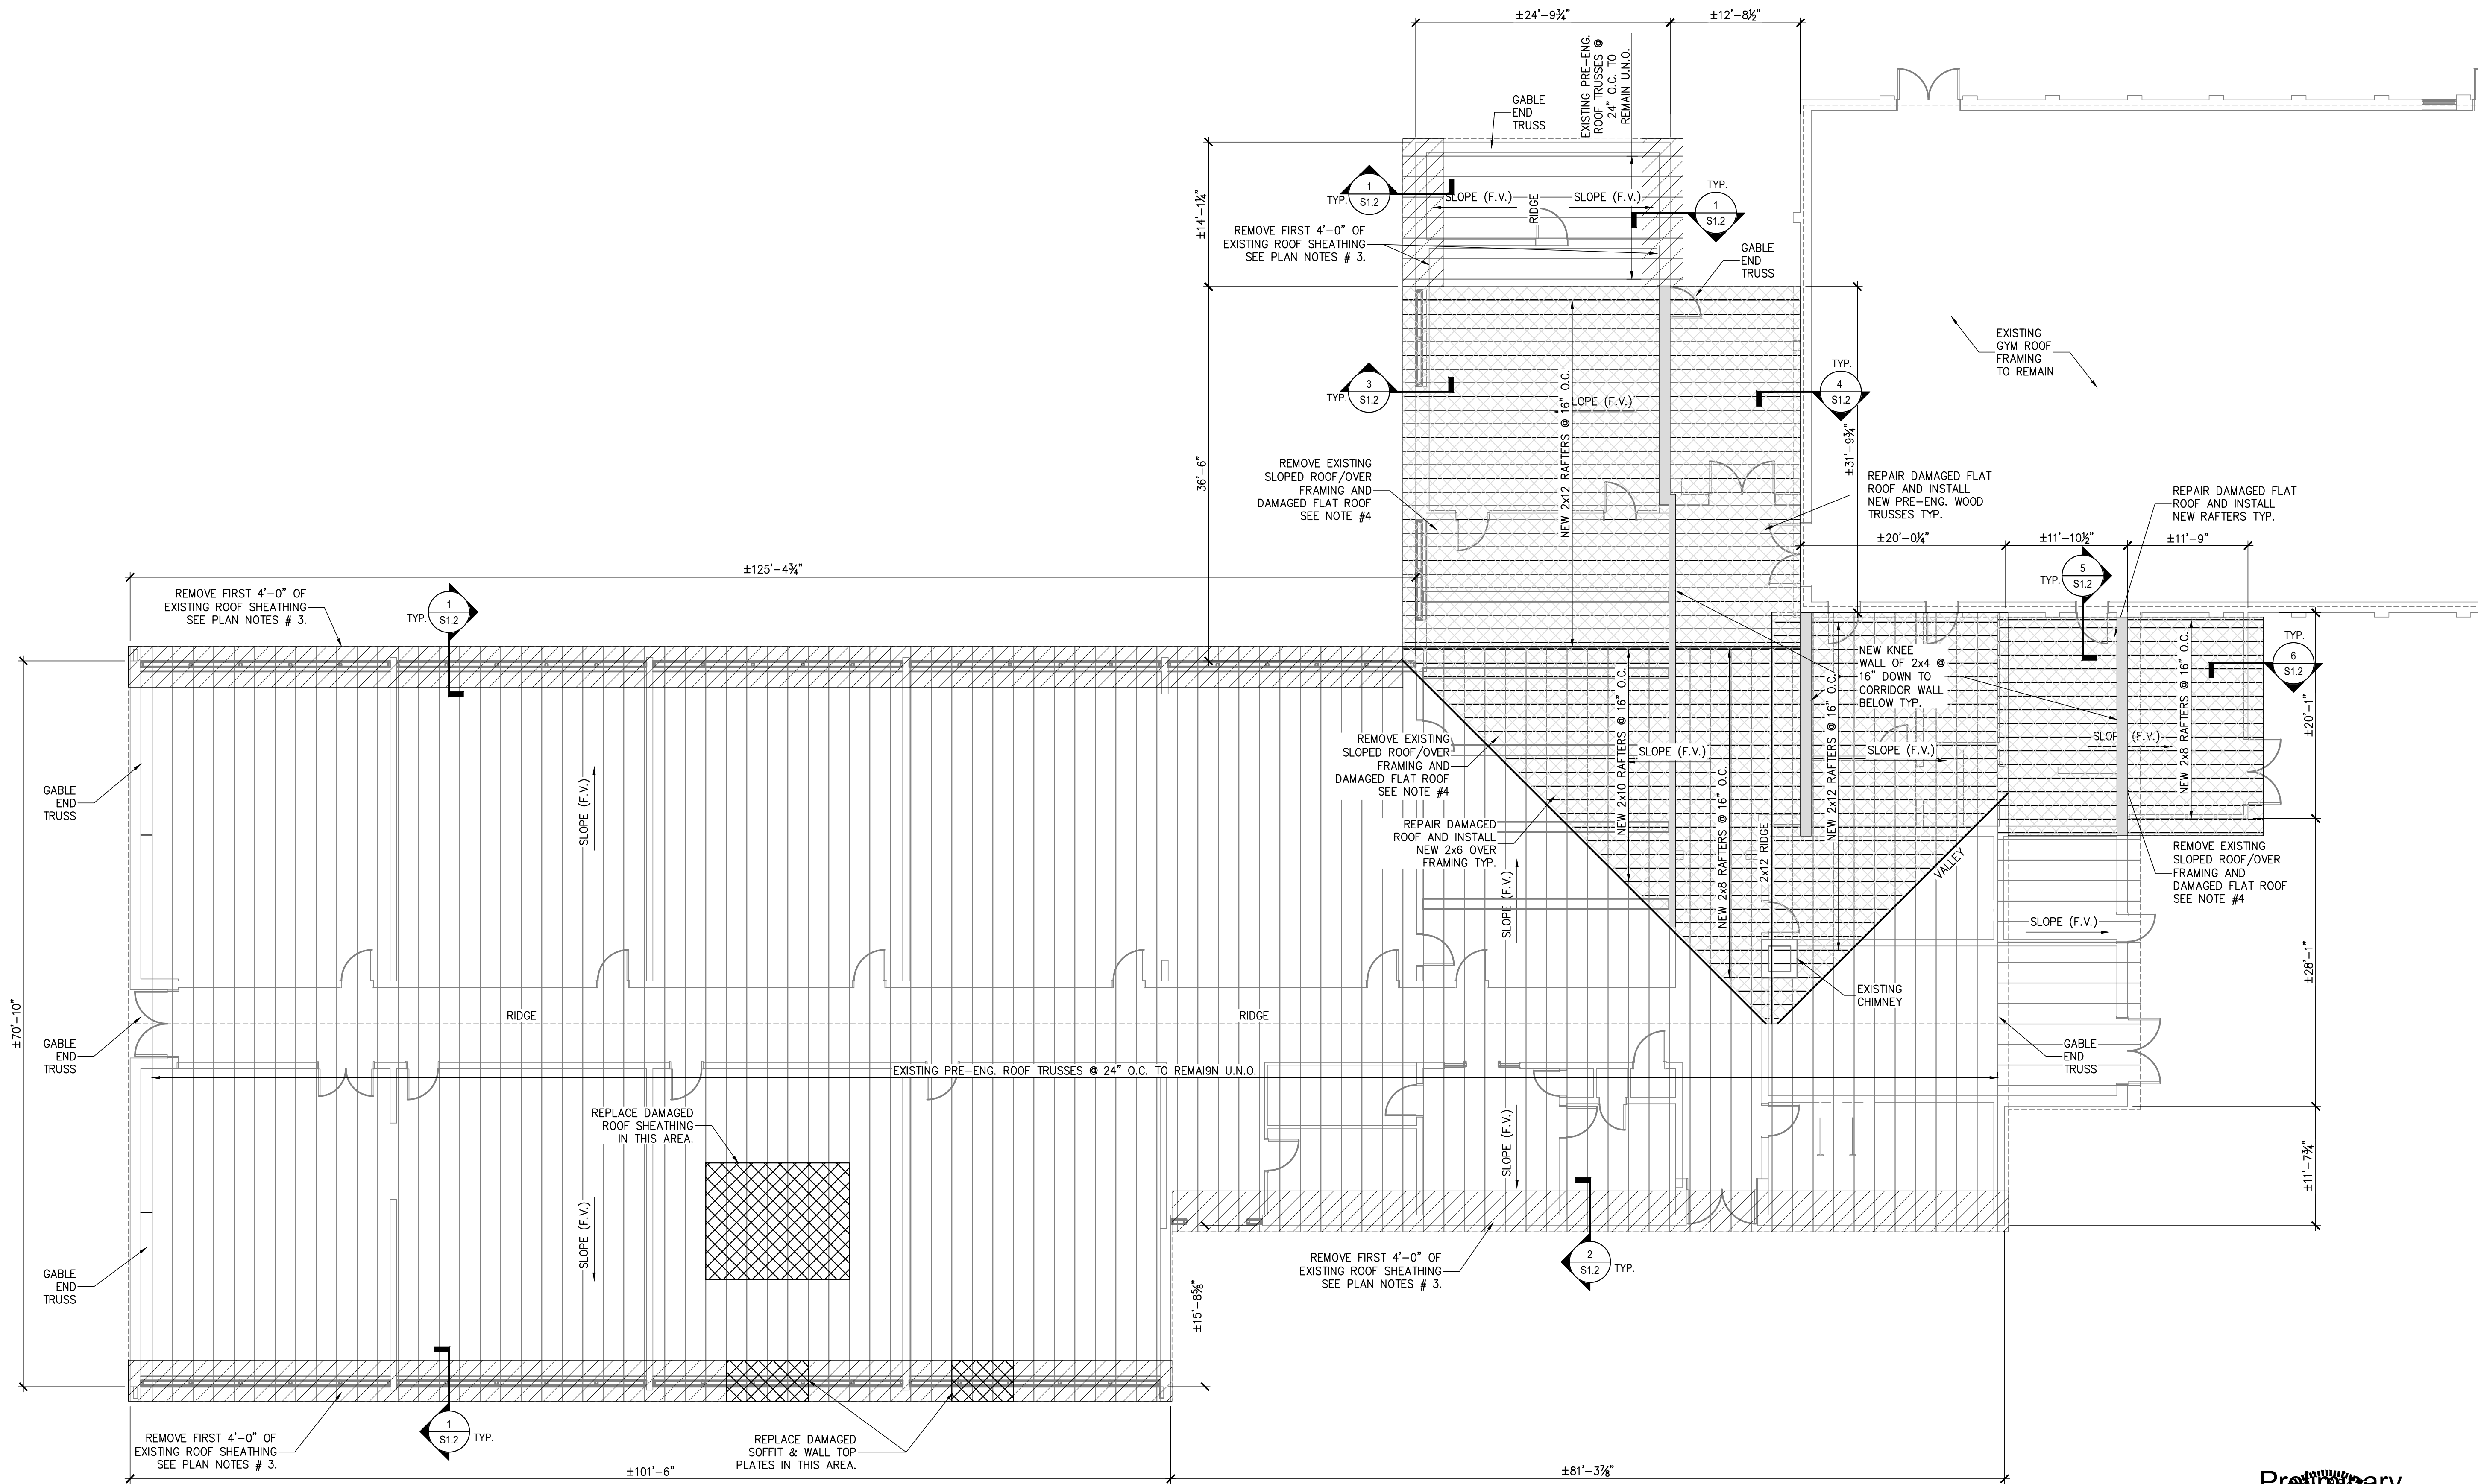
PARTIAL ROOF FRAMING PLAN

- SEE SHEET S1.2 FOR DESIGN CRITERIA, GENERAL STRUCTURAL NOTES AND SCHEDULES.
- ALL BUILDING DIMENSIONS ARE FROM FACE TO FACE OF STUD WALLS, U.N.O.
- REMOVE FIRST 4'-0" OF ROOF SHEATHING TO EXPOSE TRUSS ENDS FOR INSTALLATION OF NEW HURRICANE TIES AT EA. TRUSS, U.N.O. AND REINSTALL ROOF SHEATHING TO MATCH EXISTING.
- REMOVE EXISTING SLOPED ROOF OVER FRAMING AND DAMAGED FLAT ROOF (ORIGINAL ROOF) WOOD FRAMING IN THESE AREAS. REPAIR ORIGINAL ROOF, AND INSTALL NEW FRAMING AS SHOWN ON PLAN, TO MATCH EXISTING.
- ± DENOTED FIELD VERIFY ALL DIMENSIONS WITH ARCHITECTURAL DRAWINGS.
- U.N.O. DENOTES UNLESS NOTED OTHERWISE.

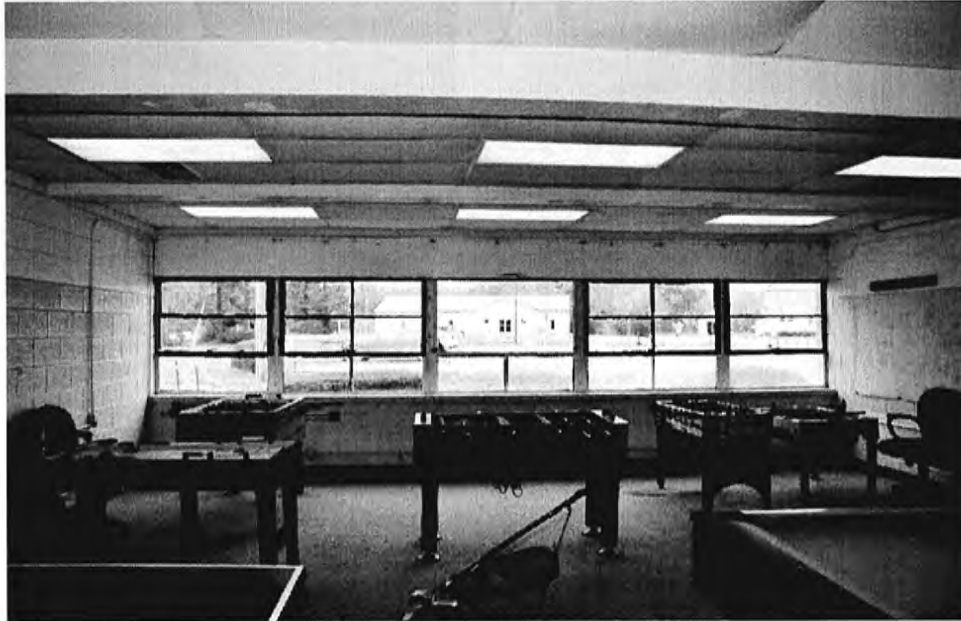
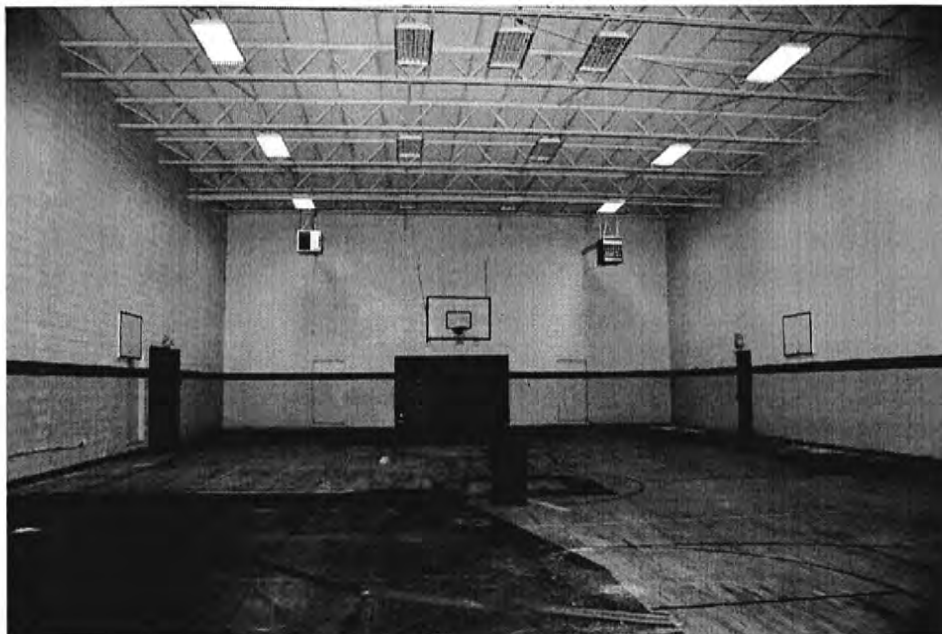
8. northwest classroom, looking west (above) and
9. gymnasium/auditorium, looking south (below)

The 1964 gymnasium/auditorium has painted concrete-block walls, a hardwood floor, and exposed steel roof trusses. Insulated ceiling panels above the trusses ameliorate noise during athletic events. The roof and floor were replaced in 2004 following complete destruction in September 2003 during Hurricane Isabel. In September 2019, rain from Hurricane Dorian penetrated the wall vents and again destroyed the floor, which will be replaced. At the gymnasium's northwest corner, two small locker rooms with showers flank the athletic equipment storage room. These rooms, located between the 1953 building and gymnasium, have sustained extensive ceiling damage due to roof failure. The restrooms have plaster ceilings. The storage room's roof structure—trusses and insulated ceiling panels—have always been exposed. Faux-wood paneling covers a portion of the north locker room walls.

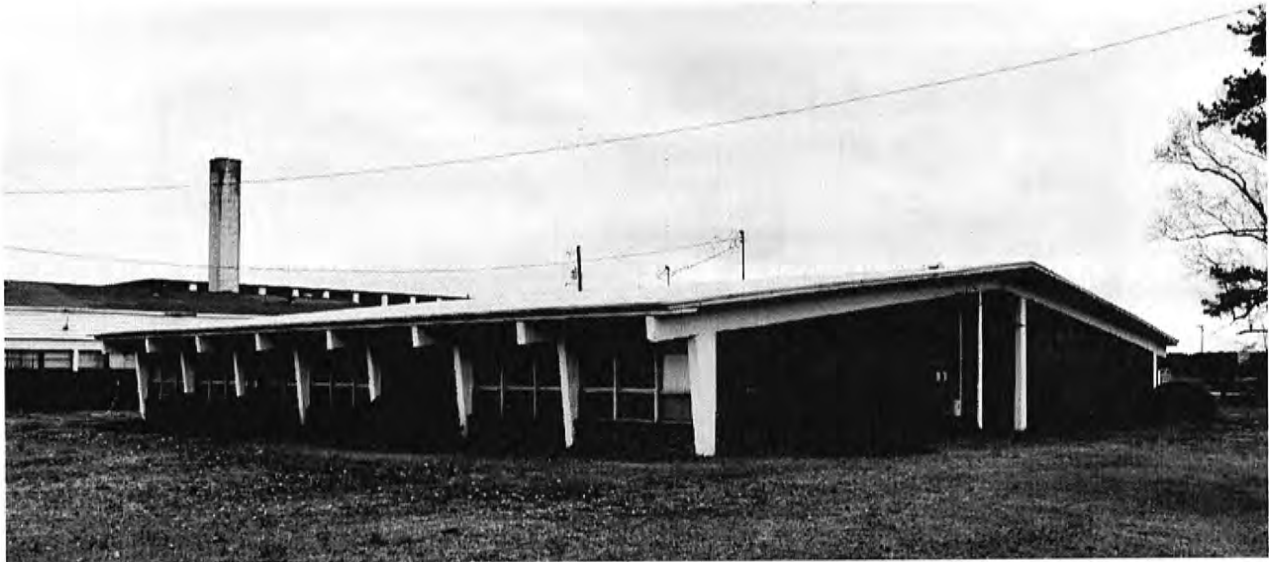
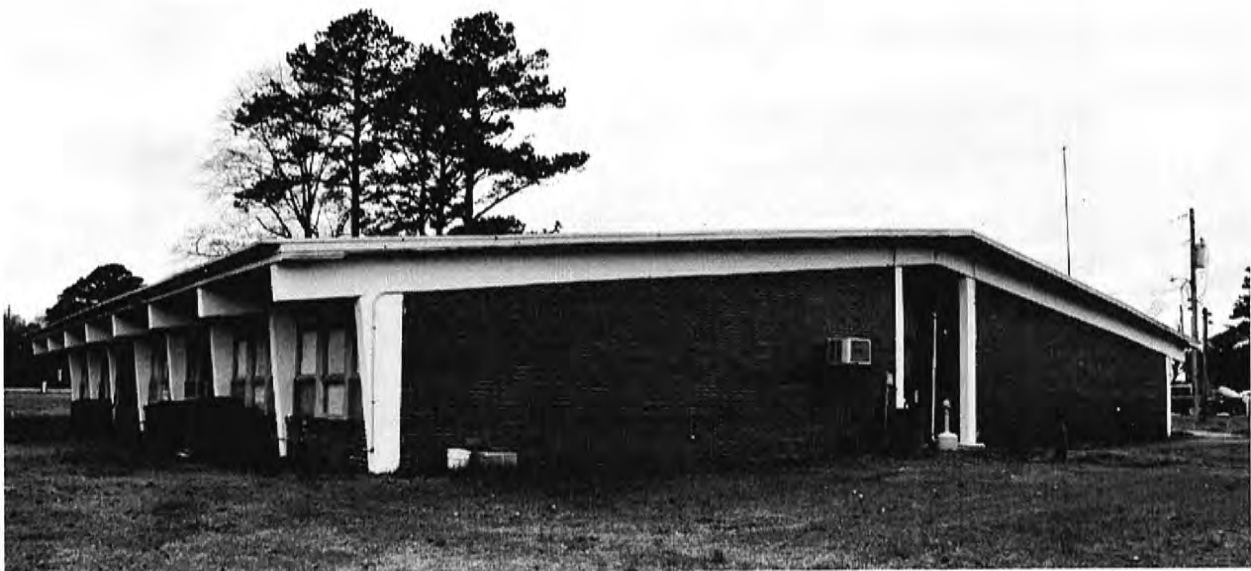
10. 1964 classroom building, northwest oblique (above) and 11. southeast oblique (below)

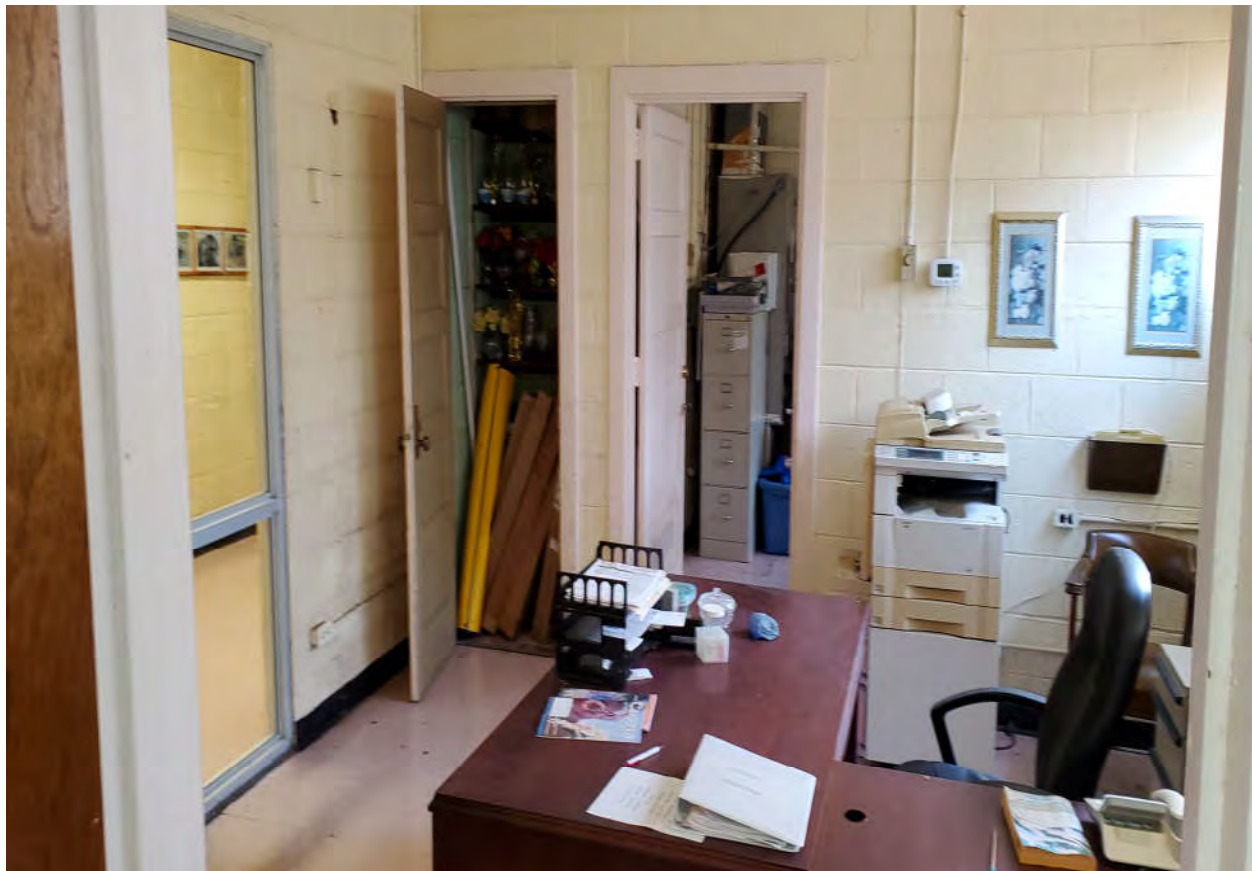
Photograph 8 - Typical Lead-Based Paint on CMU Walls in This One Room Only in Office Area in Main Building.

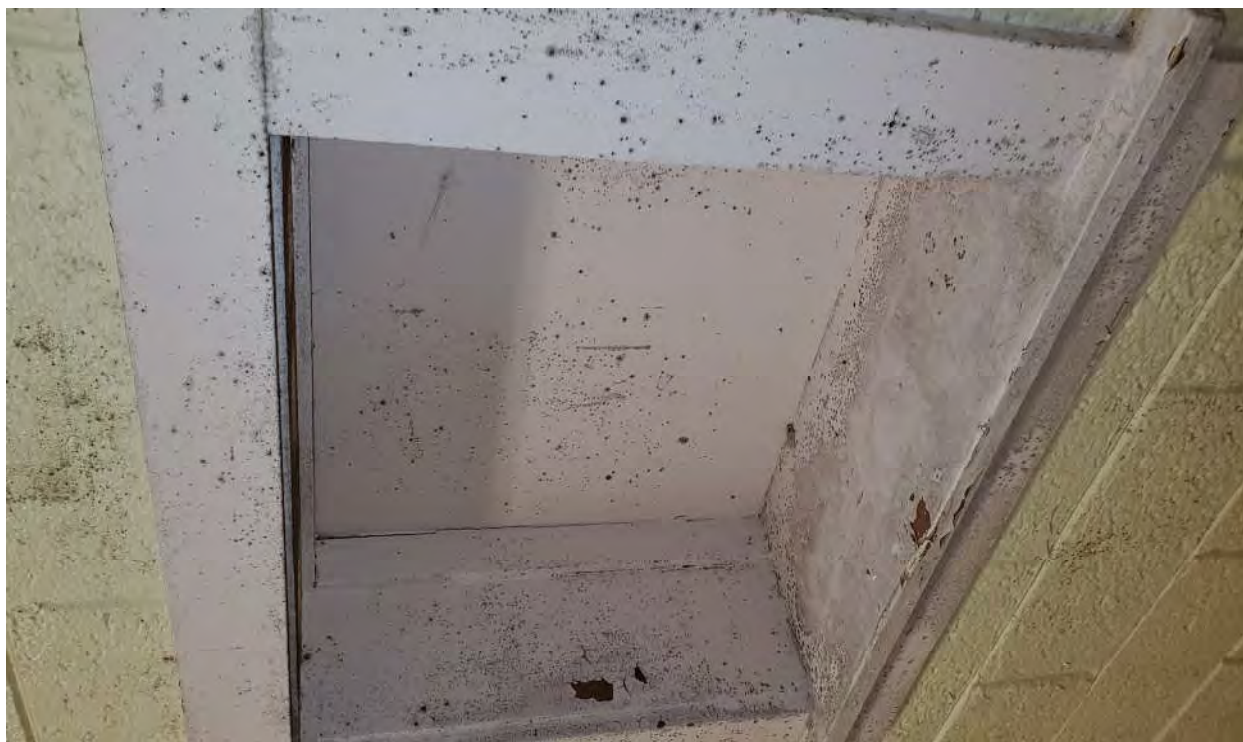
Photograph 11 - Typical Mold Growth on Walls, Door Components, & Other Surfaces Located Throughout the Main Building.

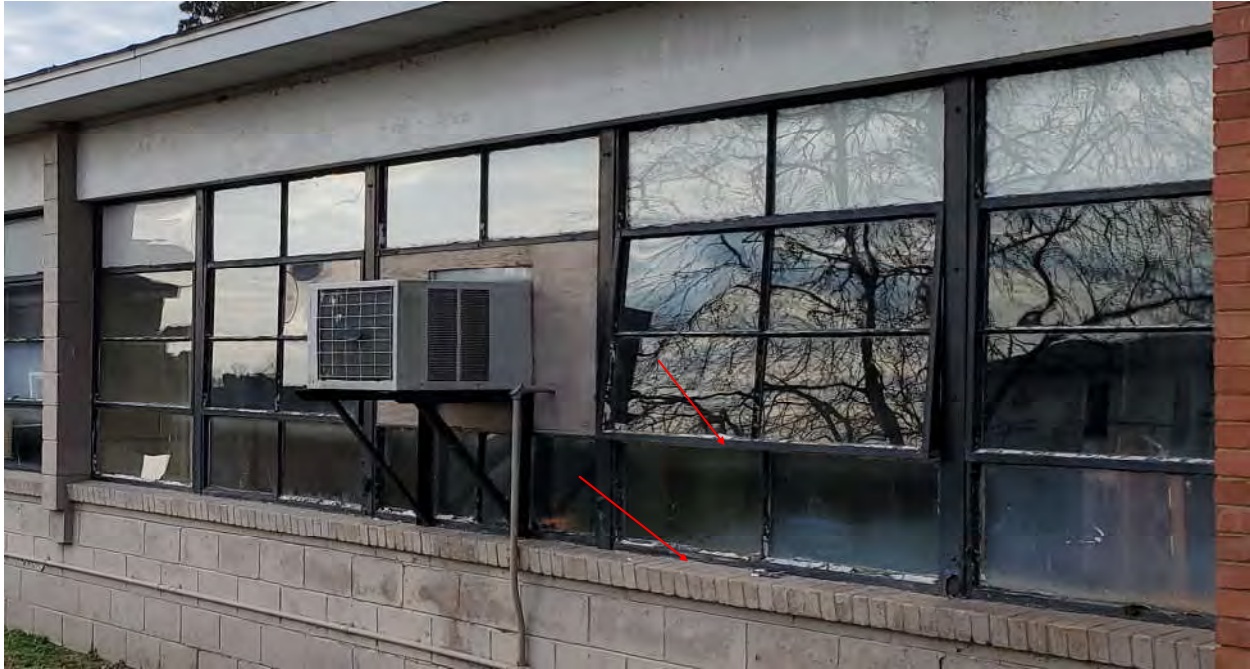
Photograph 1 - Homogeneous Areas A-01 & A-22—Typical Asbestos-Containing Exterior Window Glazing and Window Frame Caulking Located Throughout Main Building Window Units. (57 Window Units)

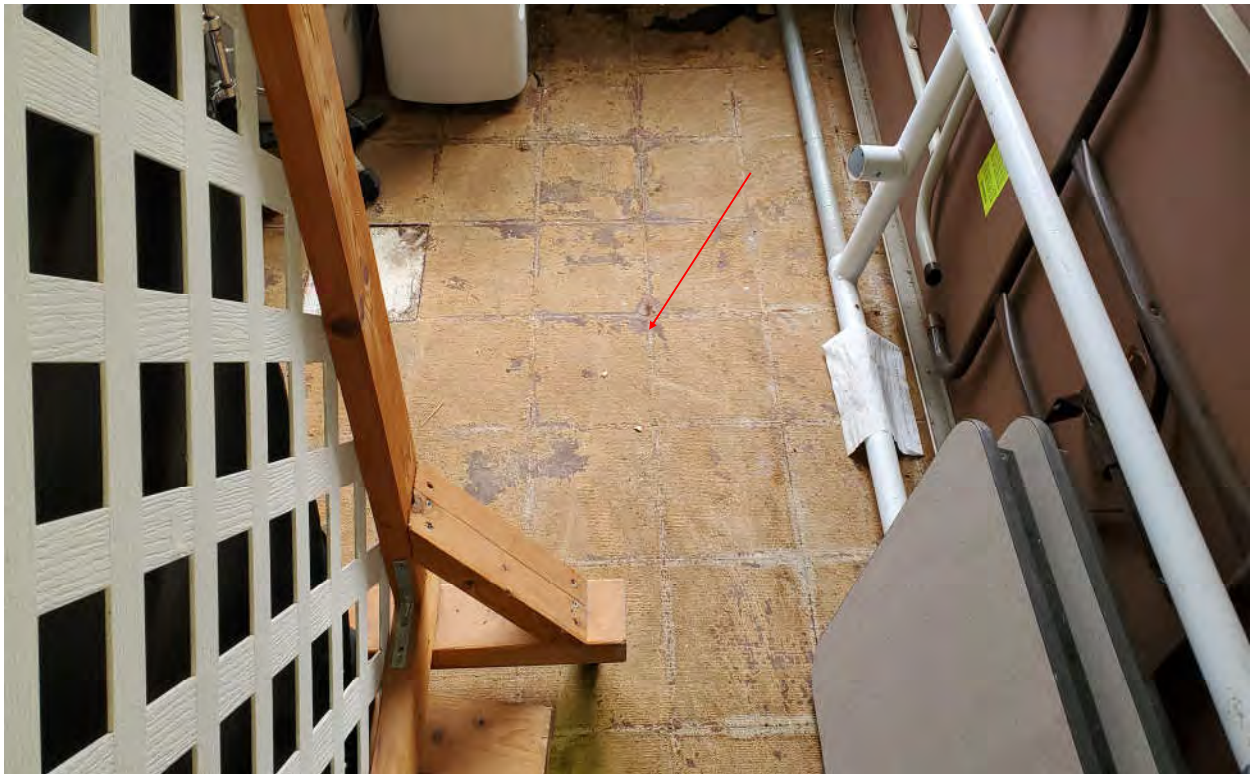
Photograph 2 - Homogeneous Area A-06—Typical Asbestos-Containing 9" x 9" Floor Tile & Black Mastic (Green & Brown Colors) Located as Underlayer Throughout Main Building Classrooms, Corridors, & Office Area Under Carpet or Non-ACM Floor Tile or Linoleum (9,700 SF)
